RE: Brittany Commons
Rochester, NY 14618

INTRODUCTION

Per your request, we performed a limited visual inspection of the exterior siding and roofing for 5 of the 19 buildings of the subject townhouse complex. This was to provide a professional opinion as to the condition of the siding and the roofs, along with the expected remaining life. These inspections were performed from the ground and with the use of a 14 foot telescoping ladder to view and walk many of the roofs. We did not directly walk a few of the roofs towards the center of each building, but walked the roofs on each end of the subject buildings as well as several of the adjacent accessible roofs.

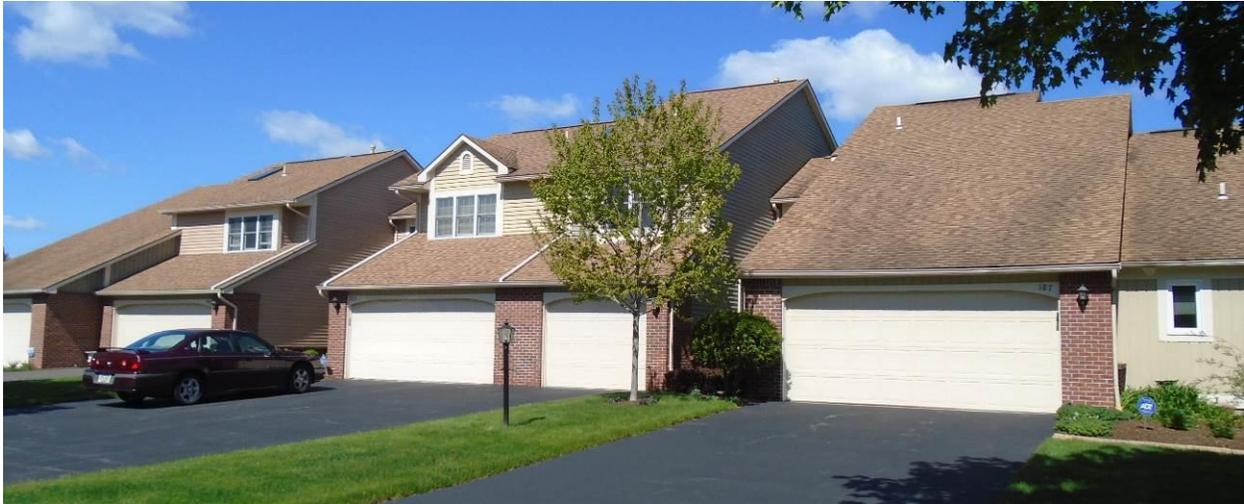
Bldg "O" (example of typical building with various types of siding)

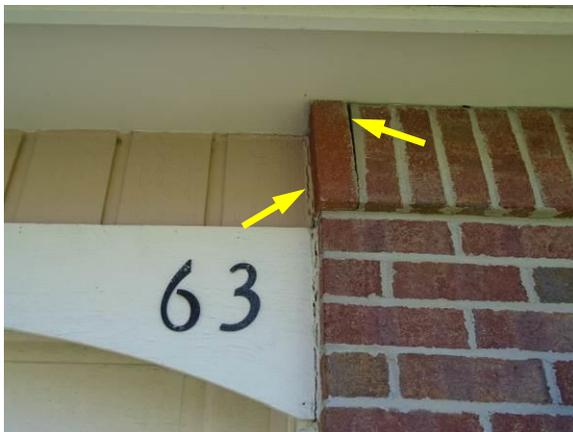
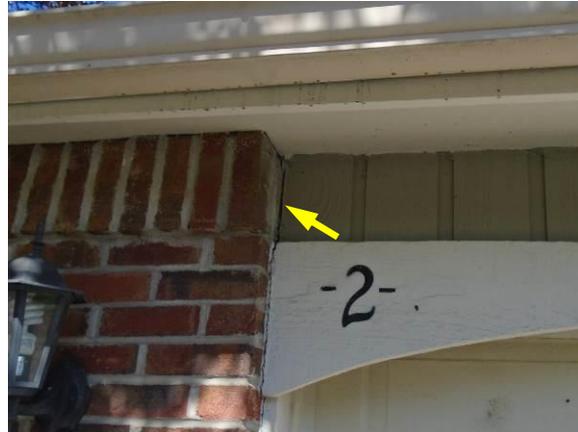
In general, the brick siding appeared to be in good condition. We noted a few small cracks, such as one at a corner of the garage door opening of unit #63. Such cracks should be kept caulked or repointed as maintenance. The subject crack is likely due to slight sag of the garage door header, and the sag of the garage door headers is also causing some gaps between the brick siding and adjacent wood siding and wood trim. We did not find visible sag to an extent that requires structural repairs to the garage door opening headers at this time, but periodic gaps will need to be repaired because of slowly progressing, ongoing sag.

Minor cracks and gaps at garage door openings

The brick siding is in serviceable condition other than some minor caulking or pointing repairs that could be made. The brick siding should be kept in service and maintained.

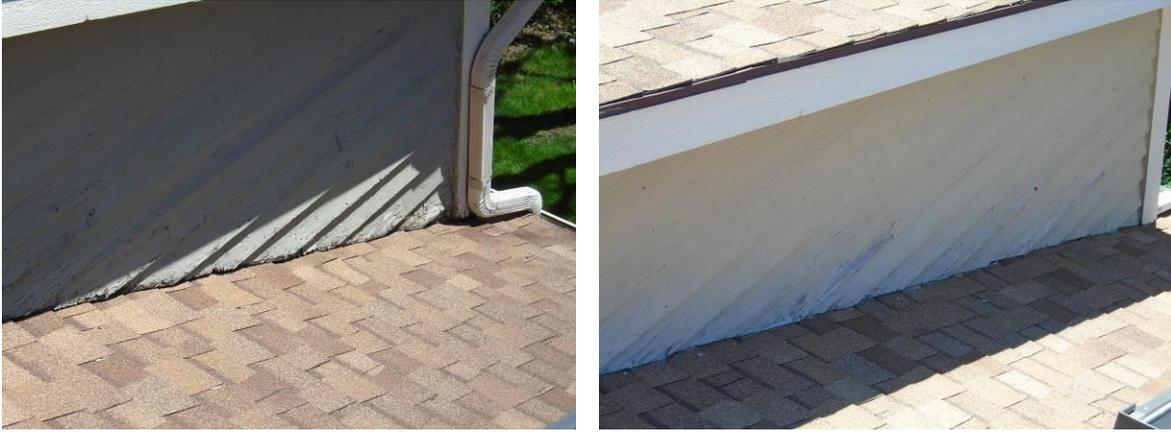
The horizontal clapboard style wood siding is mostly in serviceable condition. We did find some deteriorated areas, mostly along chimney enclosures. Also, stain and paint on this siding is peeled and worn in several areas to varying degrees.

Bldg. "H" and Bldg. "F" worn upper horizontal siding

The horizontal wood clapboard siding is in serviceable condition in most areas, except where exposed directly to water with some frequency, such as chimney enclosures and where flashing is lacking at intersections with roofs and gutters. Chimney enclosures should continue to be replaced with vinyl siding and flashing should be improved at intersections to direct water away from wood siding with some areas of siding that could be replaced. Yes, additional horizontal clapboard wood siding will need to be replaced due to ongoing weathering and wear as time progresses, and eventually considering complete replacement with vinyl siding will be warranted.

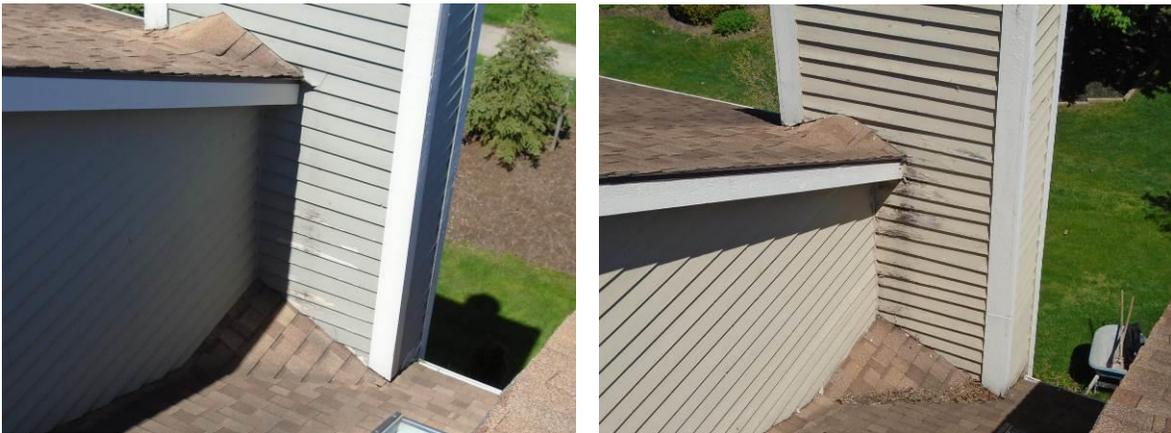
Chimney enclosures have deteriorated more than other wood siding and trim. This is due to the number of angles and intersections associated with these, and the resulting increase in the amount of water flowing across them and their exposure to the weather. Several chimney enclosures already have vinyl siding on them. The chimney enclosures are originally for wood burning manufactured fireplaces with metal fireboxes and metal flues, but some have been converted to gas fireplaces. It appears that almost every townhouse has a related fireplace and chimney enclosure.

Examples of worn chimney enclosures on Bldg. "O" and Bldg. "L"

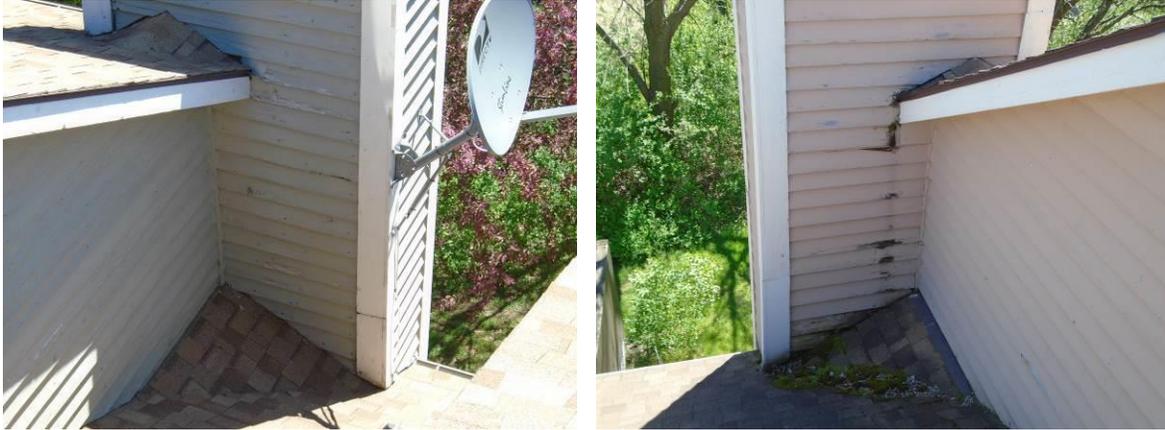
Additional deteriorated chimney enclosures on buildings "J" and "H"

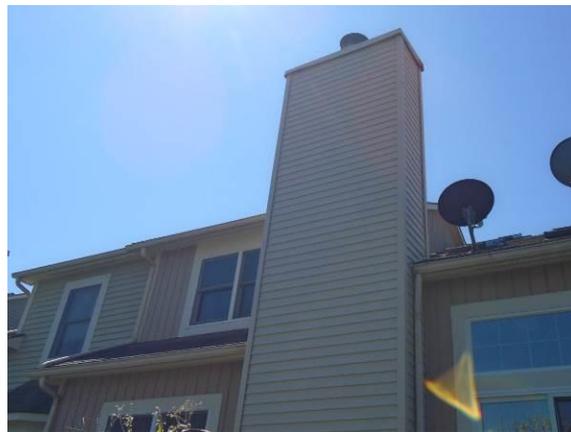
Example of a vinyl sided chimney enclosure of Bldg. "L"

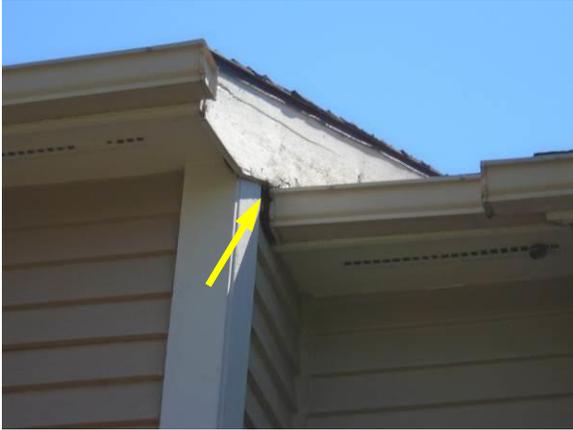
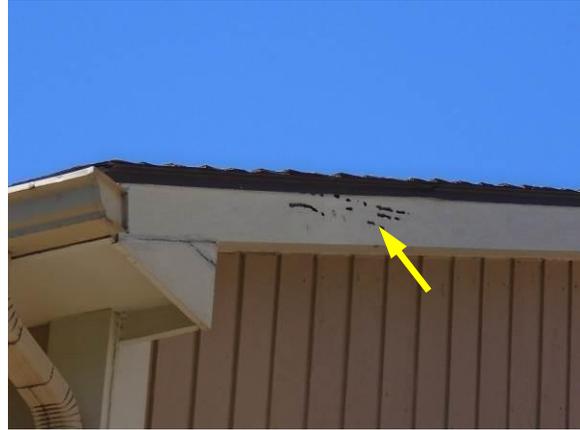
The vertical lap wood siding is in the worst overall condition, compared to the other types of siding. This has rotted and deteriorated significantly in several areas where the siding intersects brick ledges, intersects roofs, and intersects flashing. The extent of damage is difficult to determine, since there could be rotted and deteriorated materials behind the moisture damaged siding. Also, moisture damaged siding and damp building materials can attract carpenter ant activity, and, per our discussions, some of the buildings are being treated for carpenter ant activity currently. Also, we noted what appeared to be some moisture damage where units #65 and #67 have roofing and trim that intersect at the front and we suspect that ant activity is occurring in this area at the front of building "H".

Potential location of carpenter ants and location of carpenter bee damage (Bldg. "H")

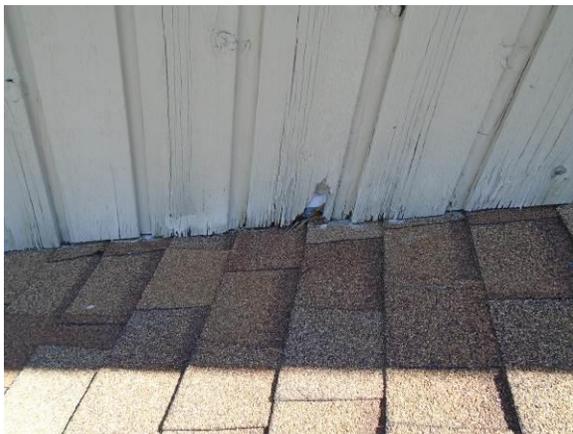
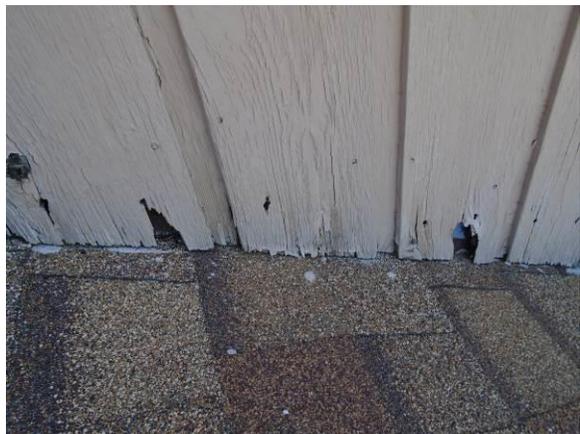
Damaged and rotted vertical siding (Bldgs. "O" and "L")

Overall, the vertical lap wood siding is in the worst condition of all of the siding. This has significant gaps and openings where it is rotted where it meets roofing and brick ledges. A lack of good flashing in such areas has accelerated this deterioration. Where siding meets horizontal ledges and flashing, deterioration has been more severe. If making repairs or replacements in such areas, the flashing should have a significant pitch away from the siding rather than being horizontal. Maintaining a space between roofing and siding is recommended, and flashing at these junctions can remain exposed for one or more inches above the roof surface to prevent the siding from rotting at the roof level.

In general, beginning to replace more and more of the vertical wood siding is recommended. This type of work should begin in the near-term in the most worn areas, and it is difficult to single out certain areas, since the deterioration is fairly widespread and is fairly consistent. One could obtain pricing for only replacing the vertical siding along with additional pricing to replace both the vertical and the horizontal wood siding.

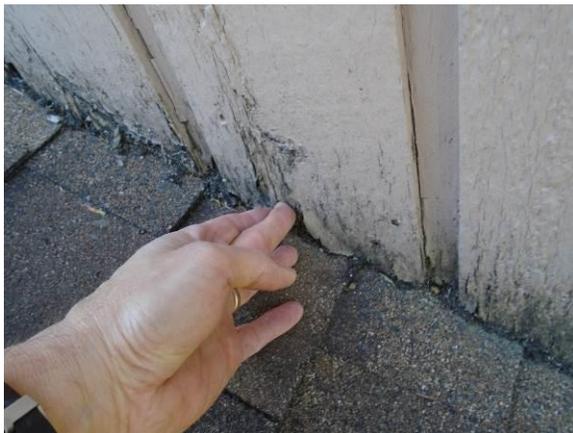
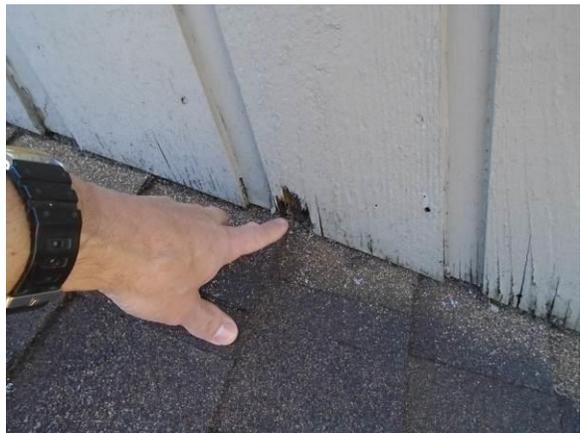
Damaged and rotted vertical siding (Bldgs. "J" and "H")

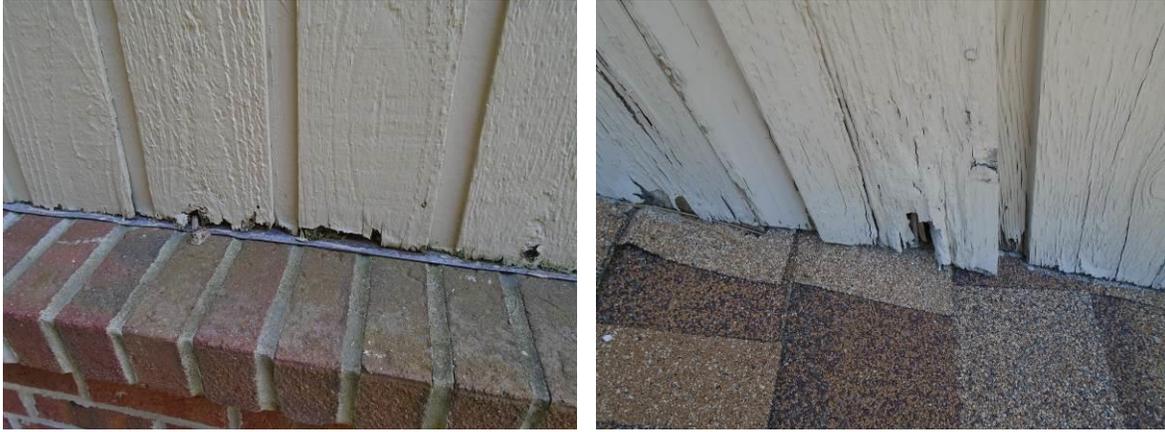
Rotted vertical siding of Bldg. "F"

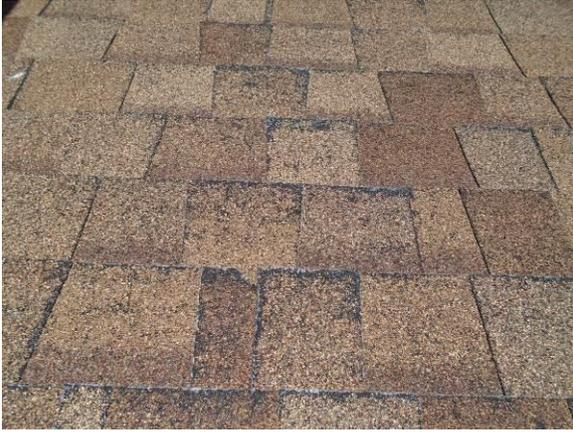
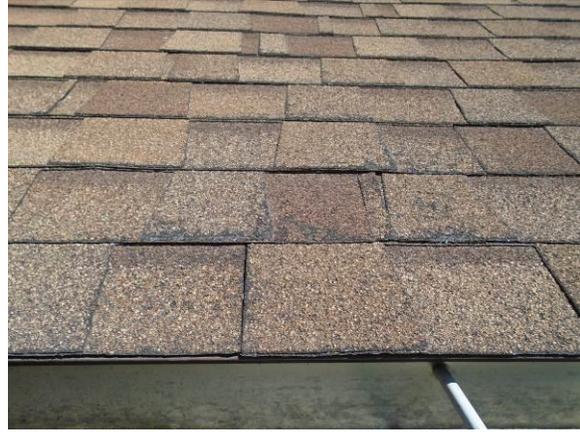
In general, of the buildings we inspected, buildings "O" and "L" show signs of more advanced deterioration of the roof shingles, such that they are in the later years of their expected lives and we suspect that these roofs were installed closer to the year 2000. Building "H" has roofs that are older and might be one or two years newer than buildings "O" and "L" (perhaps from 2002?). Building "F" has roofs that are in better condition than most of the buildings we looked at and they are probably three to five years newer than buildings "O" and "L" (perhaps from 2003-2005?). Building "J" had roofs in the best condition of the buildings that we examined, and this might be closer to the midpoint of its average expected life, if not newer than that (perhaps installed around 2005 or more recently than that?).

Worn roofs of Bldgs. "O" and "L"

In general, the roofs are still in serviceable condition and we would typically anticipate obtaining anywhere from one to four years of additional serviceable life from the older looking roofs of buildings "O" and "L". It is likely that one will obtain perhaps eight to ten years of additional serviceable life from the roofs of building "J", and perhaps four to seven years of life from the roof of building "F" and three to six years of life from building "H". These estimates can vary widely depending on rates of future wear, the severity of weather, and other factors.

As previously mentioned, in regards to the roofs, we recommend replacing roofs that are 17 – 20 years old. A schedule of replacement should be drawn up based on known ages and the information in this report about the sample buildings.

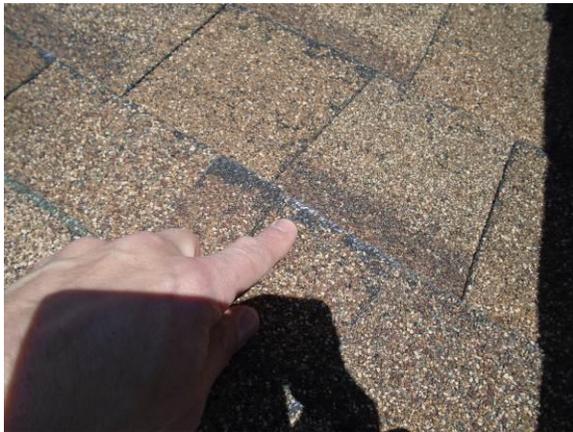
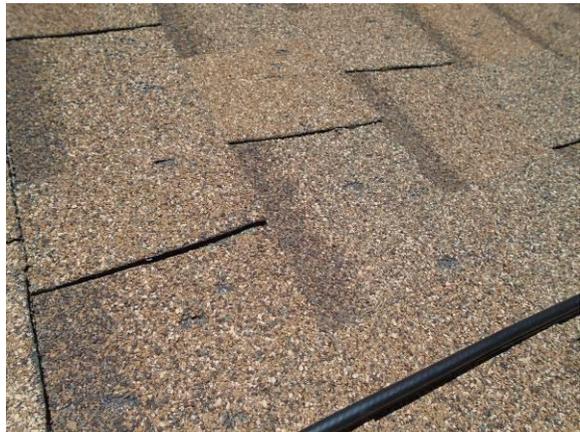
Worn roofs of Bldg. "H" and slightly chipped shingles of Bldg. "F" from ice removal at a valley/chimney

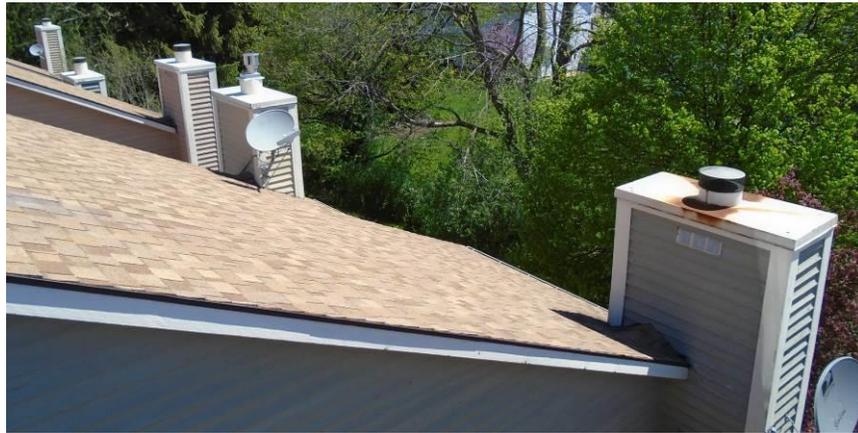
Bldg. "J" roofs are newer looking

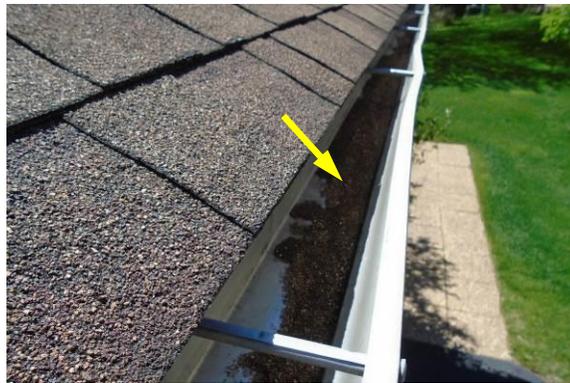
Roof granules have significantly worn away from the older shingles that we examined. A large number of roof granules were found in the gutters because of this.

Roof granules in gutters

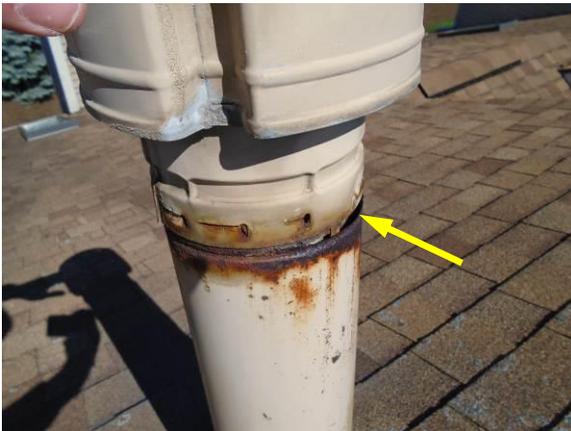
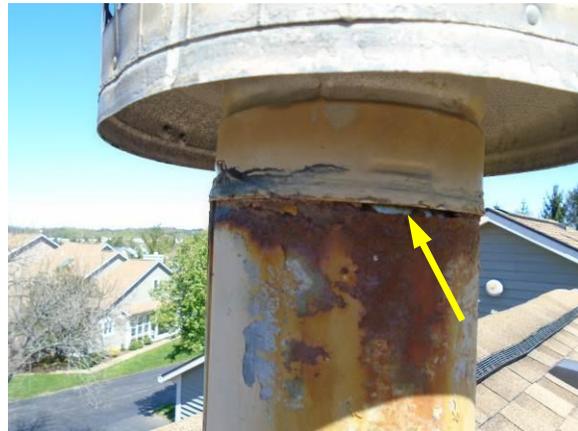
The type B-vent flue pipes that go up through the roofs vary in condition. In general, these are rusted and deteriorated and several are cracked and damaged. We even noted a missing weather cap from one of the vent pipes. These vent pipes typically serve water heaters and might serve older furnaces as well. The upper portions of these vent pipes should be removed, if not in use, or should be replaced, when resurfacing roofs in the future, or sooner if there are holes and cracks.

Cracked and rusty flues on Bldgs. "O" and "J"

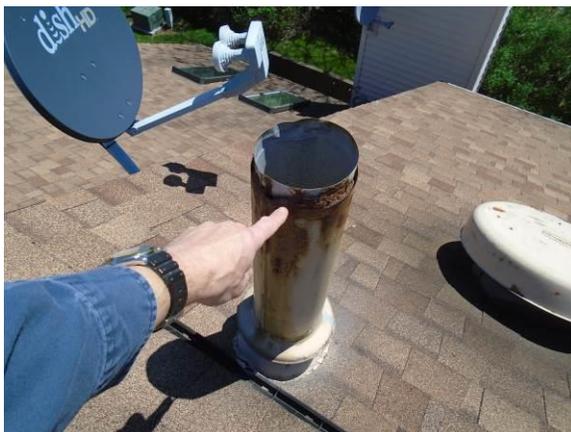
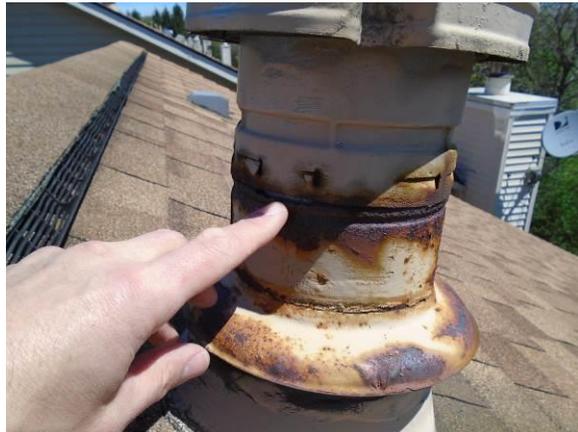
Missing cap and cracked flues on Bldg. "H"

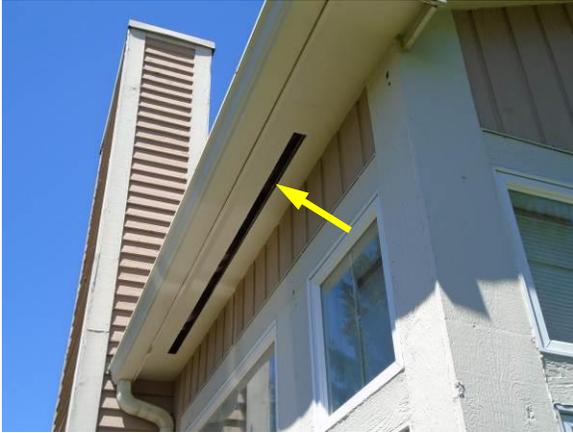
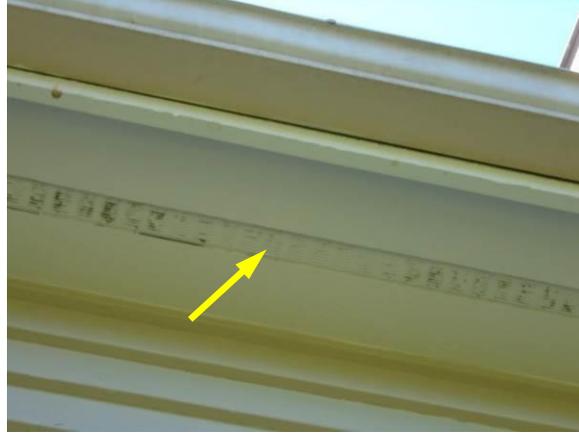
There are a good number of birds nesting in the eaves of the roofs in various locations due to a lack of proper flashing and damaged trim and siding. In one location, the soffit vent grilles are missing at the rear of unit #28, and this should be replaced to prevent birds from entering and nesting. There are soffit vents blocked by dust and debris that should be cleaned and others painted over that should be replaced. In several areas, where roof overhangs intersect other roof surfaces, there are gaps and there is flashing missing that is allowing birds to nest.

Missing soffit vent grille of Bldg. "F" and painted over grille of Bldg. "L"

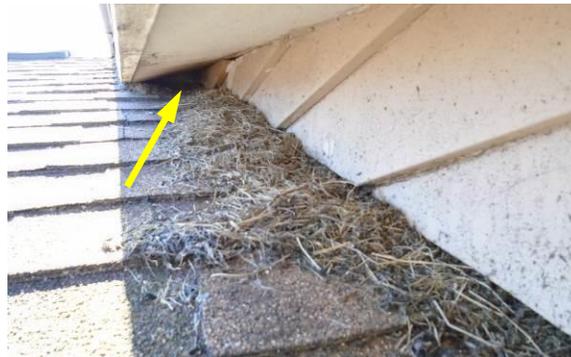
Birds nesting in eaves of Bldg. "O"

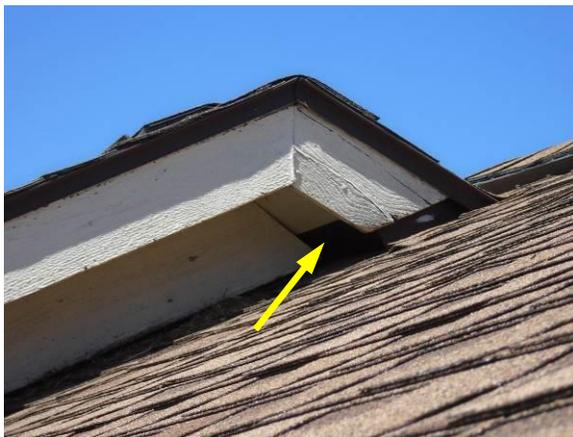
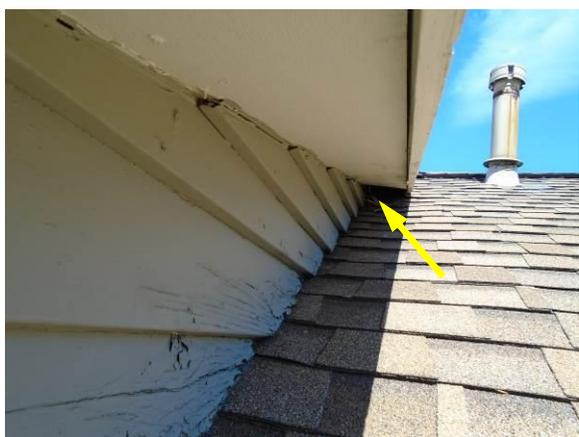
Gaps in trim Bldg. "F"
