RE: Brittany Commons  
Rochester, NY 14618

### **INTRODUCTION**

We performed a limited visual inspection of the exterior siding and roofing for 14 of the 19 buildings of the subject townhouse complex. This was to provide a professional opinion as the condition and the expected remaining life of the siding and the roofs. These inspections were performed from the ground and with the use of a 14 foot telescoping ladder to view and walk many of the roofs. We did not directly walk a few of the less accessible roofs towards the center portions of the buildings, but we walked the roofs on each end of the subject buildings as well as several of the adjacent accessible roofs.

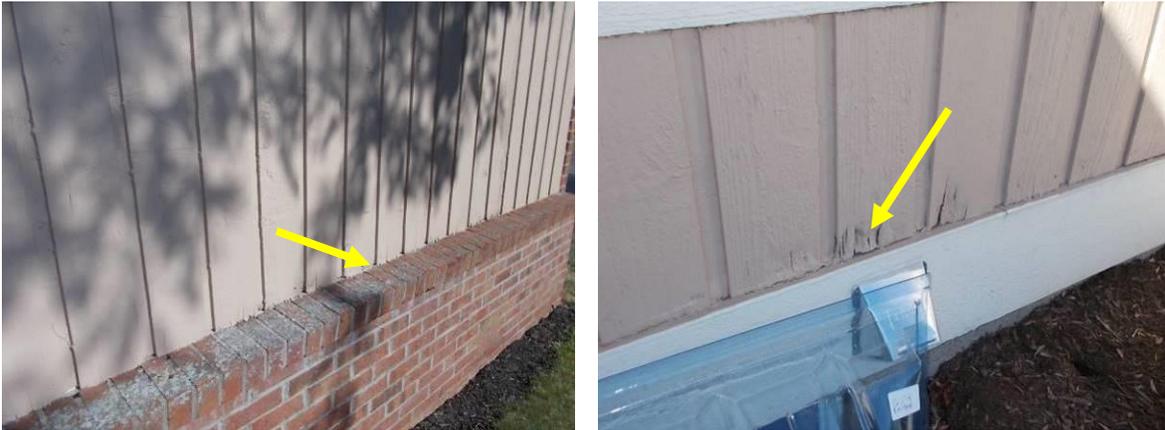
We noted many areas of deteriorated or rotted siding around the building. This is most evident where the vertical siding is in contact with the brick siding’s water table or with the roof surface. Typically, this deterioration is an indication of improper flashing.

*Deterioration at Water Table & Area of Rot*

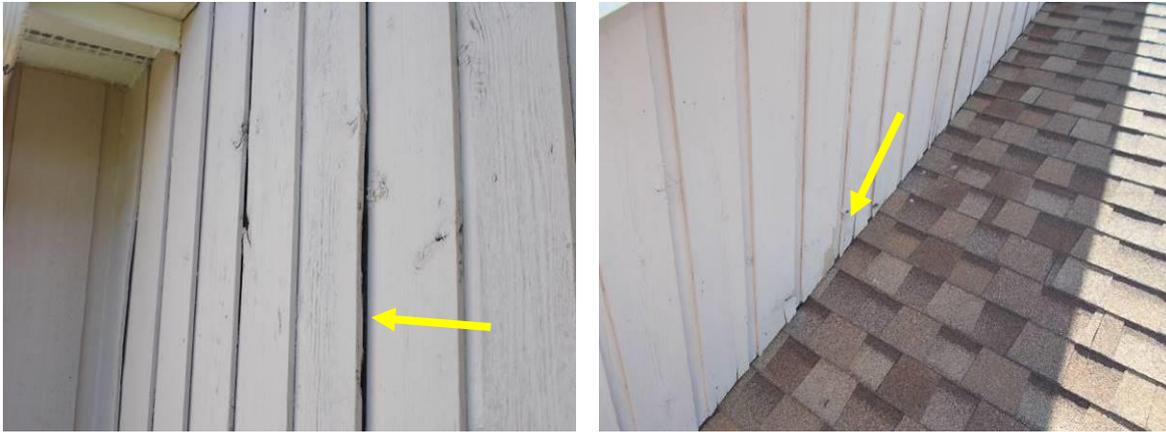
There are several areas around the building that have developed gaps between the vertical laps. These gaps can be an access point for unwanted moisture or pests.

*Opening Gap & Deterioration at Roof Surface*

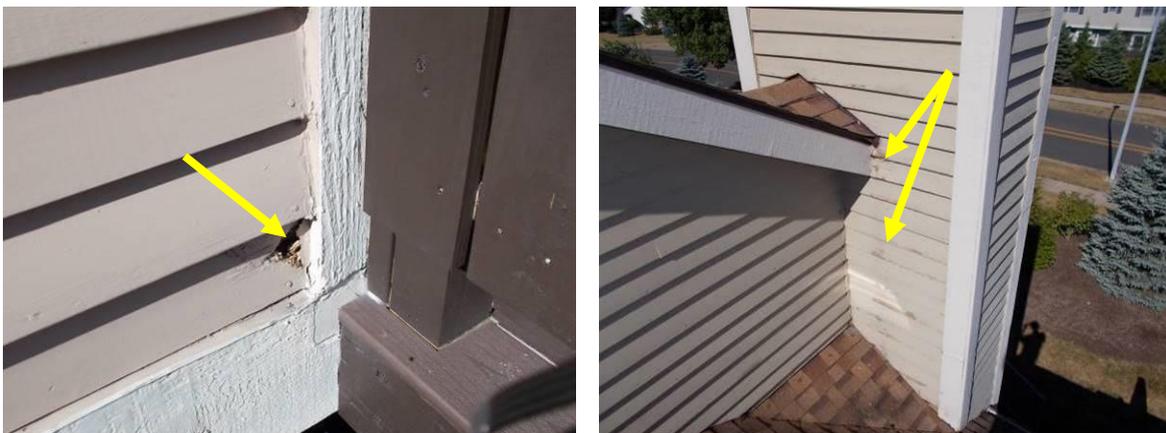
The horizontal clapboard wood siding has suffered isolated deterioration in areas in contact with roof surfaces. Also, there is deterioration to the siding on most of the chimney enclosures. This appears to be caused by improper flashing along with awkward roof angles and intersections, causing excessive contact with roof run-off.

*Rot in Clapboards*

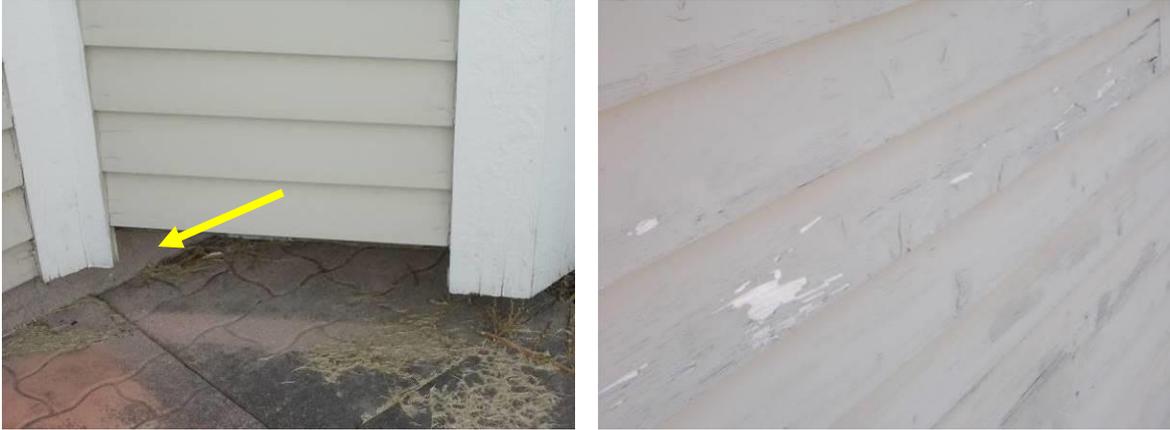
We noted a missing clapboard on a rear bay window of the building. Also, we noted that the chimney enclosure of unit #11 has replacement vinyl siding.

*Missing Clapboard & Paint Delamination*

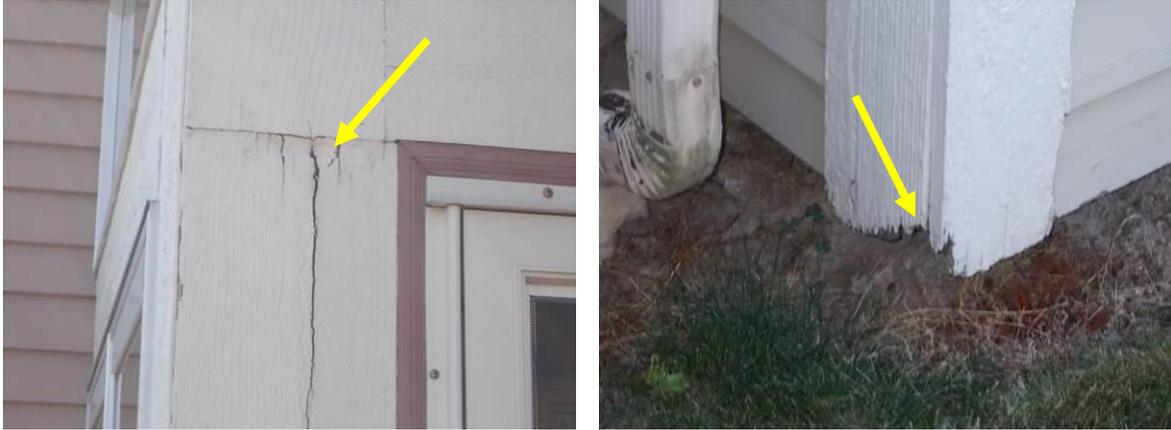
Areas of rot and deterioration were noted sporadically throughout the trim. These were most evident in lower corners of chimney surrounds. Also, we noted deteriorated or rotted trim at the lower corners of some window surrounds.

*Trim with Rot and Damage*

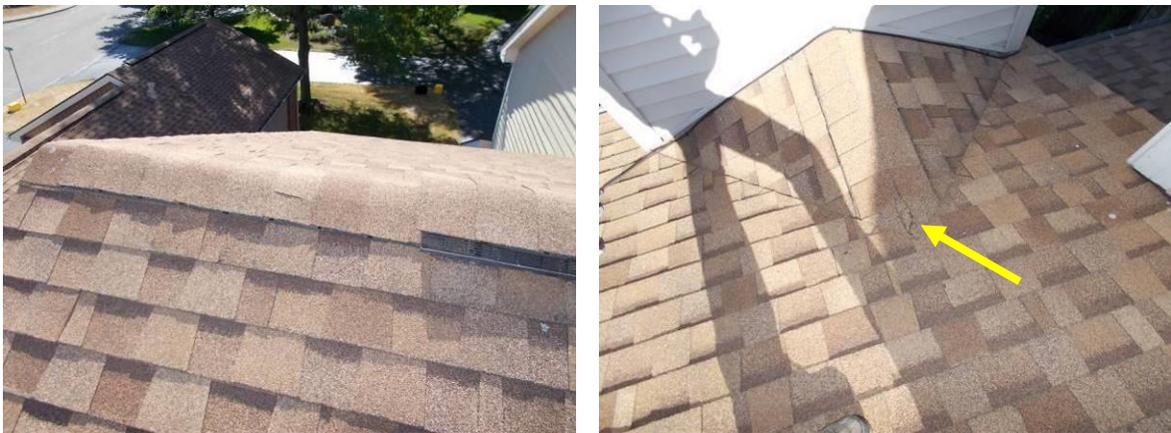
*Roof Surface with Some Damage*

We did note some areas of isolated shingle damage. These damaged areas can be more prone to roof leakage. Damaged shingles can be replaced as needed.

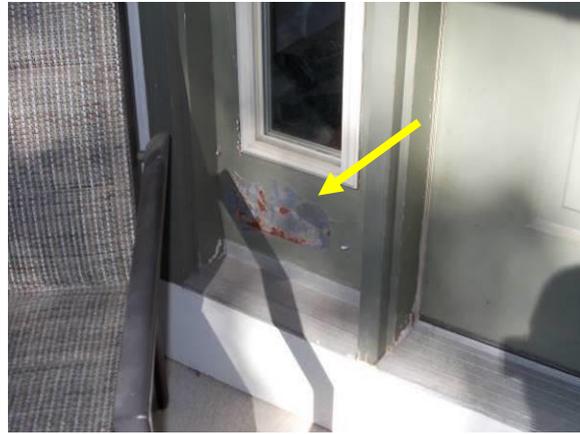
We noted the majority of the steel flue pipes penetrating the roof are rusty. Some amount of painting, repair or replacement may become necessary as deterioration continues.

*Rusted B-Vent and Paint on Front Door*

We noted peeling paint on the front door assembly of one of the units. Preparing, priming, and repainting this is recommended.

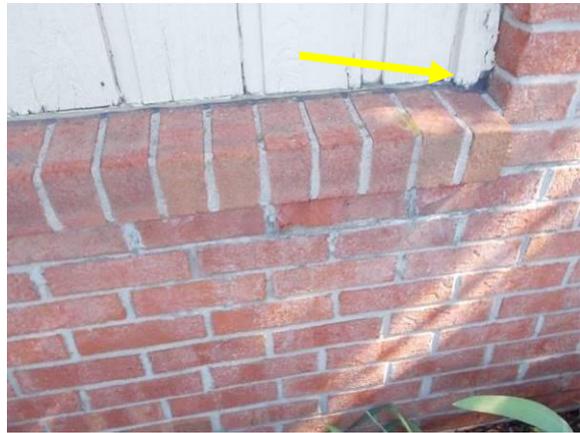
*Rot and Deterioration at Water Table/Brick Ledge*

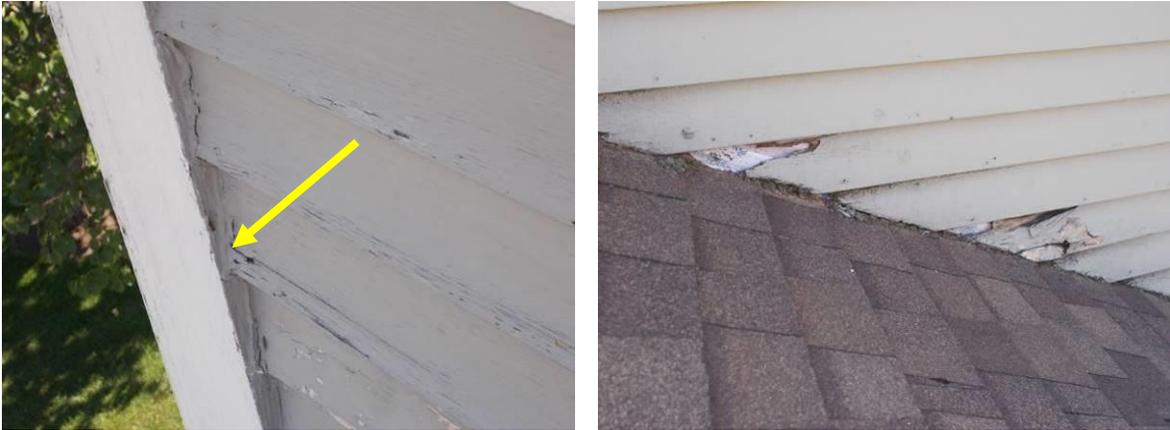
We noted isolated areas of severe rot and damage to horizontal siding on this building. Portions of chimney enclosures have suffered the most concentrated rot and damage. We noted that three of the chimney enclosures on this building have replacement vinyl siding installed already.

*Deterioration to Siding on Chimney Enclosure and at Roof Interface*

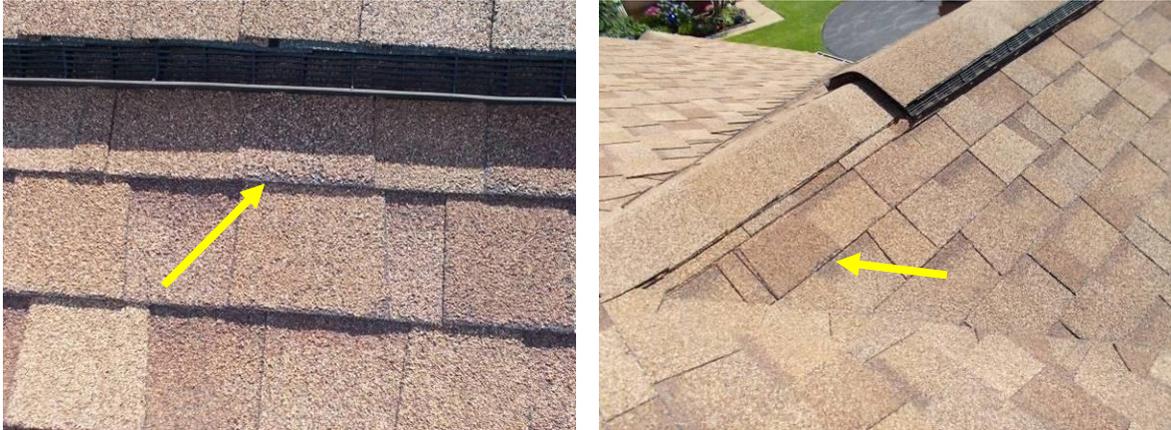
*Examples of Roof Wear*

There are signs of wear and age on the roof surface. This is most evident in some damage to roof shingles as well as the amount of granules that appear to have come loose from the shingles.

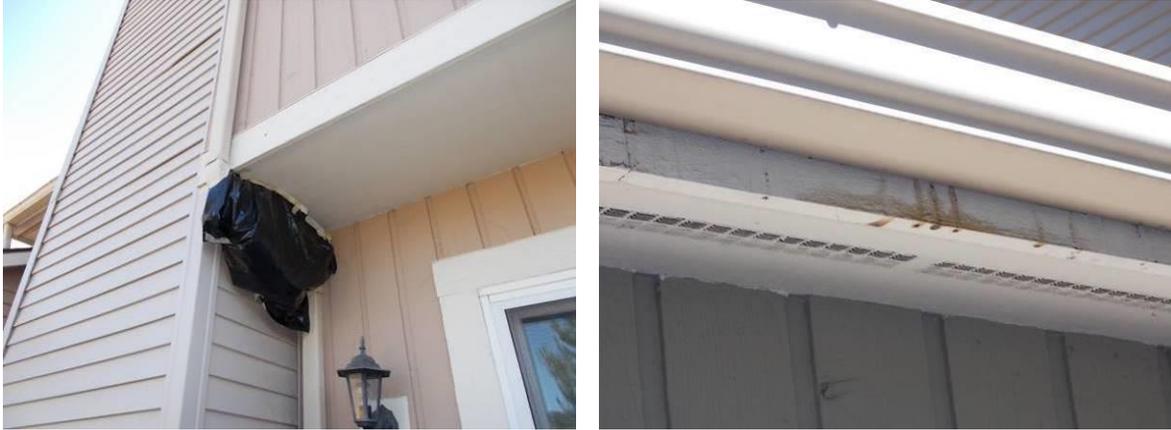
We noted a section of gutter downspout on the rear of the building that is wrapped in a garbage bag. We suspect this is due to leakage and a more permanent repair should be made.

We noted evidence of leakage behind a gutter on the front of the building. These stains are typically an indication of leakage due to improperly installed gutters (not properly behind the roof drip edge) or ice damming and related leakage.

*Gutter Downspout Wrapped in Garbage Bag & Staining Behind Gutter*

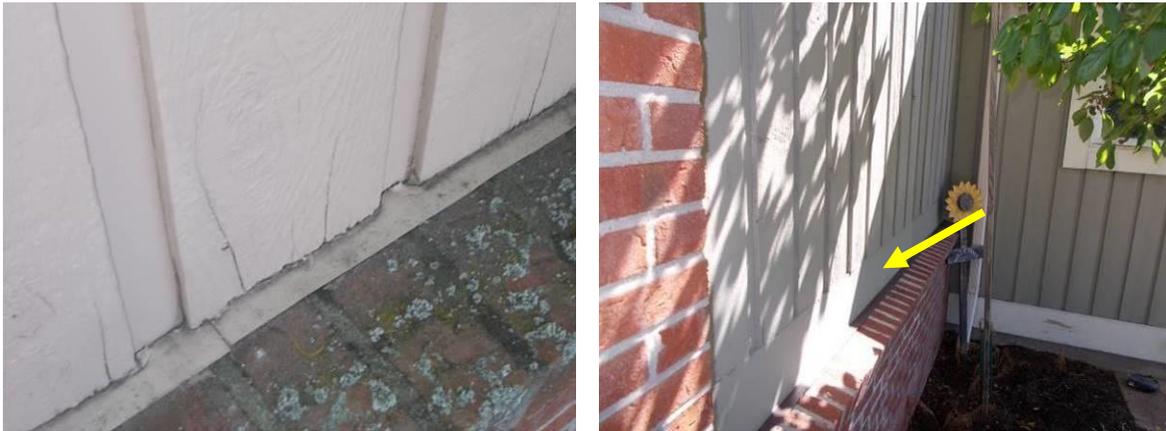
*Cracking to Vertical Siding & Repair to Vertical Siding at Brick Ledge*

We noted a repair that had been completed at the vertical siding and brick water table interface on unit #28. We suspect this was due to some amount of rot or deterioration.

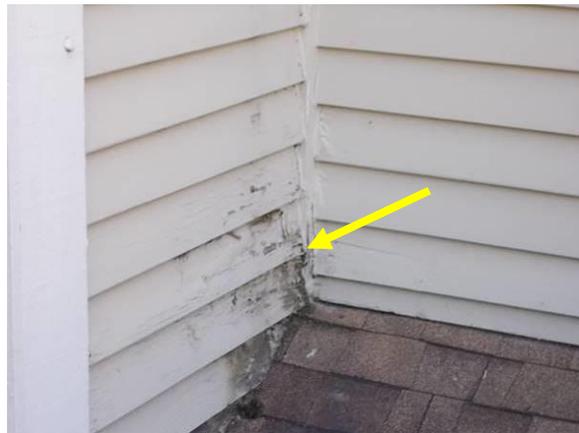
As is typical with most buildings, siding deterioration is concentrated around chimney enclosures. We noted two chimney enclosures that have been previously vinyl sided.

*Rot at Roof Interface & Chimney Enclosure*

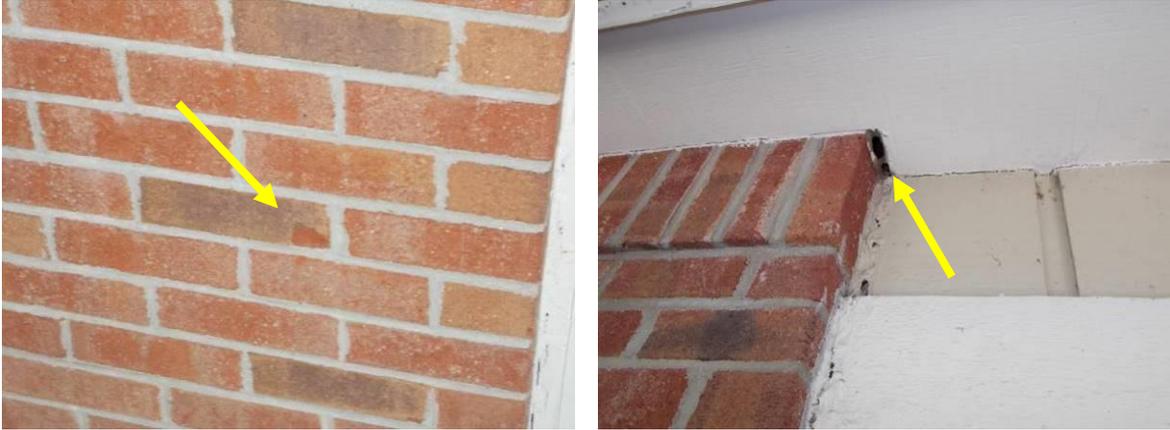
Brick on this building appeared to be in serviceable to good condition. We did note areas of isolated spalling. Also, there are areas in need of caulking and sealing between the veneer and adjacent siding or trim to eliminate gaps where pests could enter or nest.

*Spalled Brick & Area to Seal Around Brick Veneer*

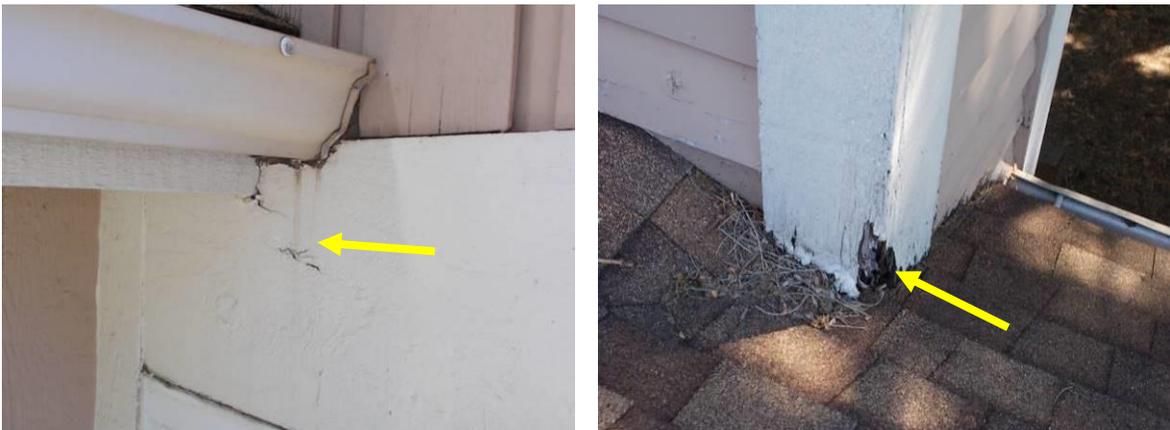
In relation to damage caused by leaking gutters on the horizontal siding, we also noted rot and damage to trim due to leaking gutters. Also, we noted a relatively large amount of insect damage to the trim on this building.

*Trim Damaged from Leaking Gutter & Trim Damage at Chimney Enclosure*

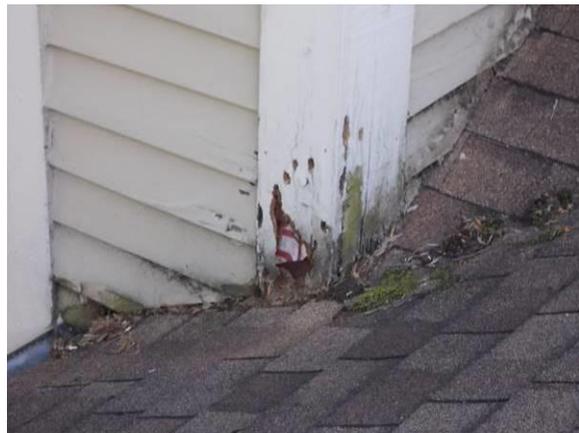
Signs of wear were noted on the roof surface, such as missing granules from the shingle surfaces. We also noted areas of moss growth. While this is not necessarily a sign of advanced deterioration, cleaning off moss is recommended.

*Moss Growth and Trim Damage*

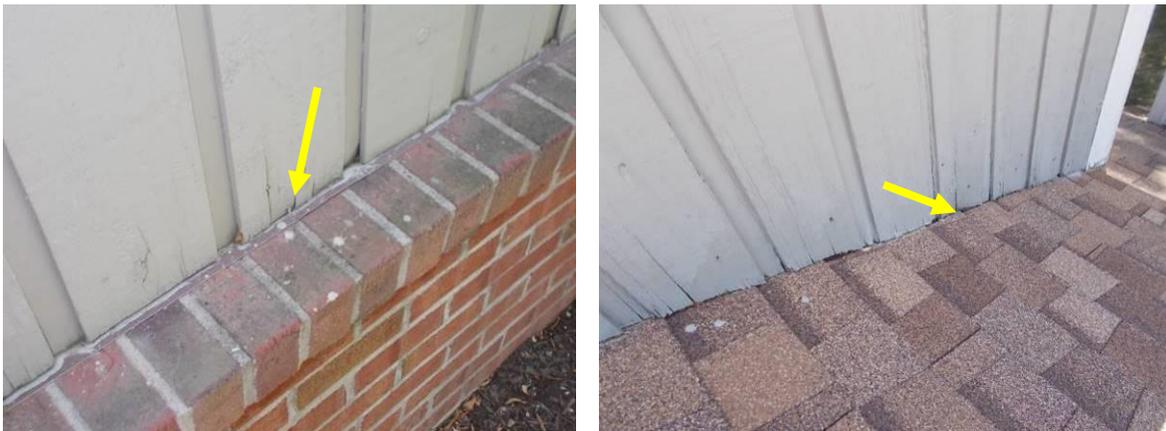
The vertical siding on this building appeared to be in generally serviceable condition with the exception of deterioration in typical areas, including interfaces with brick siding and roof surfaces.

*Examples of Vertical Siding Areas of Deterioration*

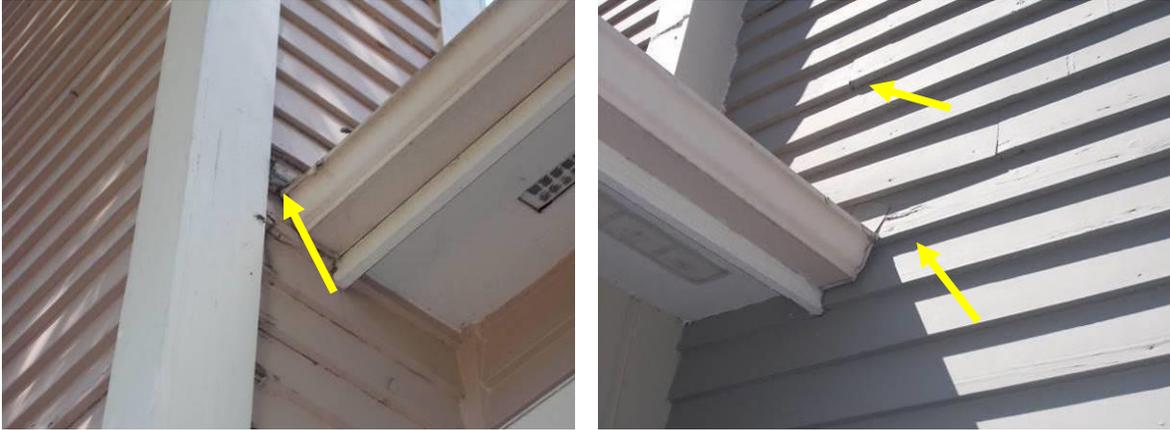
This siding has isolated damage to chimney enclosures as well as cupping and twisting of clapboards. This is an indication of deterioration and weathering.

*Deterioration and Cupping to Clapboards*

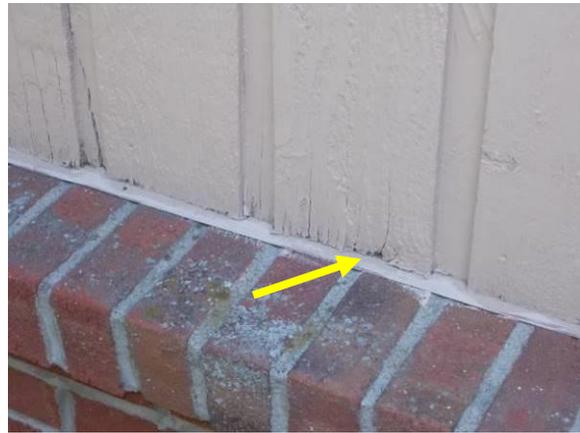
Areas of wear were noted at brick siding water tables. Also, gaps were noted in vertical seams.

*Examples of Deterioration at Brick and Roof Interfaces*

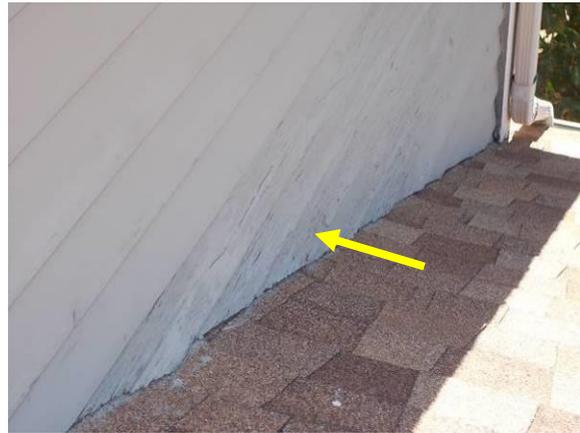
This siding has suffered typical damage at chimney enclosures. Also, we noted areas near gutter ends showing signs of deterioration. This is most likely due to leaks in these gutters along with a lack of kick-out flashing at roof and siding intersections.

*Examples of Deterioration to Clapboards*

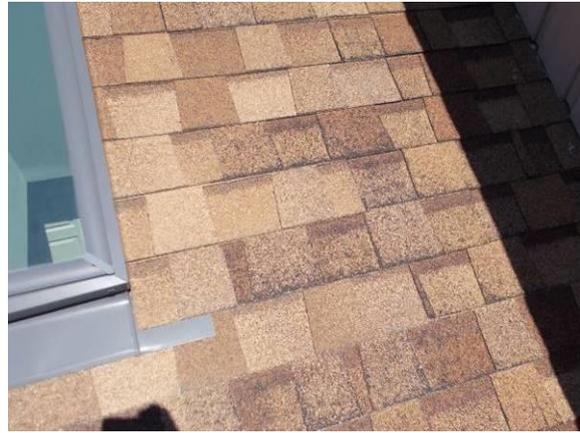
An above average amount of deterioration was noted on the shingle surfaces. Also, some areas of damaged shingles were encountered.

*Example of Roof Condition (Advanced Wear on this Building)*

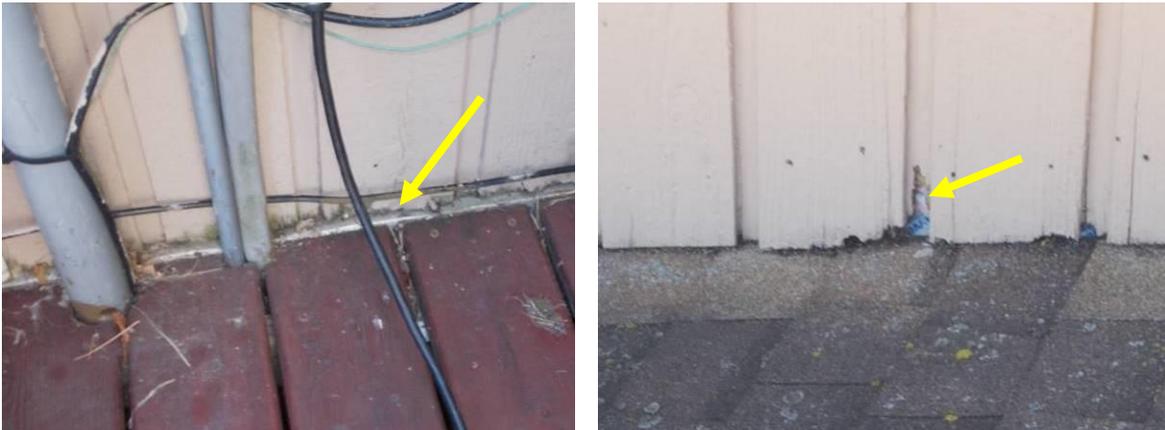
Deterioration was noted at interfaces with differing materials. Also, portions of the siding appear to be worn due to weather.

*Deterioration at Deck & Roof Interfaces*

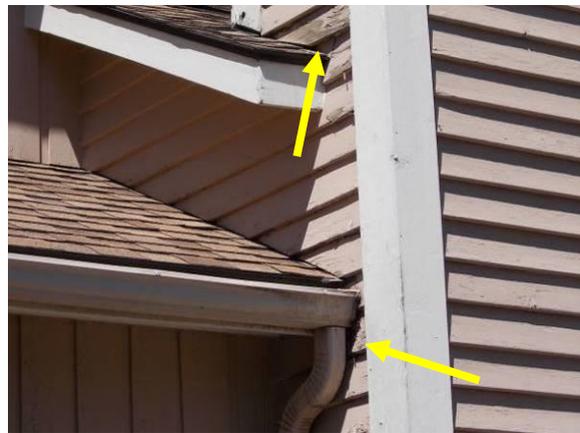
We noted areas of more severe damage to the clapboard siding. These are most notable at roof interfaces and on chimney closures. Better flow control of water from roofs is necessary in these areas along with better intersection and flashing details.

*Examples of Deteriorated Clapboards*

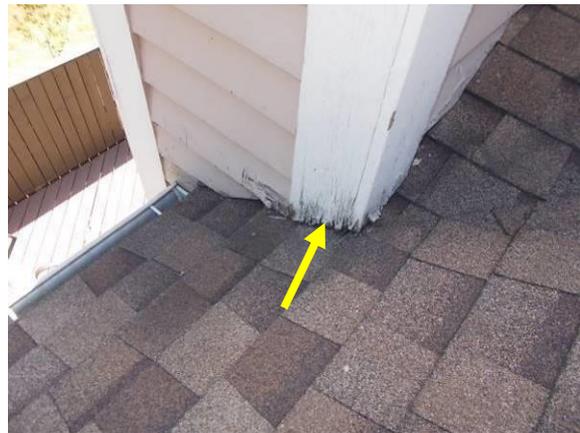
We noted areas of rotted or damaged trim around most chimney enclosures. Also, areas of isolated damage were noted.

*Examples of Deteriorated Trim*

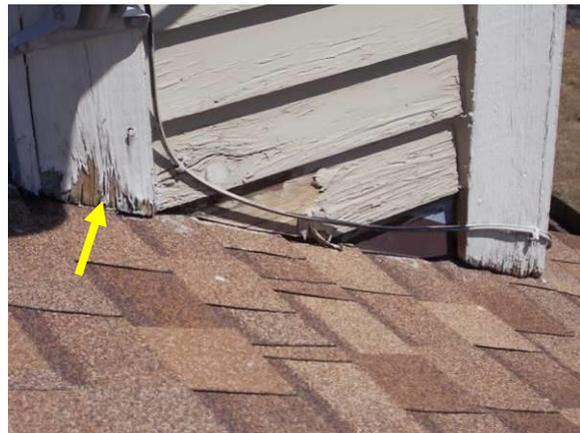
*Examples of Deteriorated Trim*

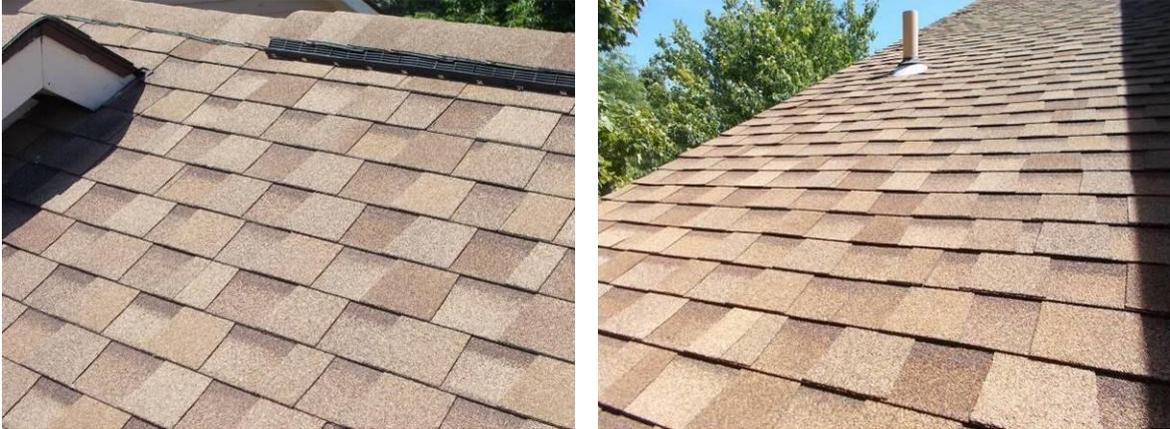
The roof surface appeared to be in generally serviceable condition. The shingles appeared to be in better than average condition in relation to other buildings.

*Roof Surface*

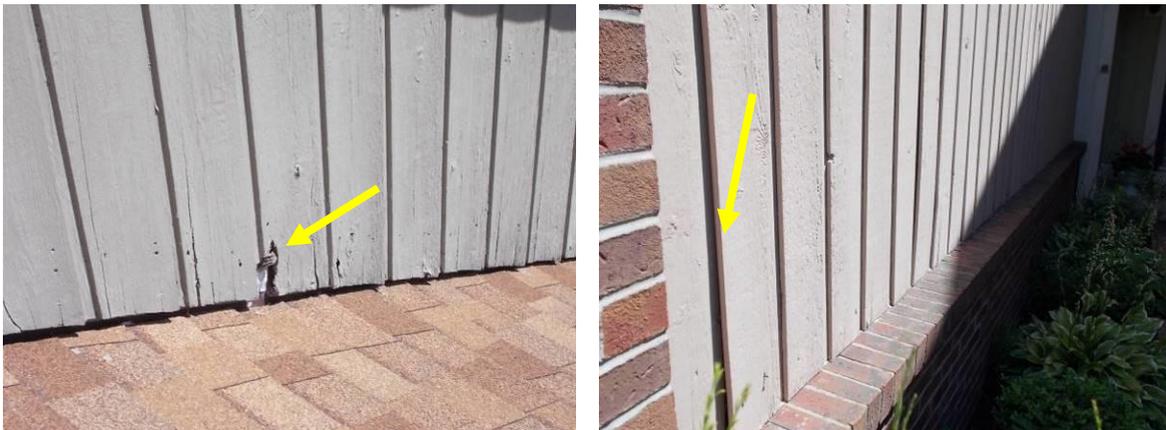
Some openings of seams were noted, as well as deterioration adjacent to brick ledges and roof interfaces.

*Deteriorated Vertical Siding & Opening Vertical Seams*

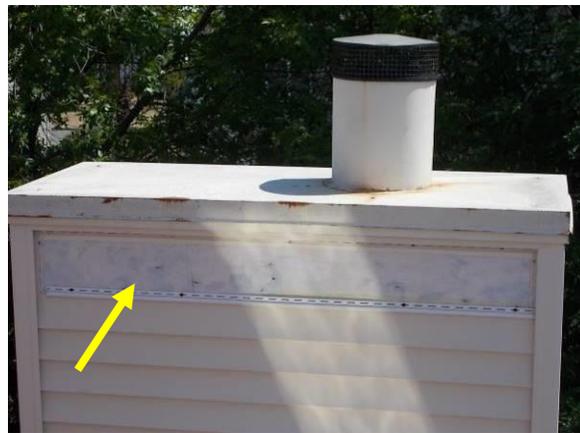
*Water Damaged Clapboards & Missing Vinyl Siding on Chimney Enclosure*

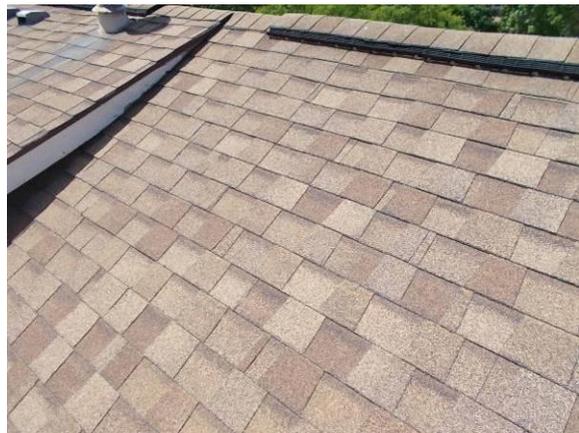
The roof surface appeared to be in average condition in comparison with other buildings. Some amount of deterioration and granule loss was noted.

*Roof Surface*

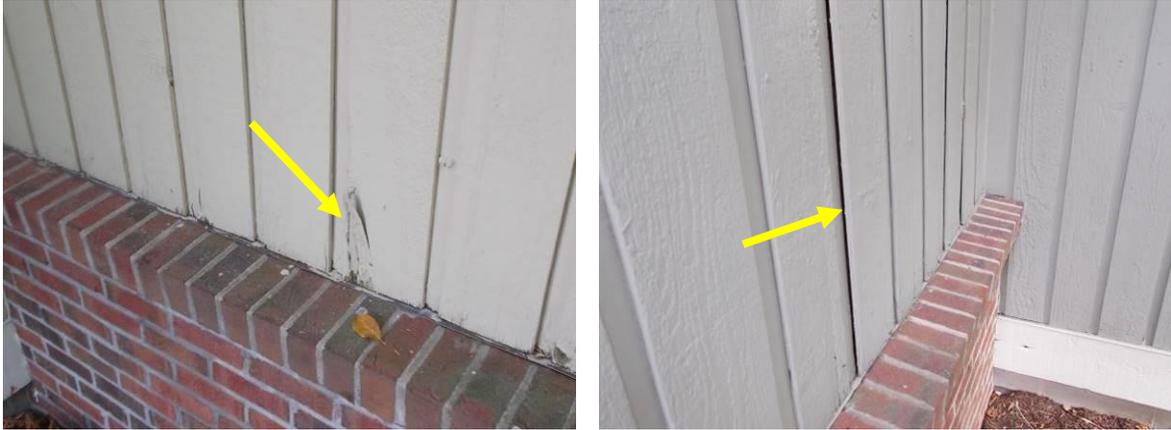
Gaps and openings were noted in various areas of the vertical siding. In relation to other buildings, an average amount of deterioration was noted at brick ledges as well as at interfaces with roof surfaces.

*Examples of Deterioration and Open Joints*

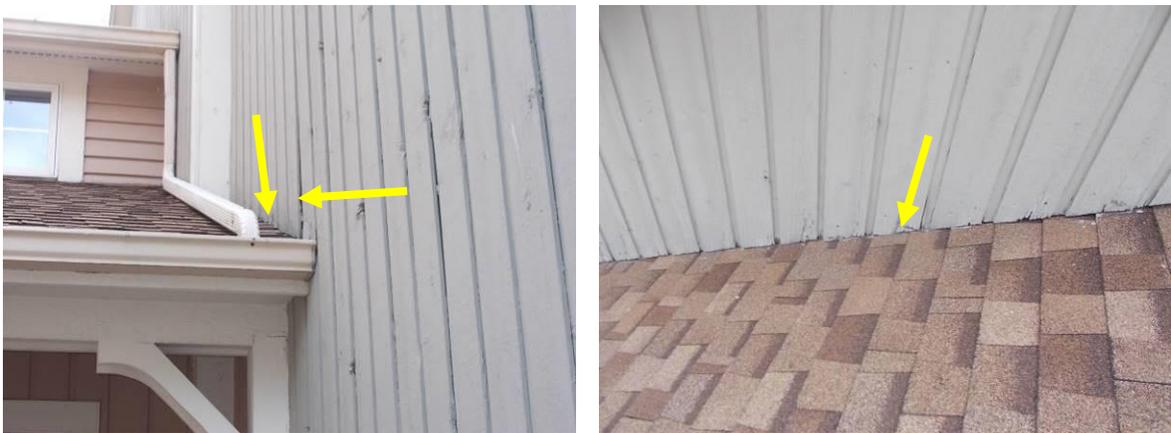
*Examples of Deterioration and Open Joints*

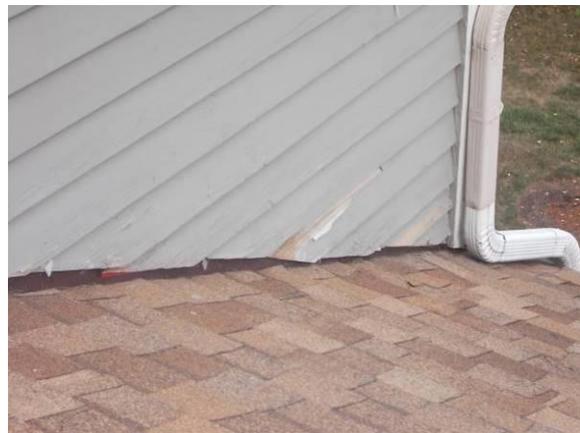
We noted isolated areas on the clapboard siding that are showing signs of paint or stain delamination. These appear to be caused by a combination of water penetration as well as weathering.

*Examples of Delaminating Paint/Stain*

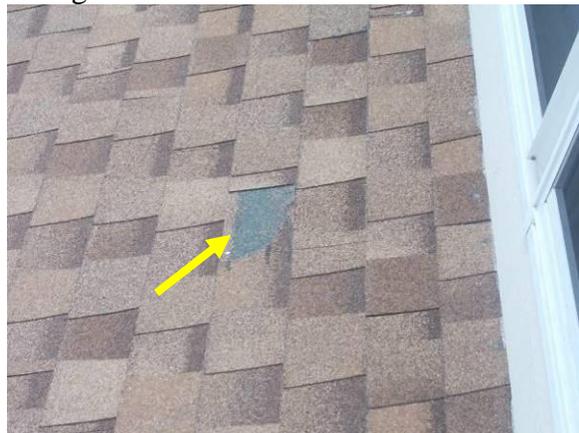
The roof surface appeared to be in better condition as compared to most of the other roof surfaces. We did note at least one missing or damaged shingle. This may be due to a high wind weather event or an isolated incident causing the damage.

*Roof Surface and Damaged Shingle*

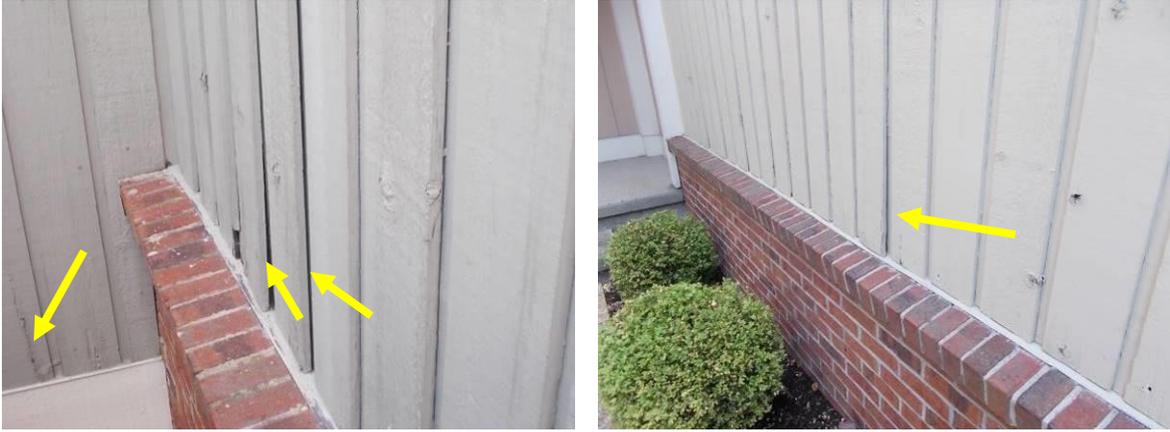
We noted an above average amount of warping and opening joints in the vertical siding. Also, as is typical with the other buildings, deterioration was noted at the base of the siding where it comes in contact with brick ledges and roof surfaces.

*Opening Joints and Deterioration*

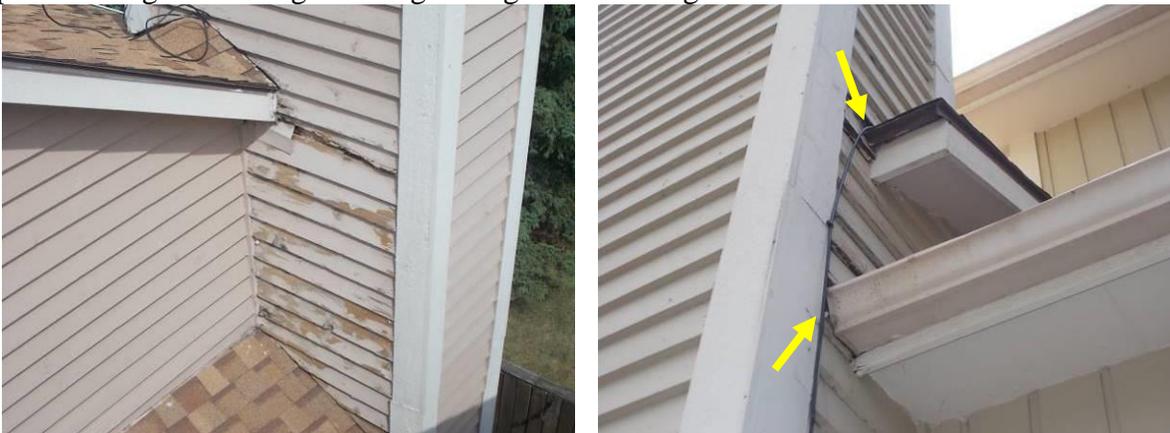
Deterioration was noted to the clapboards and on many areas of chimney surrounds. Also, there appears to be gutter leakage causing damage to the siding.

*Water Damage To Chimney Enclosures*

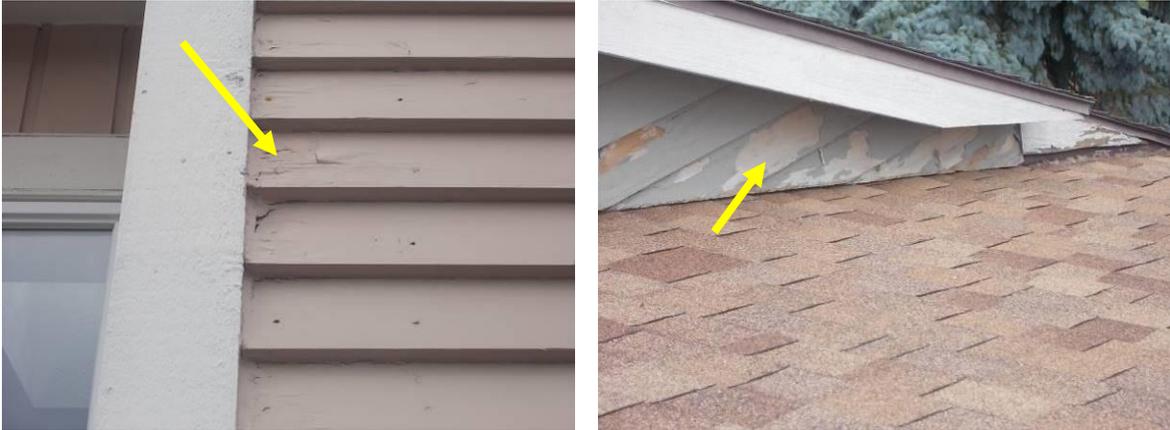
Paint and stain delamination was noted in some areas with a higher chance of water penetration.

*Clapboard Rot and Paint/Stain Delamination*

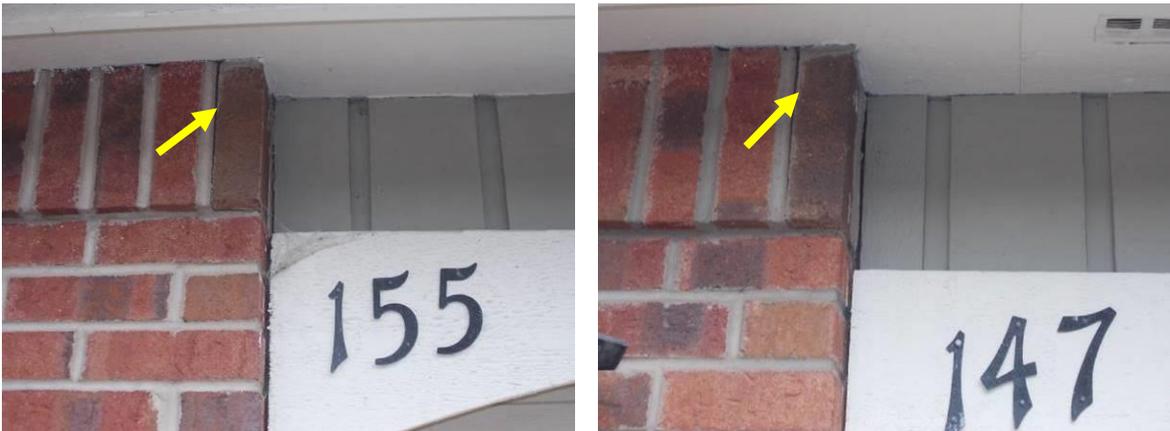
Some cracks in mortar joints were noted at garage headers from long term sag. However, the brick siding appeared to be in serviceable condition.

*Examples of Cracked Mortar Joints at Garage Headers*

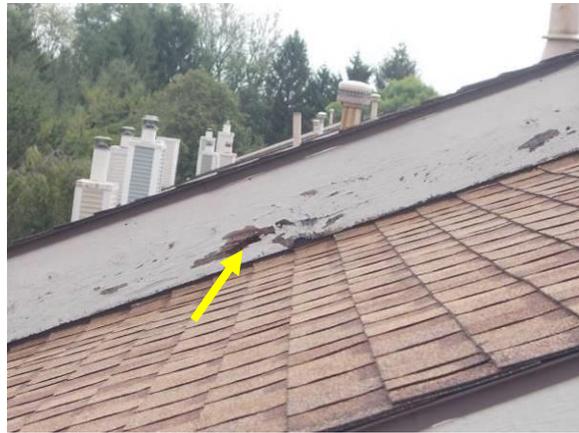
Isolated areas of damage were noted. These areas include chimney surrounds as well as lower portions of trim under windows. Some trim along roof surfaces is showing above average amounts of damage.

*Examples of Trim Damage and Deterioration*

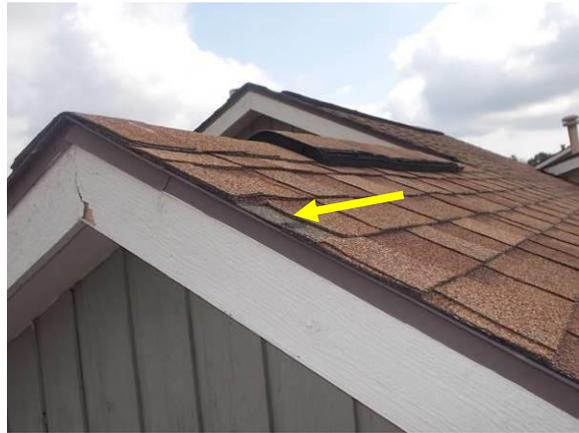
The roof surface appears to be in below average condition. We noted a damaged and missing shingle above unit #155.

*Example of Worn Shingle Surfaces and a Missing Shingle Tab/Edge*

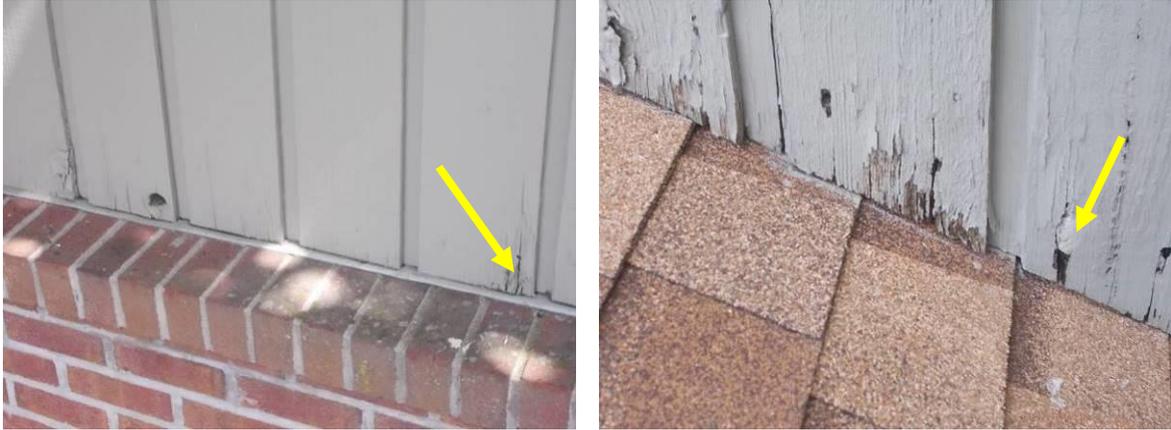
Deterioration was noted at interfaces of different materials. Also, portions of the siding appear to be worn due to weather.

*Signs of Deterioration and Wear*

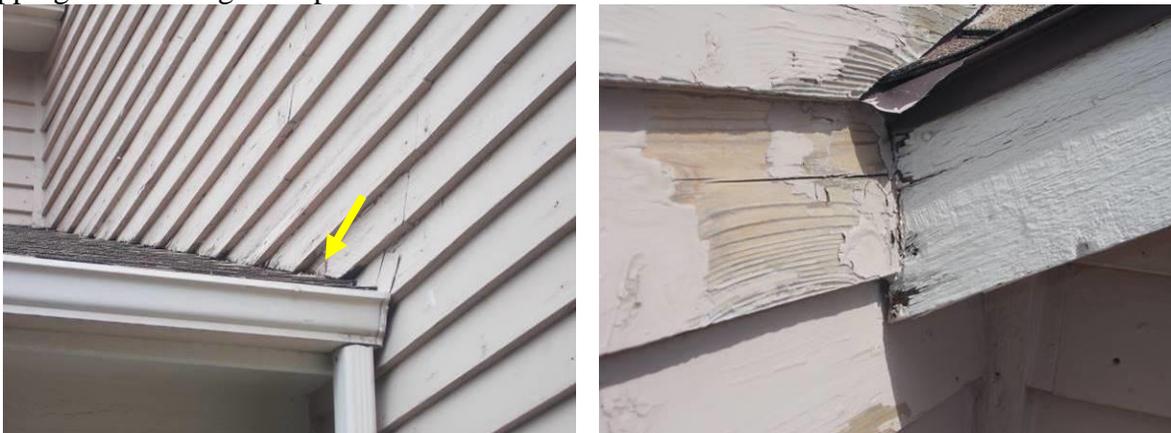
This siding has experienced typical isolated damage around chimney enclosures as well as cupping and twisting of clapboards.

*Examples of Water Damage*

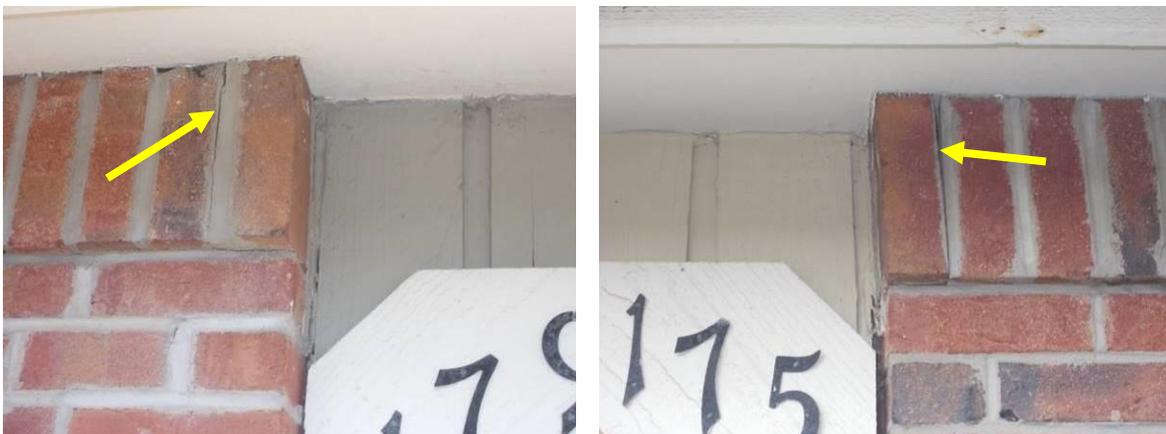
The brick veneer appeared to be in generally good condition, with the exception of some isolated cracked mortar joints at garage headers due to long term minor sag.

*Examples of Cracked Mortar Joints*

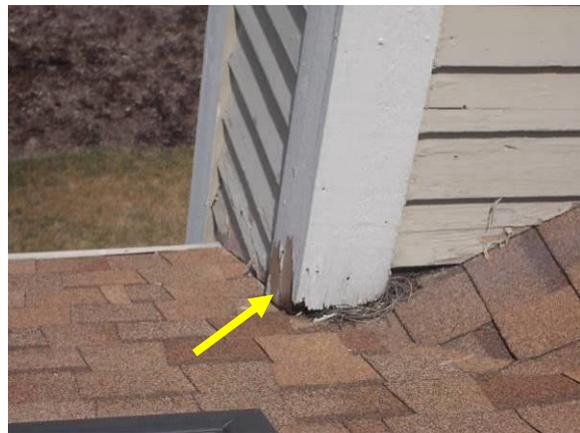
As with most buildings, areas of isolated trim damage can be found around the chimney surrounds. Also, there are areas with leaking and bypassed gutters causing trim damage. We noted evidence of insect damage on various portions of the trim, including some window trim.

*Examples of Trim Deterioration*

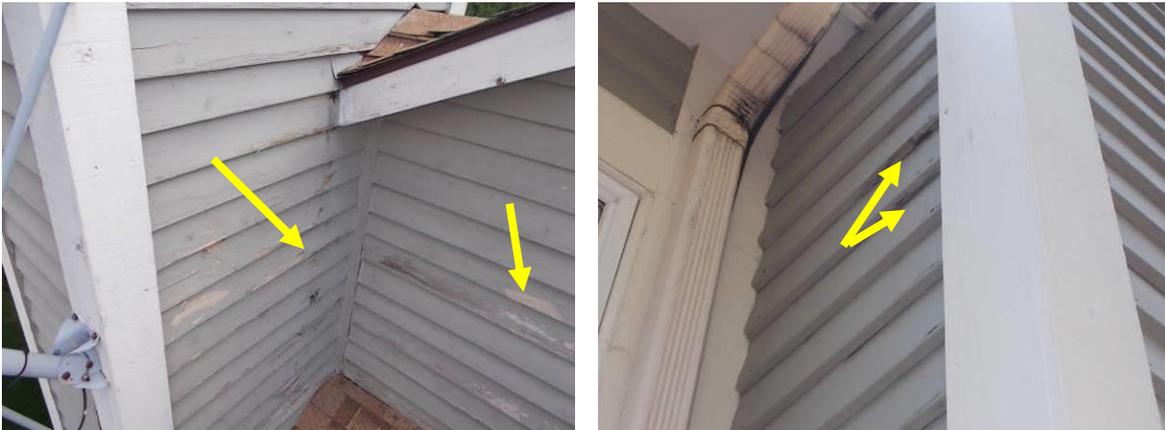
Areas of deteriorating and delaminated paint/stain were noted. These are in areas that appear to be directly affected by both water damage and weathering.

*Water Damaged and Weathered Paint & Deteriorated Clapboards*

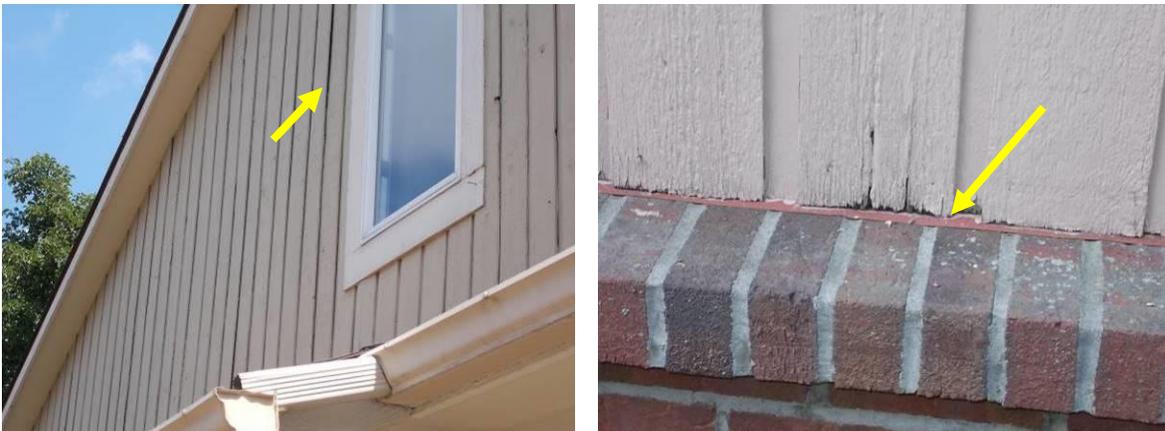
Areas of open vertical joints were noted between siding. Also, there are areas of opening horizontal edges and weathered surfaces.

*Examples of Weathered Siding with Opening Joints & Deterioration at Brick Ledge*

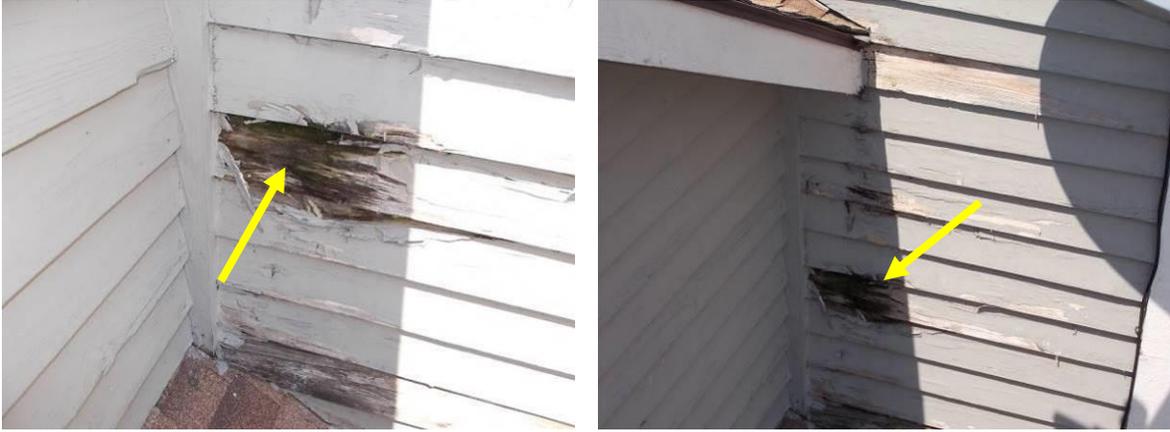
Areas of more severe damage were noted. These are typically isolated to the chimney enclosures that have not yet been sided with vinyl. Also, some cupping to the siding was noted on exposed surfaces.

*Examples of Damage and Deterioration*

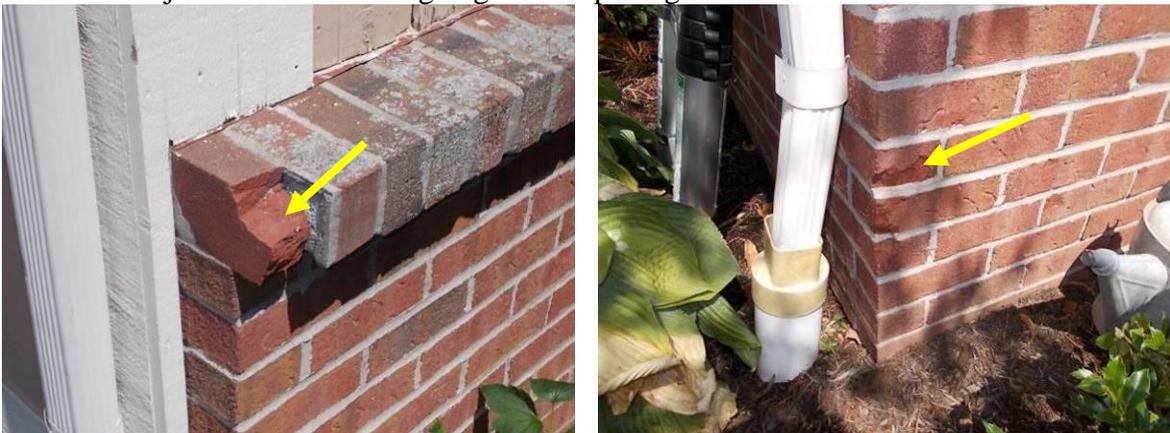
Isolated areas of damage were noted. These includes some broken and spalling bricks. Also, cracked mortar joints exist at some garage door openings.

*Damaged Bricks*

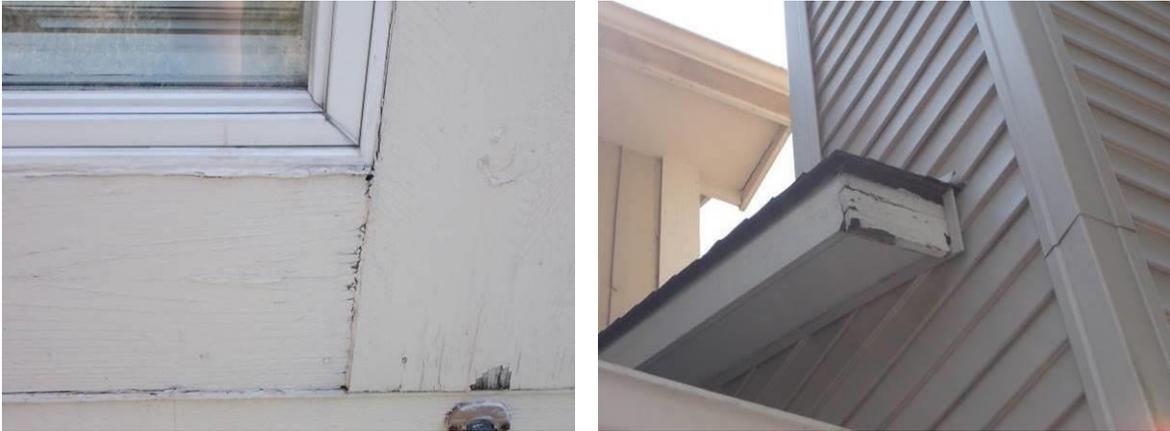
Isolated areas of rot and damage were noted to the trim. These were most prevalent on chimney surrounds. Also, some exterior window trim and soffit areas are showing signs of deterioration.

*Examples of Trim Rot and Deterioration*
