RE: Brittany Commons  
Rochester, NY 14618

### **INTRODUCTION**

We performed a limited visual inspection of the exterior siding and roofing for 14 of the 19 buildings of the subject townhouse complex. This was to provide a professional opinion as the condition and the expected remaining life of the siding and the roofs. These inspections were performed from the ground and with the use of a 14 foot telescoping ladder to view and walk many of the roofs. We did not directly walk a few of the less accessible roofs towards the center portions of the buildings, but we walked the roofs on each end of the subject buildings as well as several of the adjacent accessible roofs.

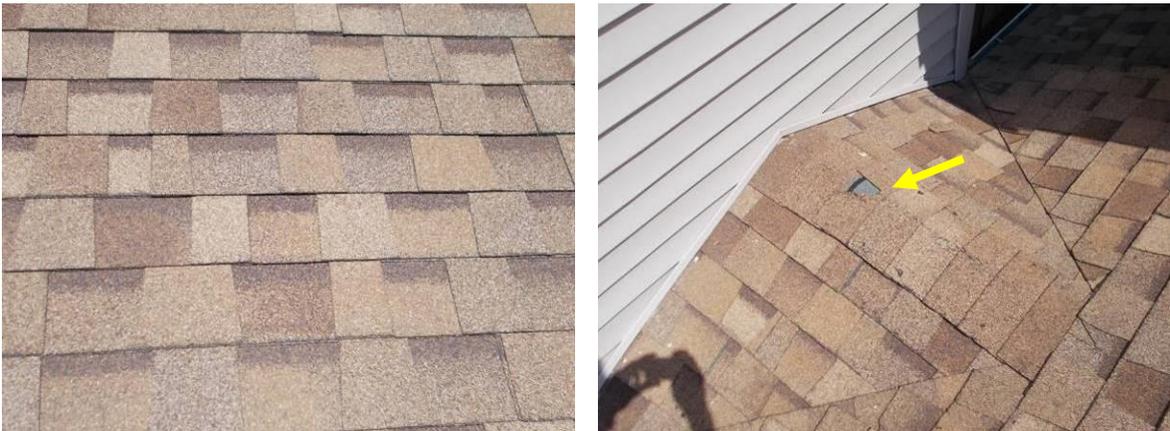
The roof surface appeared to be of average quality in comparison with other buildings. Some amount of deterioration and granule loss was noted. Also noted, are some damaged shingles on a chimney cricket that is showing more severe wear. Replacing several shingles on this cricket will likely be required prior to complete roof resurfacing.

*Example of Shingle Condition & Damaged Shingle on Chimney Cricket*

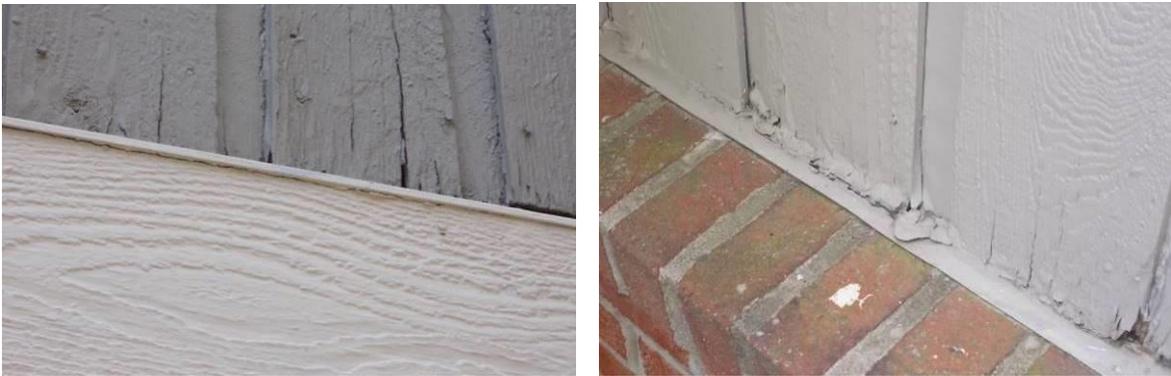
Areas of wear were noted at interfaces of differing materials. Also, gaps were noted along vertical seams.

*Examples of Deteriorated End Grain*

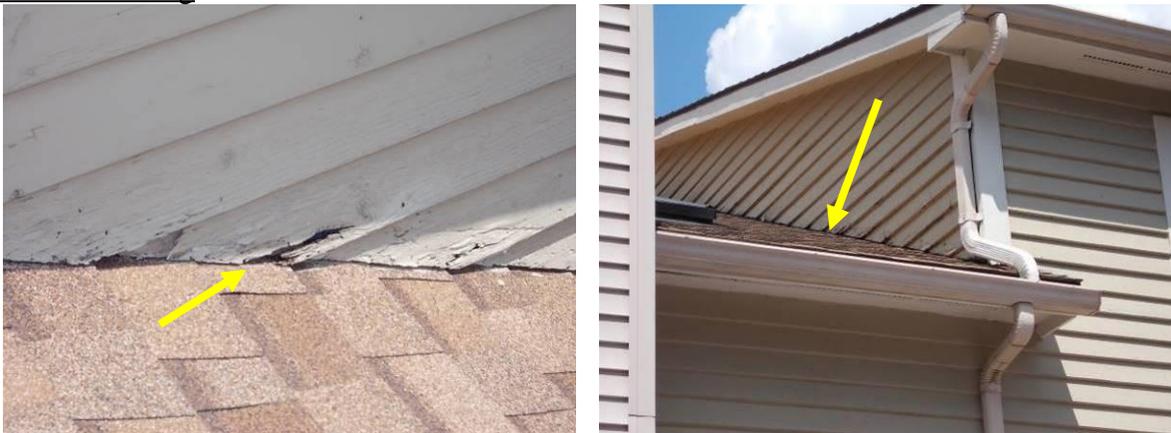
*Examples of Trim Deterioration at Roof Interfaces*

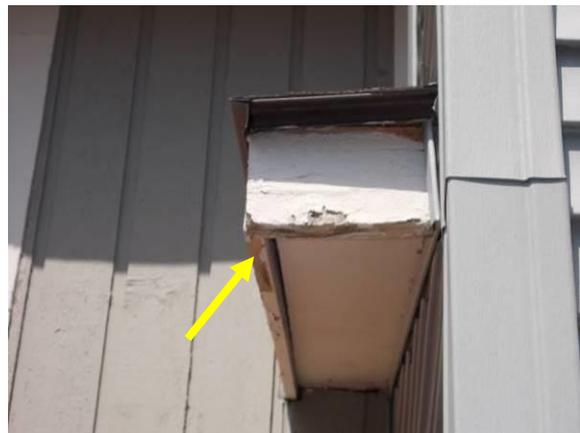
We noted areas of rotted or damaged trim around portions of most chimney enclosures. Also, areas of isolated deterioration and insect damage were noted.

*Examples of Rot in Need of Repair and Gaps in Trim*

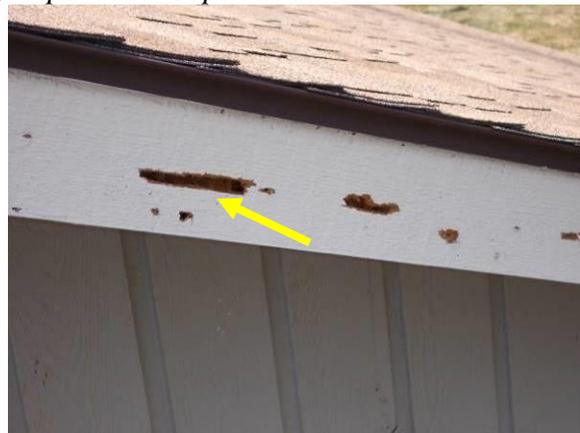
*Examples of Rot in Trim & Insect Damage (Carpenter Bees)*

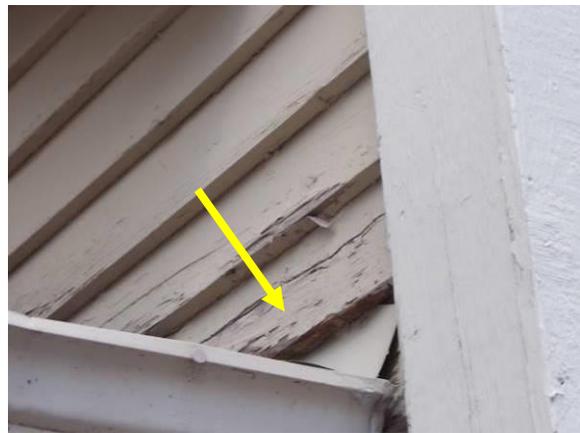
*Examples of Deterioration to Siding and Paint/Stain*

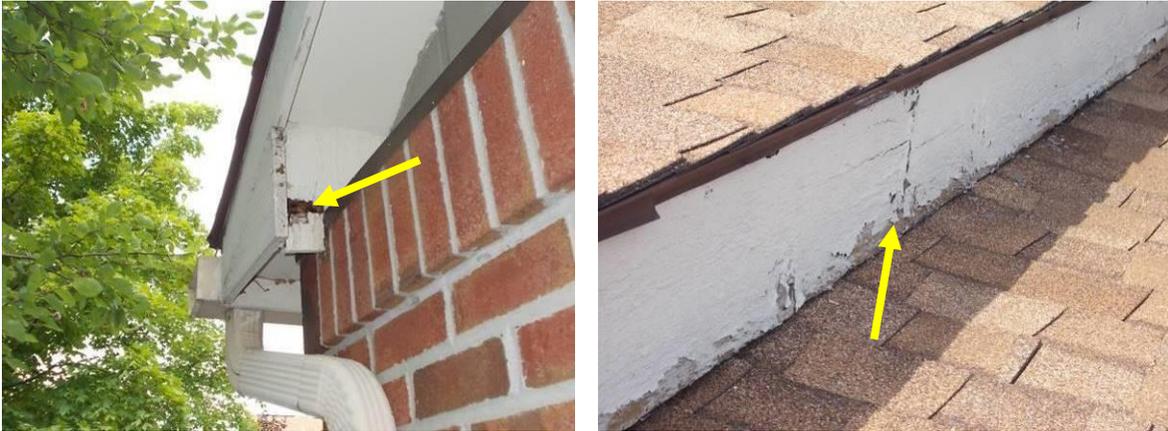
*Examples of Damage and Deterioration to Trim in Need of Replacement*
