PRO-ENGINEERED INSPECTIONS

RE: Brittany Commons  
Rochester, NY 14618

### **INTRODUCTION**

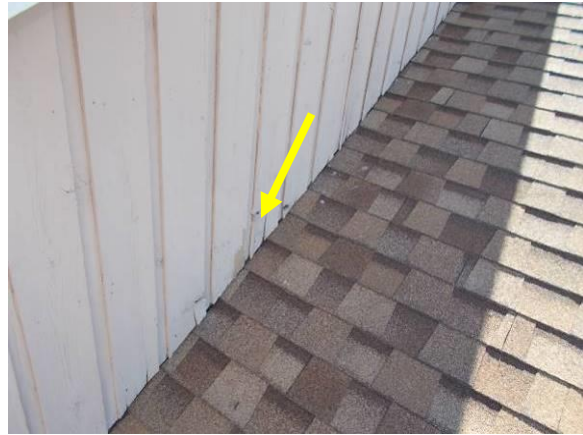
We noted many areas of deteriorated or rotted siding around the building. This is most evident where the vertical siding is in contact with the brick siding's water table or with the roof surface. Typically, this deterioration is an indication of improper flashing.

There are several areas around the building that have developed gaps between the vertical laps. These gaps can be an access point for unwanted moisture or pests.

*Opening Gap & Deterioration at Roof Surface*

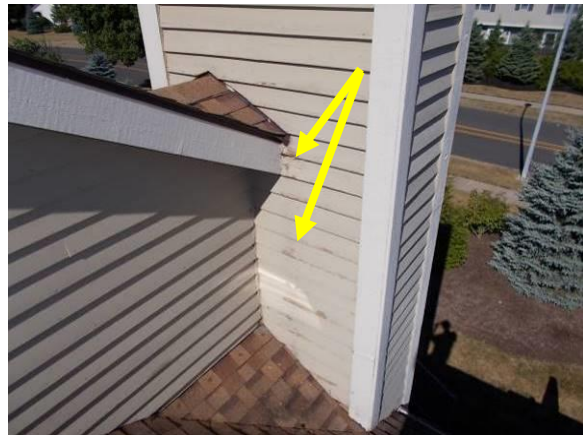
The horizontal clapboard wood siding has suffered isolated deterioration in areas in contact with roof surfaces. Also, there is deterioration to the siding on most of the chimney enclosures. This appears to be caused by improper flashing along with awkward roof angles and intersections, causing excessive contact with roof run-off.

*Rot in Clapboards*

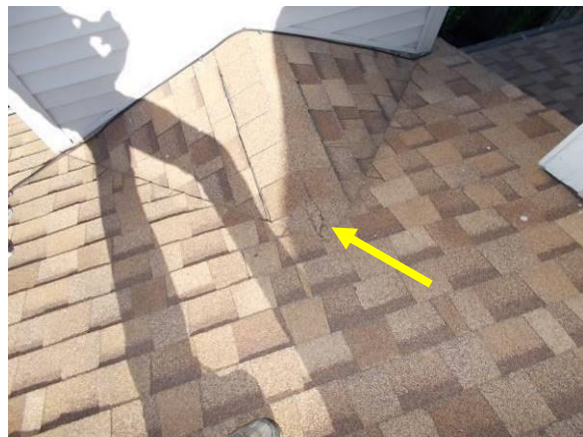
*Roof Surface with Some Damage*

We did note some areas of isolated shingle damage. These damaged areas can be more prone to roof leakage. Damaged shingles can be replaced as needed.

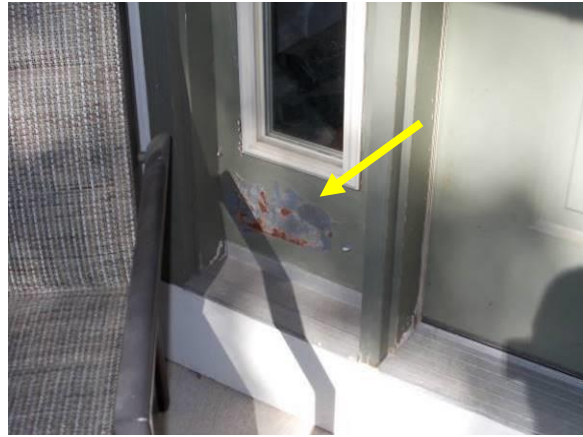
We noted the majority of the steel flue pipes penetrating the roof are rusty. Some amount of painting, repair or replacement may become necessary as deterioration continues.

*Rusted B-Vent and Paint on Front Door*

We noted peeling paint on the front door assembly of one of the units. Preparing, priming, and repainting this is recommended.

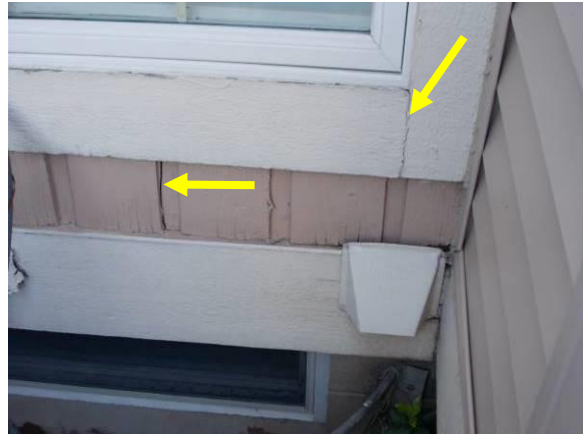
The vertical siding on this building is showing signs of damage and wear in typical areas. These include intersections with brick water tables as well as areas that are in contact with roof surfaces. We also noted areas of opening vertical seams.

*Open Seam in Vertical Siding & Deteriorated Siding and Trim*

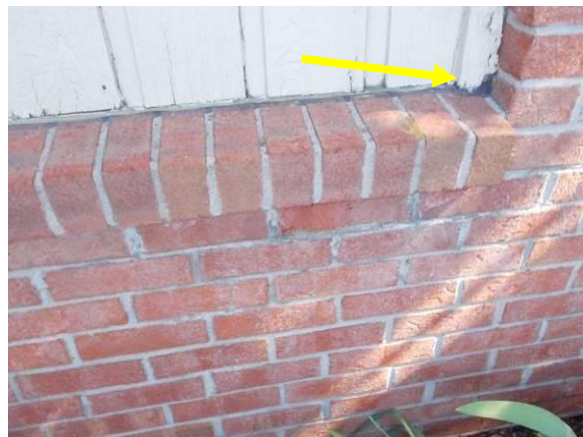
*Rot and Deterioration at Water Table/Brick Ledge*

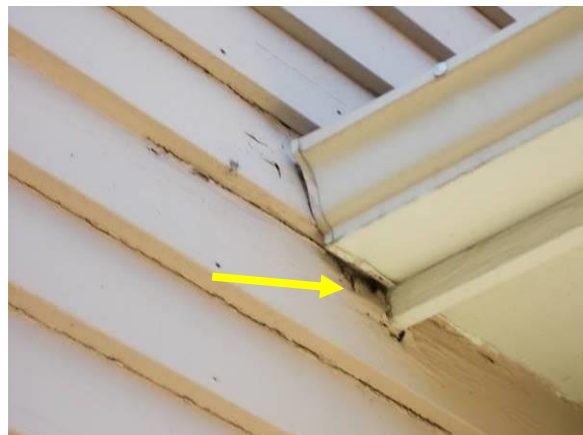
*Damaged Siding & Rot at Gutter End Cap (lack of kick-out flashing above gutters)*

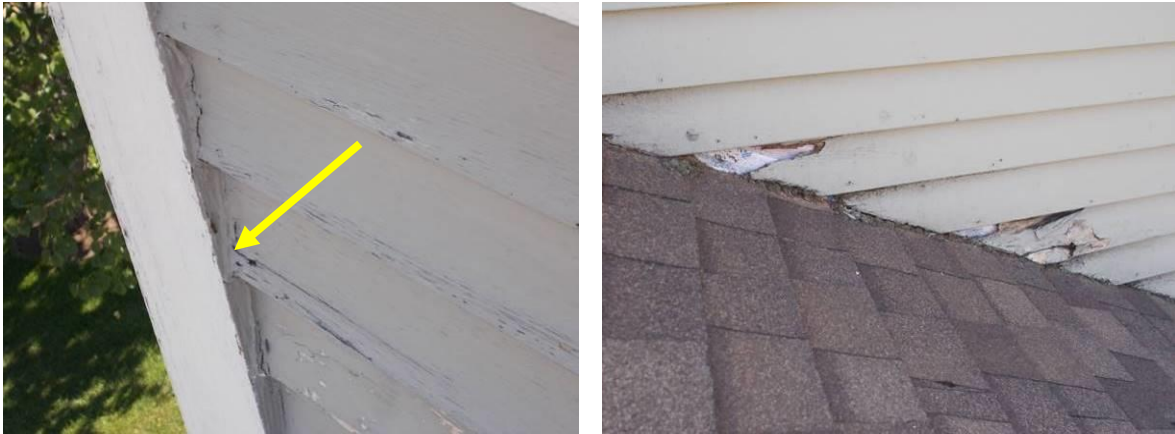
We noted isolated areas of severe rot and damage to horizontal siding on this building. Portions of chimney enclosures have suffered the most concentrated rot and damage. We noted that three of the chimney enclosures on this building have replacement vinyl siding installed already.

*Deterioration to Siding on Chimney Enclosure and at Roof Interface*

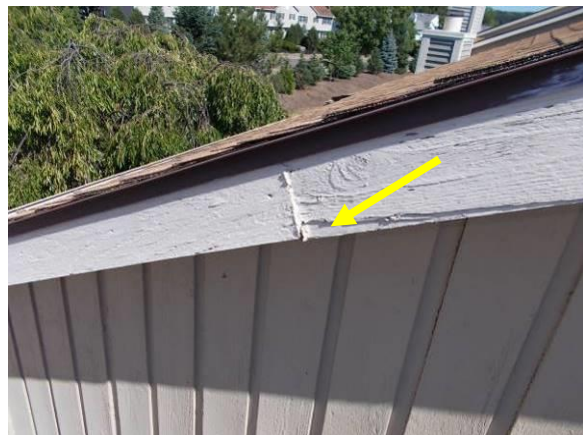
*Examples of Trim Rot and Deterioration*

The areas heaviest rot and deterioration appear on the chimney enclosures. Also, we noted damage or broken trim in upper eaves. As is typical with most buildings in the complex, we noted a fair amount of rot that is not readily visible, since it has been painted over.

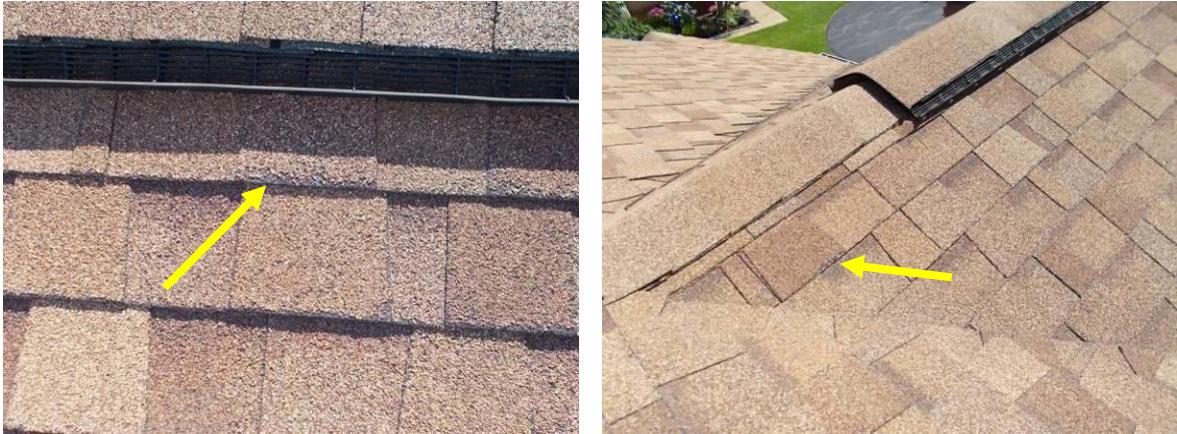
*Examples of Roof Wear*

There are signs of wear and age on the roof surface. This is most evident in some damage to roof shingles as well as the amount of granules that appear to have come loose from the shingles.

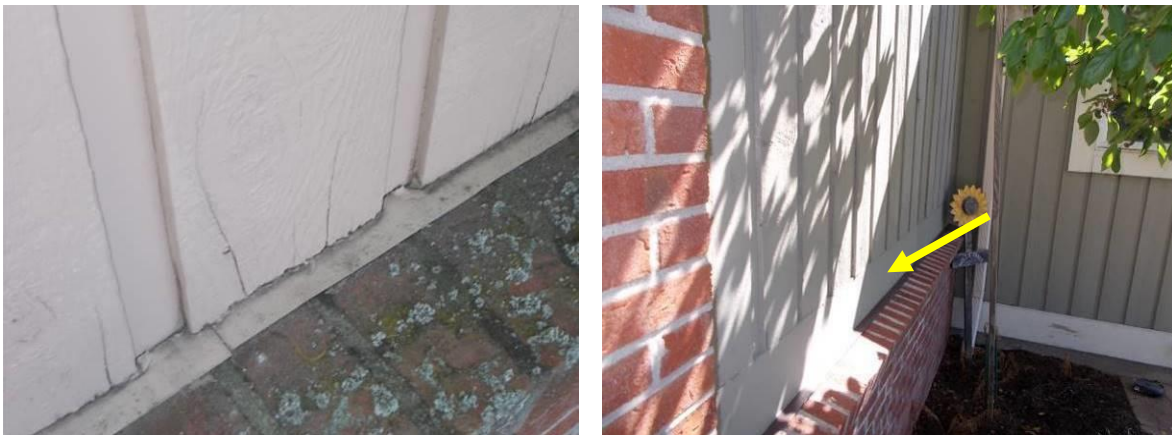
*Cracking to Vertical Siding & Repair to Vertical Siding at Brick Ledge*

We noted a repair that had been completed at the vertical siding and brick water table interface on unit #28. We suspect this was due to some amount of rot or deterioration.

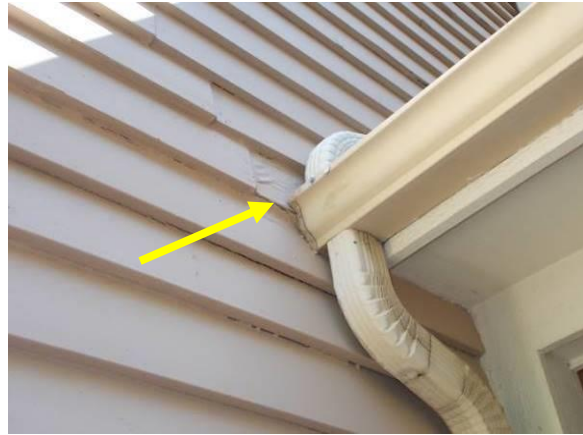
We noted areas of deteriorated and rotted clapboard siding, most notably under or near areas of gutters that appear to be leaking.

*Rot at Gutter Ends*

*(Kick-out flashing is recommended at roof and siding interfaces above these gutter ends)*

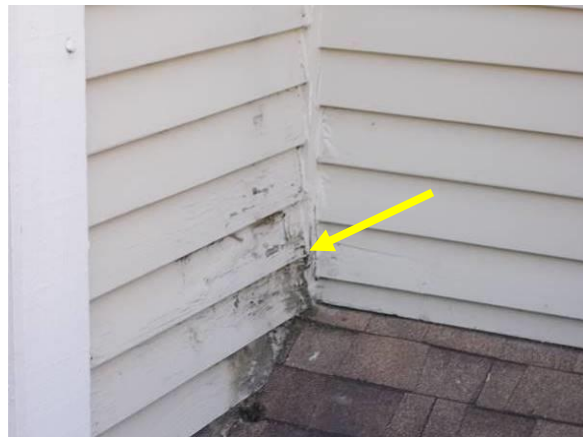
As is typical with most buildings, siding deterioration is concentrated around chimney enclosures. We noted two chimney enclosures that have been previously vinyl sided.

*Rot at Roof Interface & Chimney Enclosure*

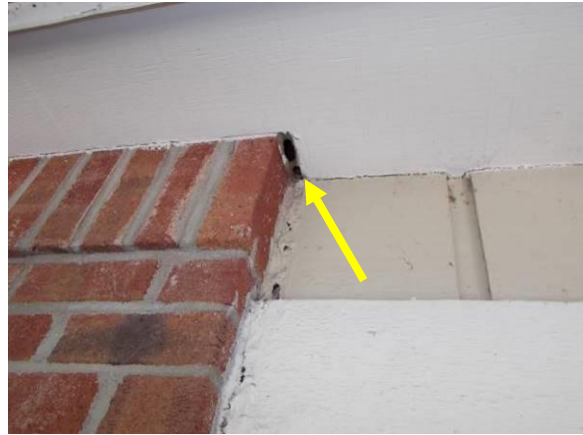
Brick on this building appeared to be in serviceable to good condition. We did note areas of isolated spalling. Also, there are areas in need of caulking and sealing between the veneer and adjacent siding or trim to eliminate gaps where pests could enter or nest.

*Spalled Brick & Area to Seal Around Brick Veneer*

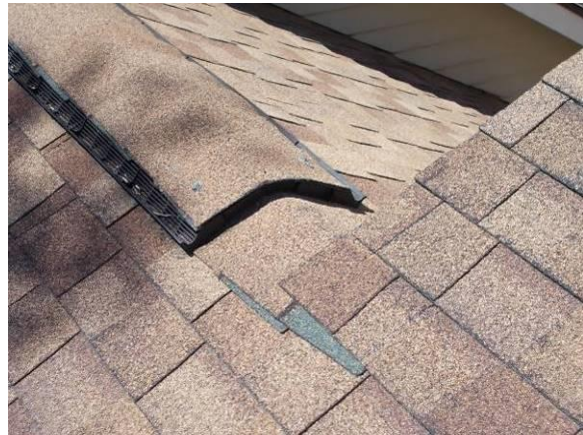
Signs of wear were noted on the roof surface, such as missing granules from the shingle surfaces. We also noted areas of moss growth. While this is not necessarily a sign of advanced deterioration, cleaning off moss is recommended.

*Roof Surface with Significant Granule Erosion*

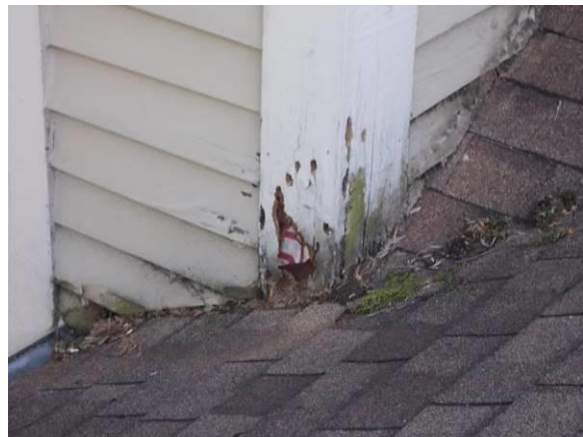
*Moss Growth and Trim Damage*

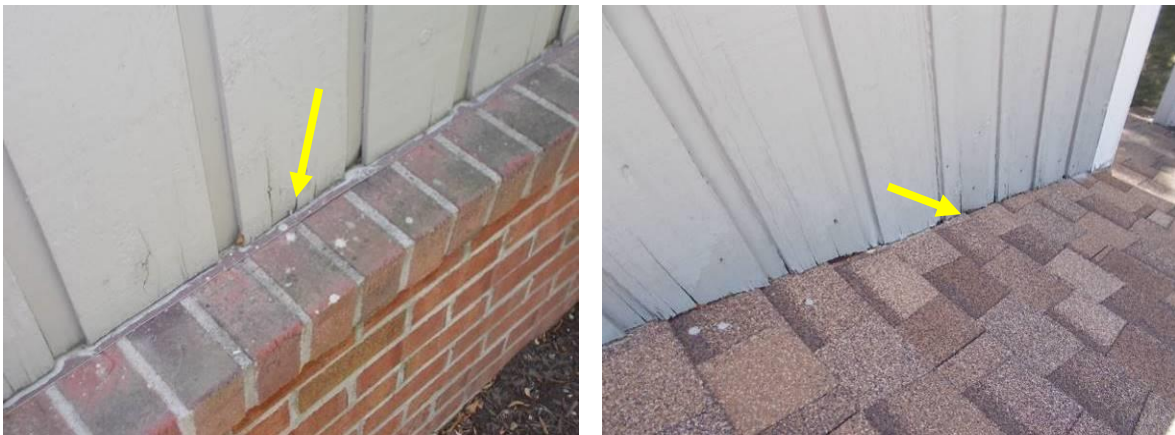
The vertical siding on this building appeared to be in generally serviceable condition with the exception of deterioration in typical areas, including interfaces with brick siding and roof surfaces.

*Examples of Vertical Siding Areas of Deterioration*

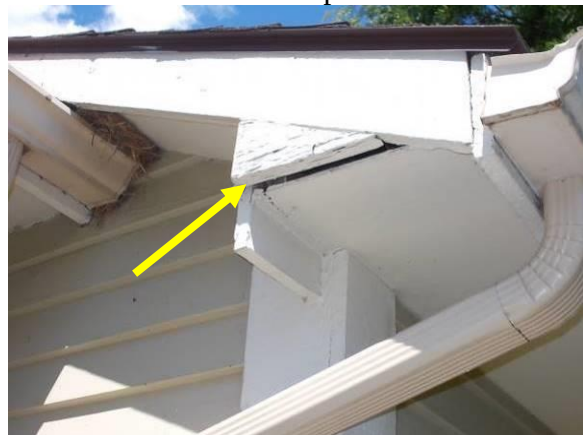
As noted with other buildings, we encountered areas of rot that have been painted over.

*Examples of Rot Behind Coating & Damaged Trim with Gaps*

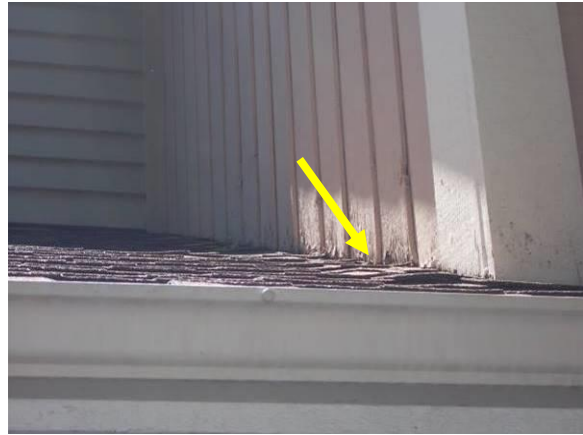
Areas of wear were noted at brick siding water tables. Also, gaps were noted in vertical seams.

*Deterioration at Roof Interface and Opening Joints*

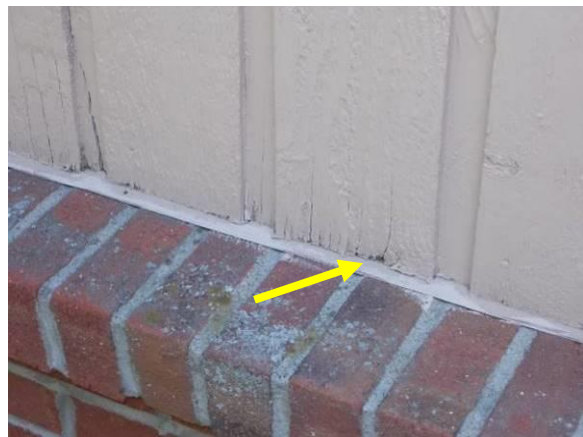
*Examples of Deterioration at Brick and Roof Interfaces*

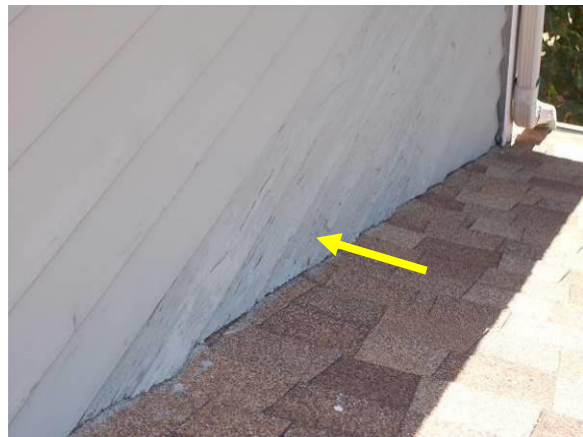
This siding has suffered typical damage at chimney enclosures. Also, we noted areas near gutter ends showing signs of deterioration. This is most likely due to leaks in these gutters along with a lack of kick-out flashing at roof and siding intersections.

*Examples of Deterioration to Clapboards*

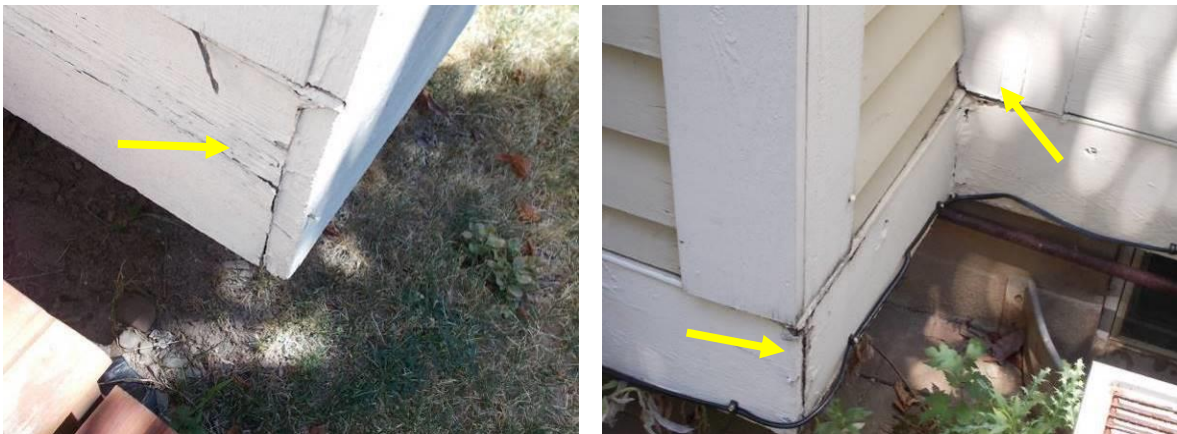
Isolated areas of rot and damage were noted to the trim. These were most prevalent at chimney surrounds. Also, exterior window trim and soffits were showing signs of deterioration. It is always possible to discover additional deterioration behind trim and siding, for all buildings, if removing and replacing materials.

*Rot to Trim on Chimney Enclosures*

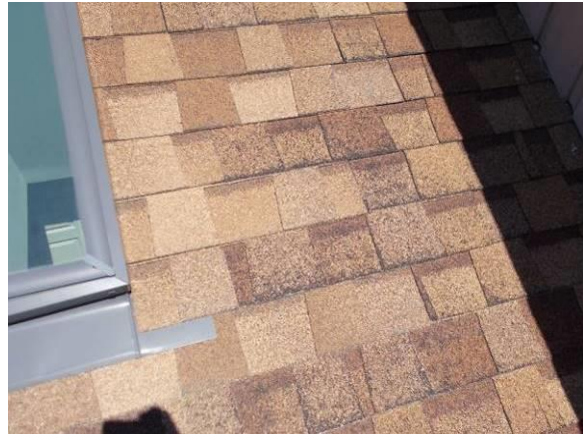
An above average amount of deterioration was noted on the shingle surfaces. Also, some areas of damaged shingles were encountered.

*Example of Roof Condition (Advanced Wear on this Building)*

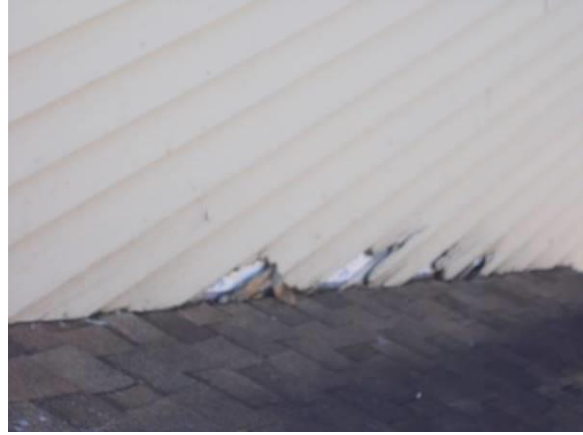
We noted areas of more severe damage to the clapboard siding. These are most notable at roof interfaces and on chimney closures. Better flow control of water from roofs is necessary in these areas along with better intersection and flashing details.

*Examples of Deteriorated Clapboards*

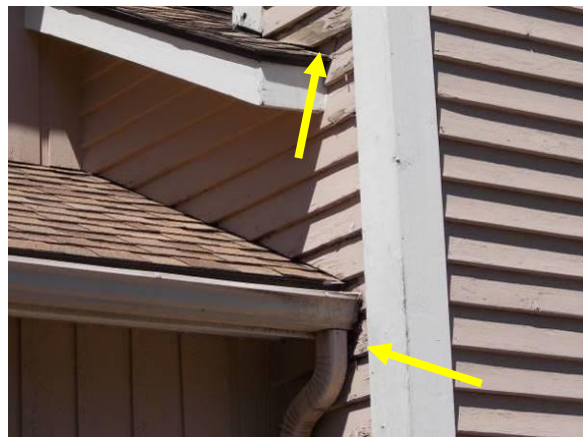
*Examples of Deteriorated Clapboards*

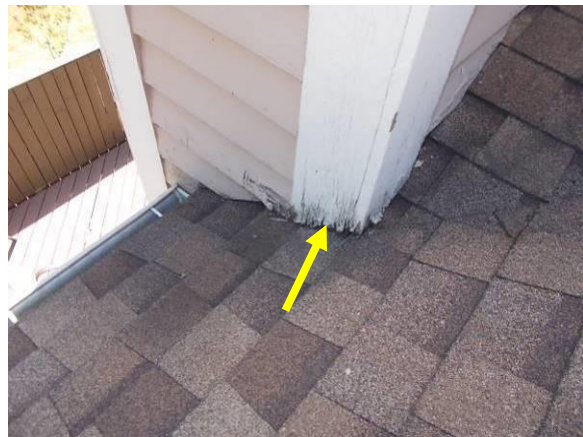
We noted areas of rotted or damaged trim around most chimney enclosures. Also, areas of isolated damage were noted.

*Examples of Deteriorated Trim*

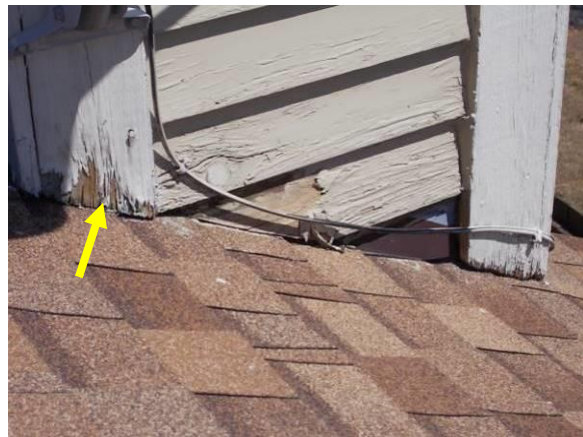
*Examples of Deteriorated Trim*

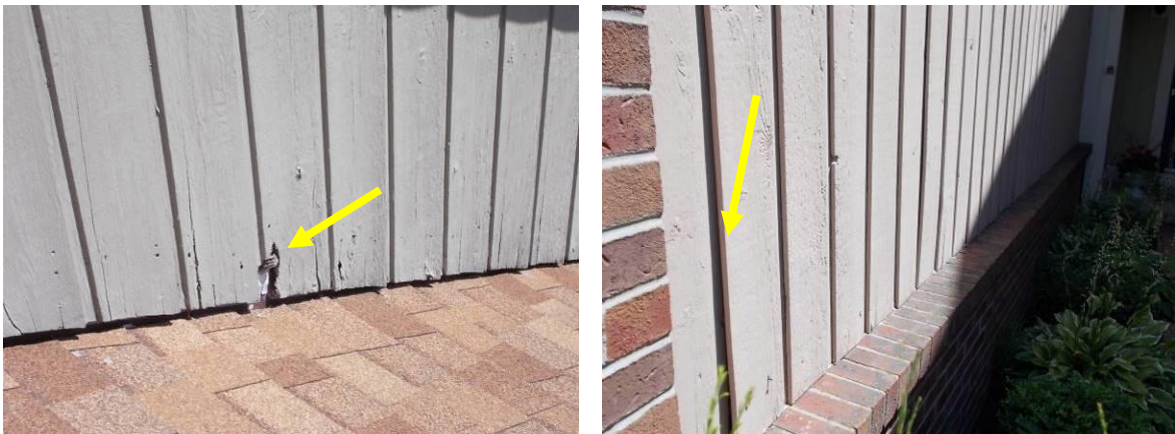
Some openings of seams were noted, as well as deterioration adjacent to brick ledges and roof interfaces.

*Deteriorated Vertical Siding & Opening Vertical Seams*

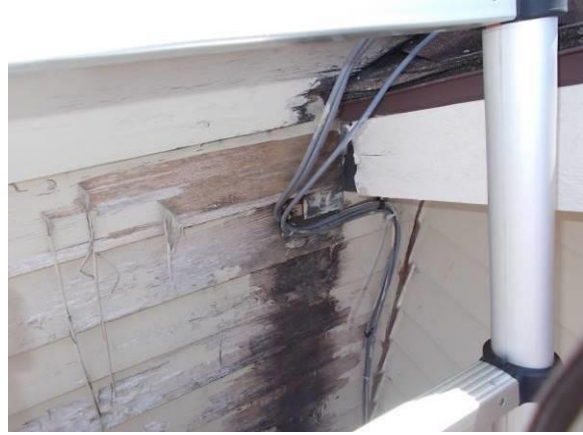
Areas of deteriorating and delaminated paint/stain were noted. These are in areas that appear to be directly affected by water damage as well weathering. Isolated areas of damage were also noted on chimney enclosures as well as near roof interfaces.

*Weathered and Damaged Siding & Paint/Stain and Siding with Water Damage*

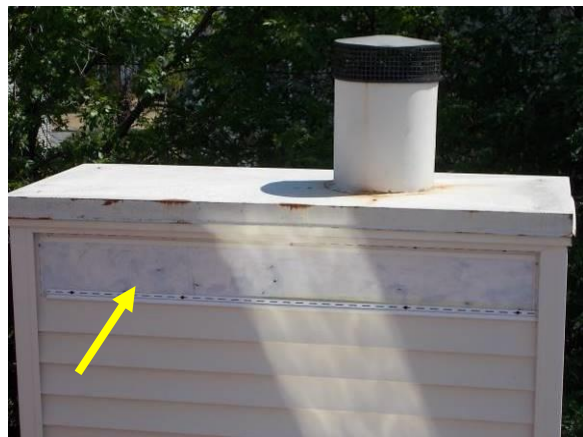
*Water Damaged Clapboards & Missing Vinyl Siding on Chimney Enclosure*

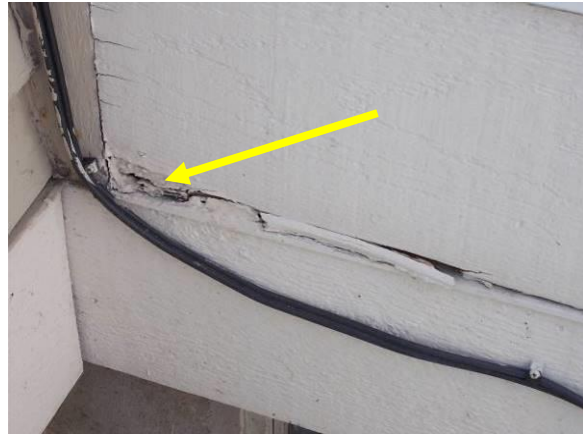
As with most buildings, areas of isolated trim damage can be found on chimney surrounds. Also, we suspect there are areas with leaking gutters and a lack of kick-out flashing causing trim damage. We noted evidence of insect damage along various portions of the trim as well.

*Trim Rot and Damage*

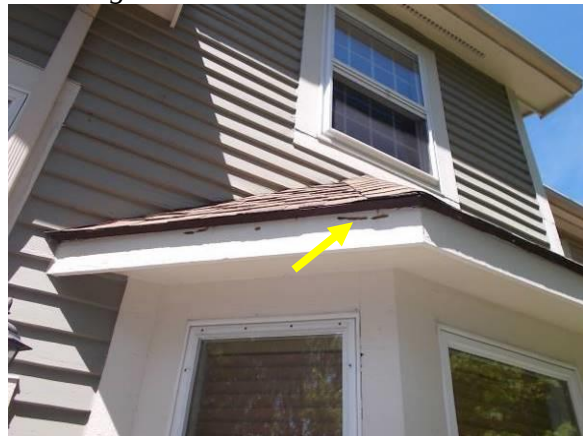
*Examples of Deteriorated Trim & Insect (Carpenter Bee) Damage*

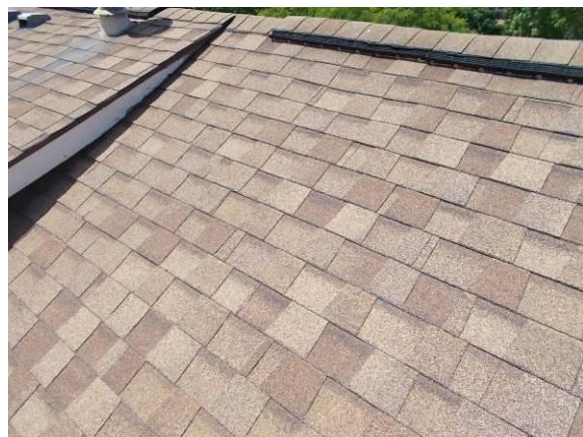
The roof surface appeared to be in average condition in comparison with other buildings. Some amount of deterioration and granule loss was noted.

*Roof Surface*

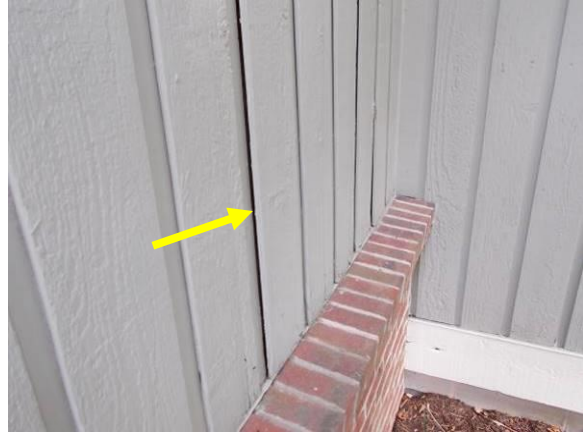
Gaps and openings were noted in various areas of the vertical siding. In relation to other buildings, an average amount of deterioration was noted at brick ledges as well as at interfaces with roof surfaces.

*Examples of Deterioration and Open Joints*

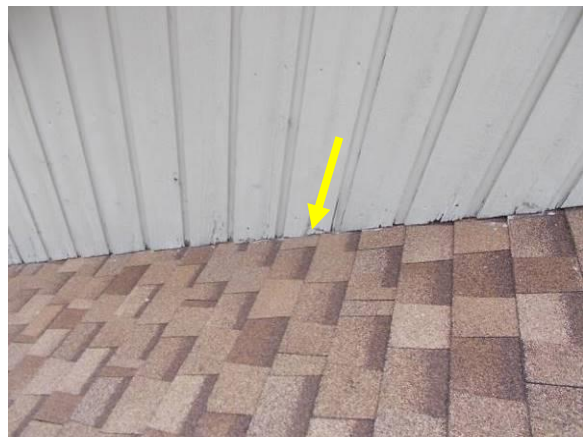
*Examples of Deterioration and Open Joints*

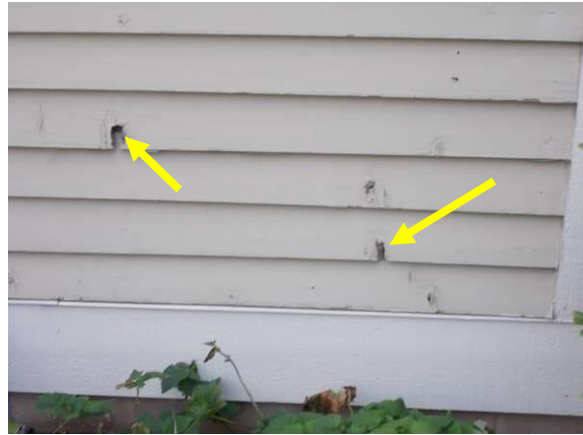
We noted that four of the chimneys have been retrofitted with vinyl siding. Because of this we suspect an above average amount of rot and deterioration most likely occurred in these areas. We noted areas with damage to the siding caused by defects in the wood, most notably some knots becoming loose and falling out.

*Examples of Deterioration & Damage Due to Wood Quality*

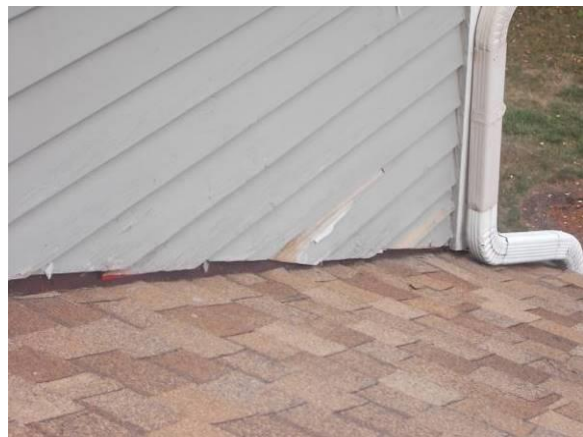
We noted isolated areas on the clapboard siding that are showing signs of paint or stain delamination. These appear to be caused by a combination of water penetration as well as weathering.

*Examples of Delaminating Paint/Stain*

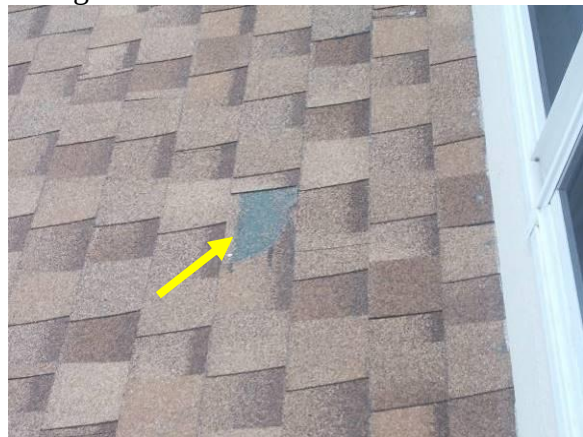
The roof surface appeared to be in better condition as compared to most of the other roof surfaces. We did note at least one missing or damaged shingle. This may be due to a high wind weather event or an isolated incident causing the damage.

*Roof Surface and Damaged Shingle*

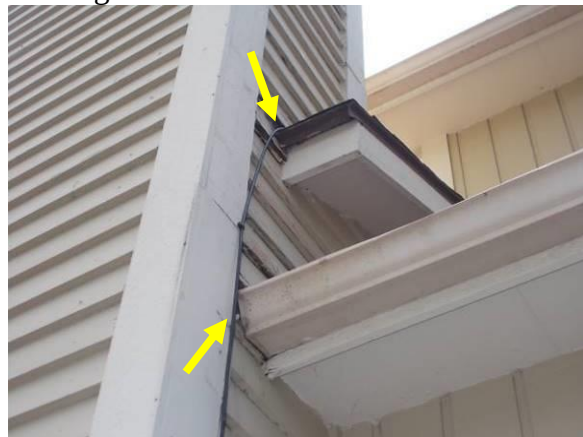
Deterioration was noted to the clapboards and on many areas of chimney surrounds. Also, there appears to be gutter leakage causing damage to the siding.

*Water Damage To Chimney Enclosures*

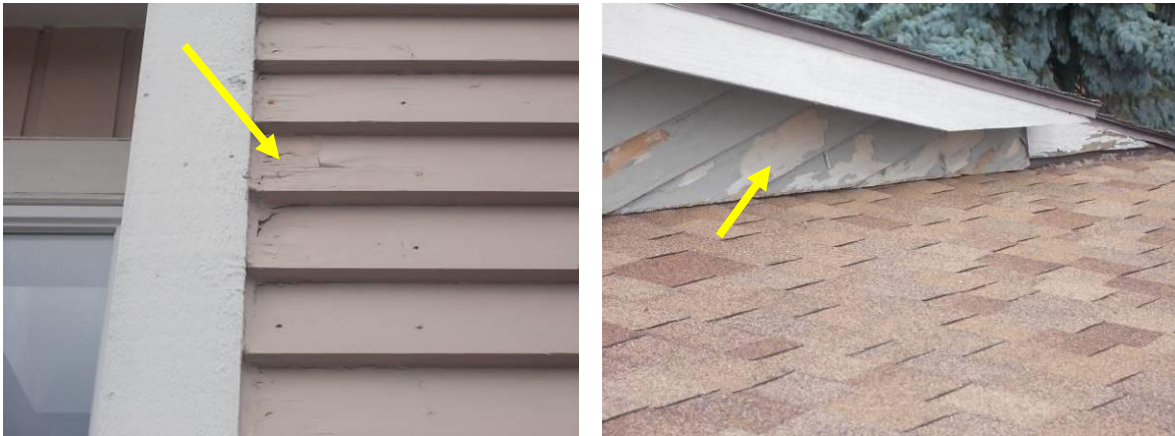
Paint and stain delamination was noted in some areas with a higher chance of water penetration.

*Clapboard Rot and Paint/Stain Delamination*

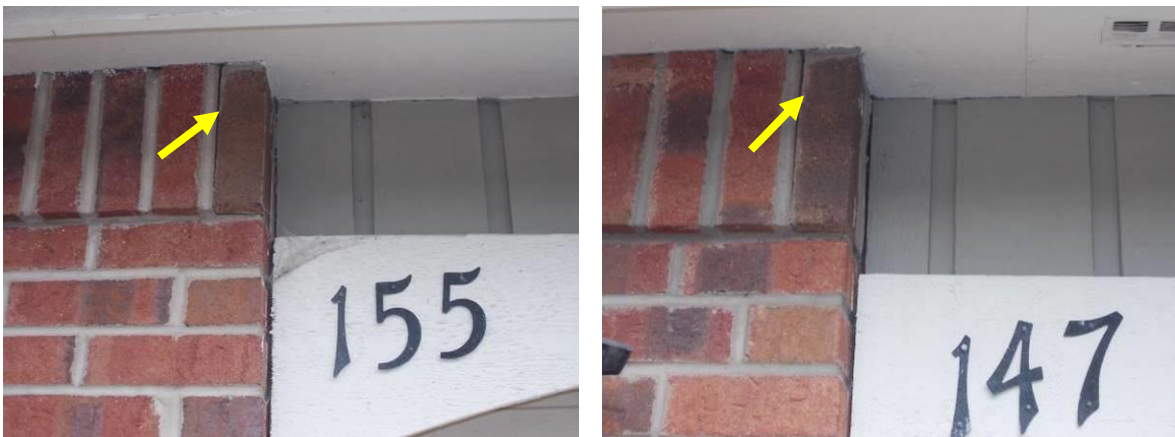
Some cracks in mortar joints were noted at garage headers from long term sag. However, the brick siding appeared to be in serviceable condition.

*Examples of Cracked Mortar Joints at Garage Headers*

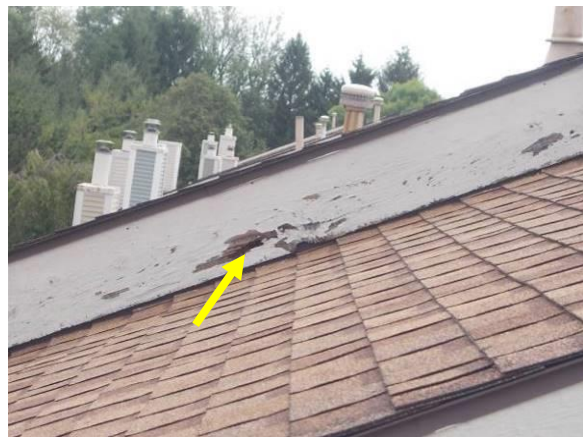
Isolated areas of damage were noted. These areas include chimney surrounds as well as lower portions of trim under windows. Some trim along roof surfaces is showing above average amounts of damage.

*Examples of Trim Damage and Deterioration*

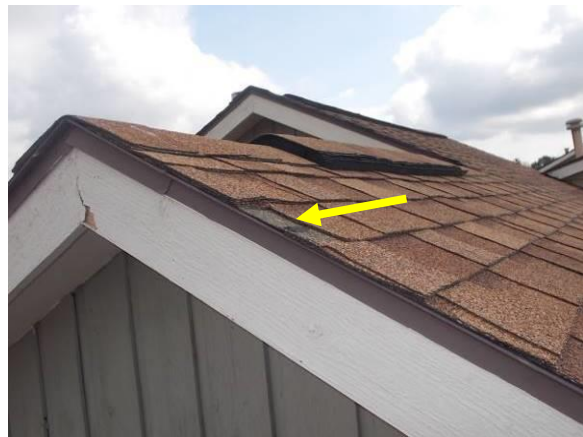
The roof surface appears to be in below average condition. We noted a damaged and missing shingle above unit #155.

*Example of Worn Shingle Surfaces and a Missing Shingle Tab/Edge*

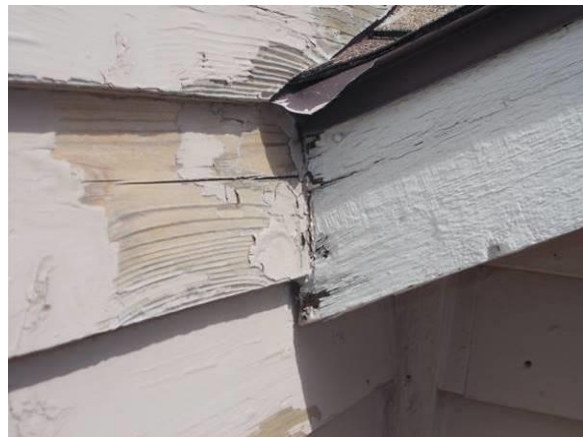
This siding has experienced typical isolated damage around chimney enclosures as well as cupping and twisting of clapboards.

*Examples of Water Damage*

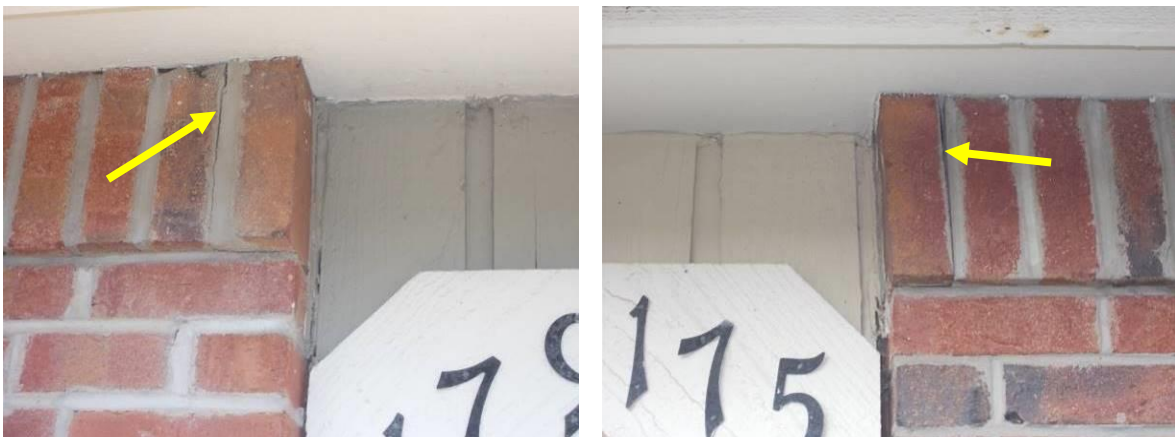
The brick veneer appeared to be in generally good condition, with the exception of some isolated cracked mortar joints at garage headers due to long term minor sag.

*Examples of Cracked Mortar Joints*

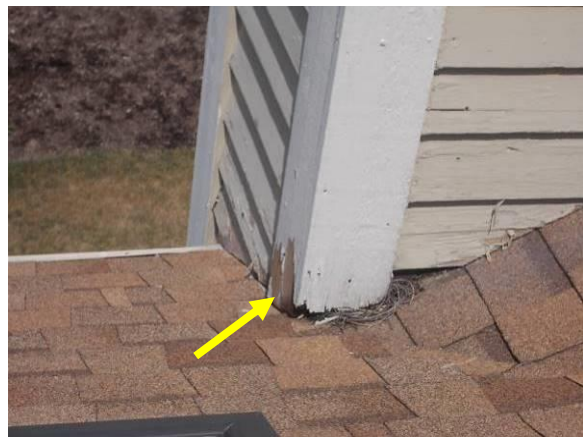
As with most buildings, areas of isolated trim damage can be found around the chimney surrounds. Also, there are areas with leaking and bypassed gutters causing trim damage. We noted evidence of insect damage on various portions of the trim, including some window trim.

*Examples of Trim Deterioration*

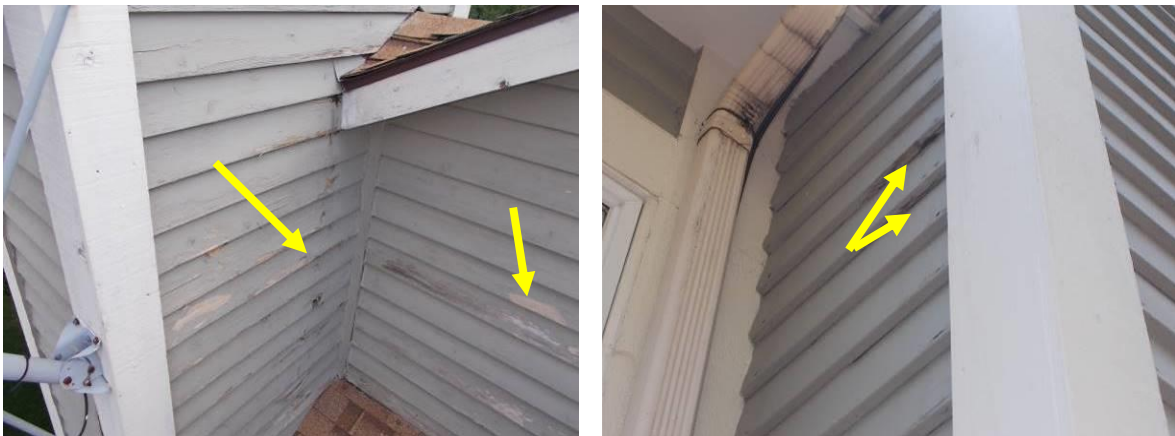
Areas of deteriorating and delaminated paint/stain were noted. These are in areas that appear to be directly affected by both water damage and weathering.

*Water Damaged and Weathered Paint & Deteriorated Clapboards*

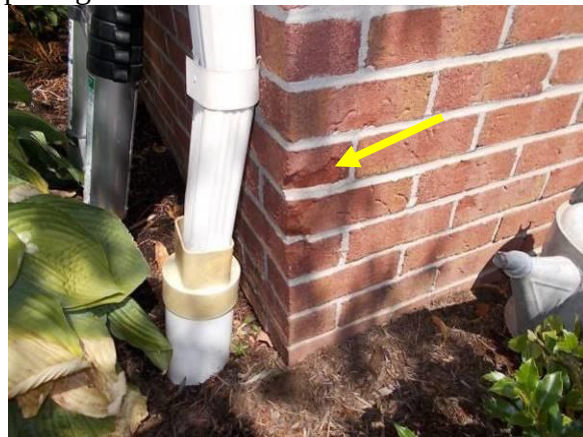
Isolated areas of damage were noted. These includes some broken and spalling bricks. Also, cracked mortar joints exist at some garage door openings.

*Damaged Bricks*

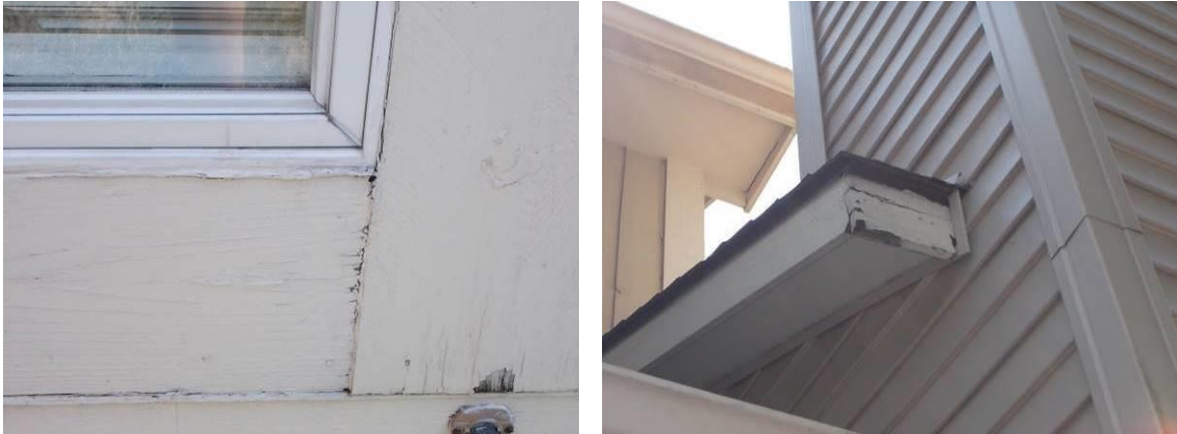
Isolated areas of rot and damage were noted to the trim. These were most prevalent on chimney surrounds. Also, some exterior window trim and soffit areas are showing signs of deterioration.

*Examples of Trim Rot and Deterioration*

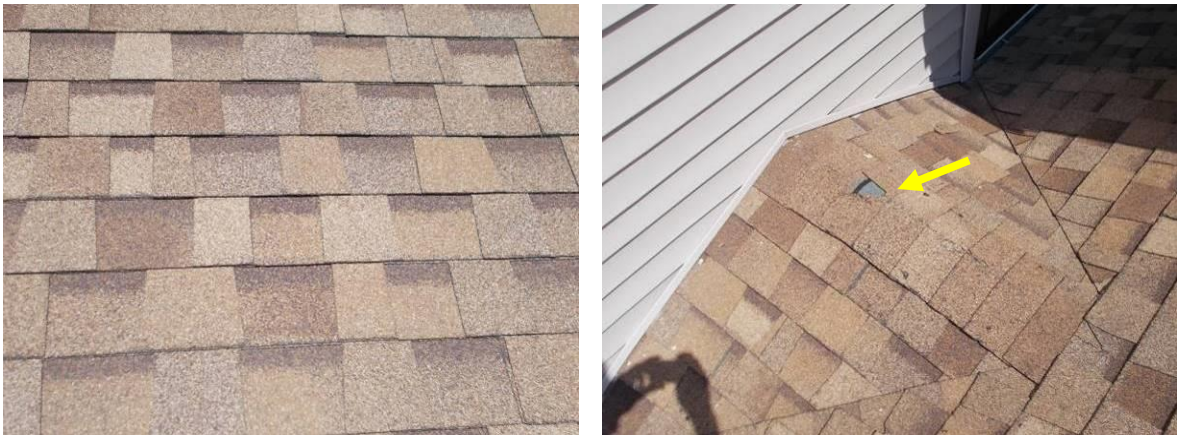
The roof surface appeared to be of average quality in comparison with other buildings. Some amount of deterioration and granule loss was noted. Also noted, are some damaged shingles on a chimney cricket that is showing more severe wear. Replacing several shingles on this cricket will likely be required prior to complete roof resurfacing.

*Example of Shingle Condition & Damaged Shingle on Chimney Cricket*

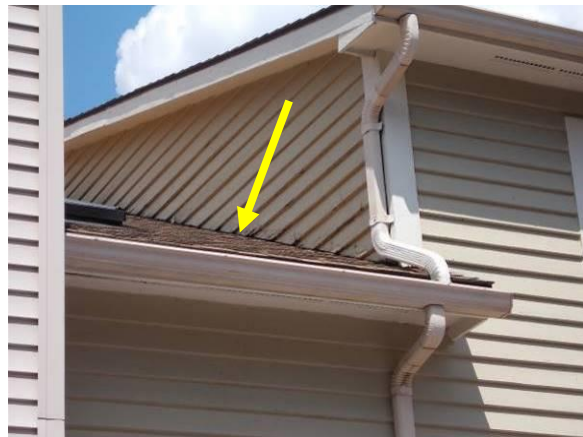
*Examples of Trim Deterioration at Roof Interfaces*

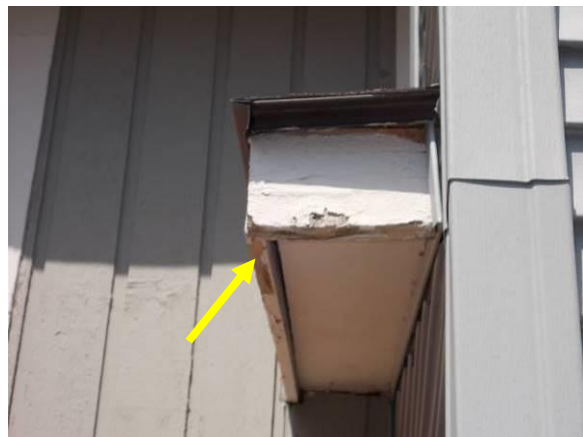
We noted areas of rotted or damaged trim around portions of most chimney enclosures. Also, areas of isolated deterioration and insect damage were noted.

*Examples of Rot in Need of Repair and Gaps in Trim*

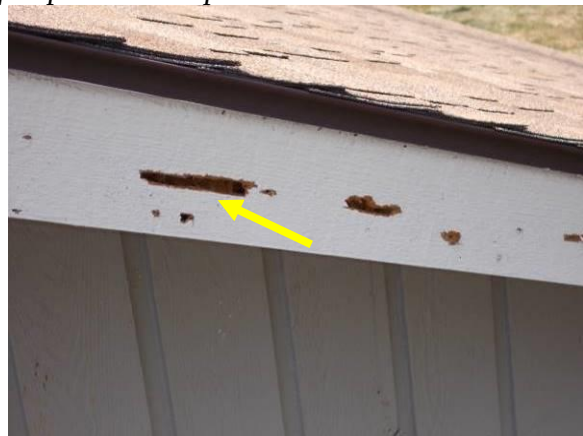
*Examples of Rot in Trim & Insect Damage (Carpenter Bees)*

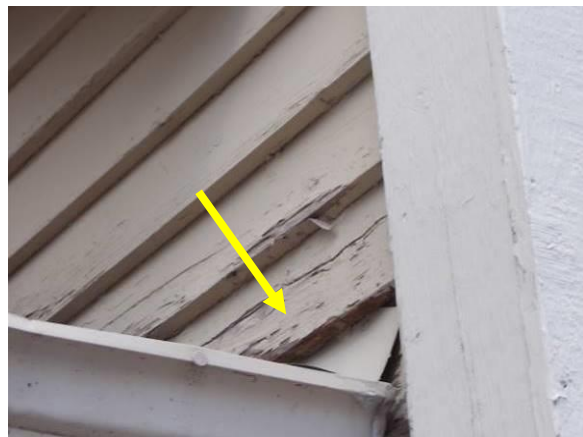
*Examples of Deterioration to Siding and Paint/Stain*

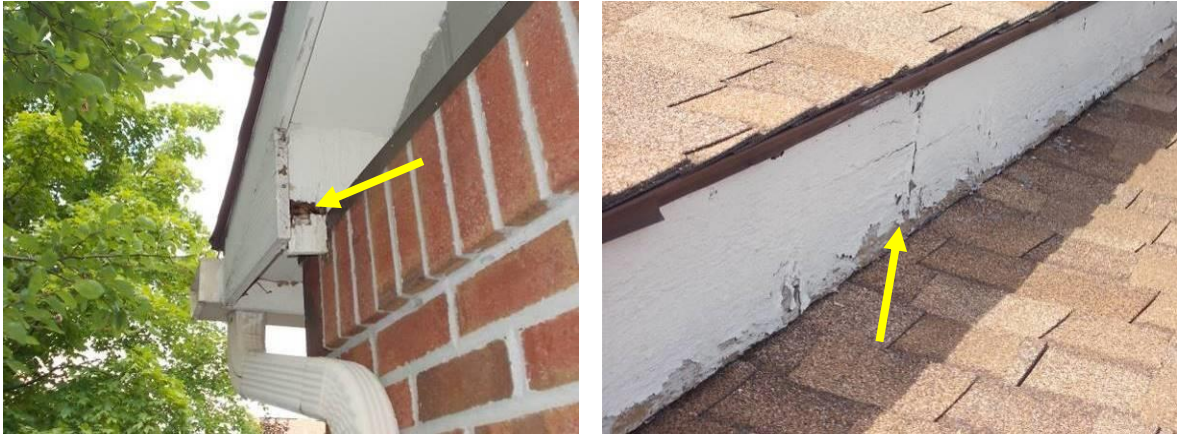
Areas of rot and damage were noted to the trim. These were most prevalent along chimney surrounds. Exterior window trim and soffit areas are showing signs of deterioration as well.

*Examples of Damage and Deterioration to Trim in Need of Replacement*
