RE: Brittany Commons  
Rochester, NY 14618

### **INTRODUCTION**

We performed a limited visual inspection of the exterior siding and roofing for 14 of the 19 buildings of the subject townhouse complex. This was to provide a professional opinion as the condition and the expected remaining life of the siding and the roofs. These inspections were performed from the ground and with the use of a 14 foot telescoping ladder to view and walk many of the roofs. We did not directly walk a few of the less accessible roofs towards the center portions of the buildings, but we walked the roofs on each end of the subject buildings as well as several of the adjacent accessible roofs.

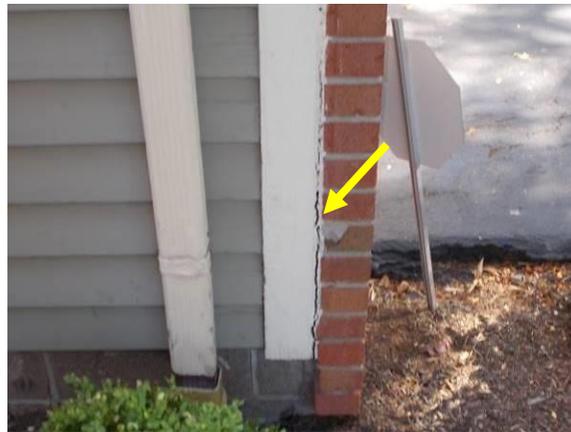
The brick siding appeared to be in generally good condition. We did note an area adjacent to wood siding with a gap. Keeping areas such as this caulked and sealed is recommended. This will help to keep unwanted pests from entering behind the siding.

*Seal Gap*

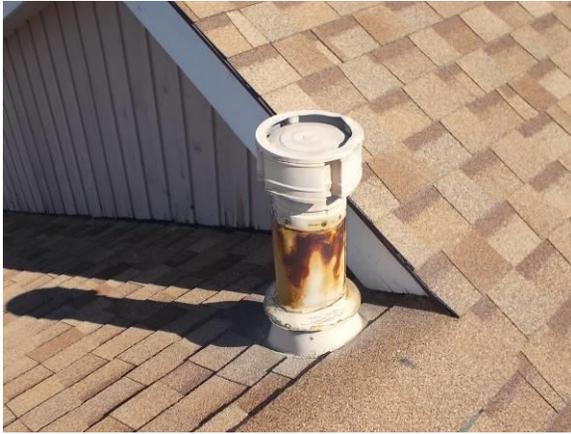
We noted the majority of the steel flue pipes penetrating the roof are rusty. Some amount of painting, repair or replacement may become necessary as deterioration continues.

*Rusted B-Vent and Paint on Front Door*

We noted peeling paint on the front door assembly of one of the units. Preparing, priming, and repainting this is recommended.

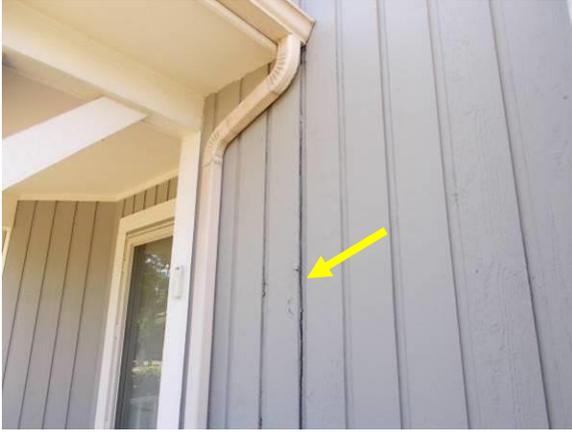
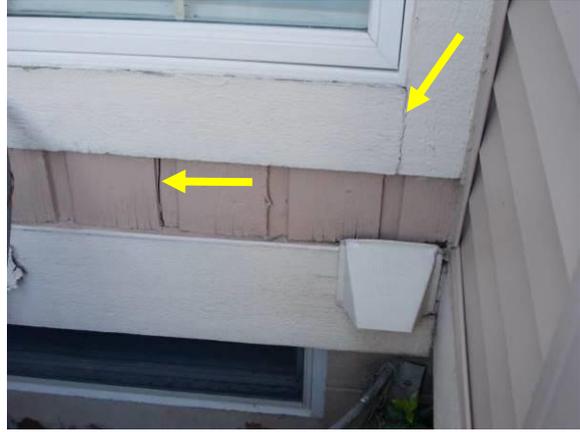
The vertical siding on this building is showing signs of damage and wear in typical areas. These include intersections with brick water tables as well as areas that are in contact with roof surfaces. We also noted areas of opening vertical seams.

*Open Seam in Vertical Siding & Deteriorated Siding and Trim*

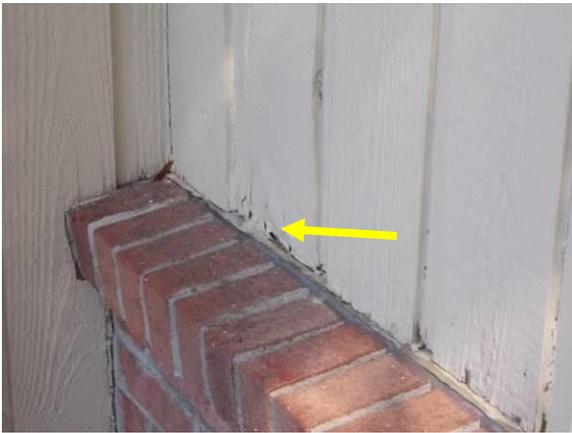
*Rot and Deterioration at Water Table/Brick Ledge*

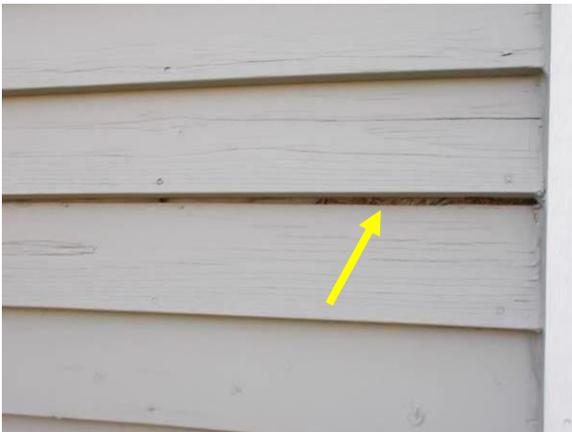
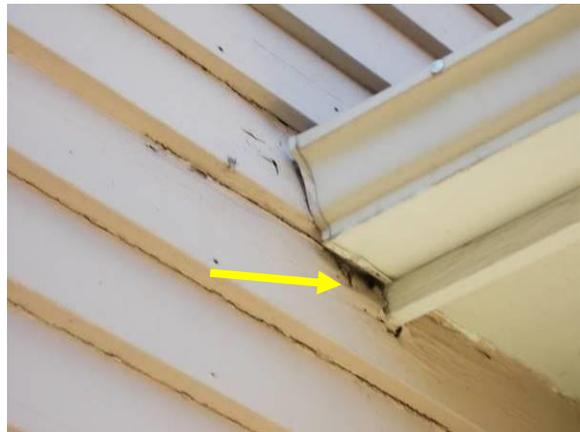
*Damaged Siding & Rot at Gutter End Cap (lack of kick-out flashing above gutters)*

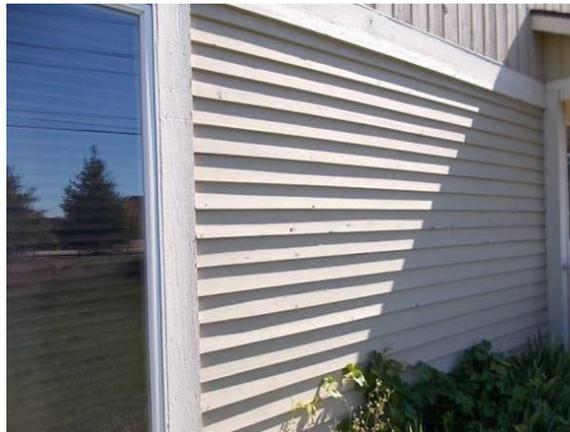
The paint on the south facing portion of the building is showing signs of weathering and deterioration. This is most likely due to the sunlight and weather that it is exposed to.

*Weathered Siding*

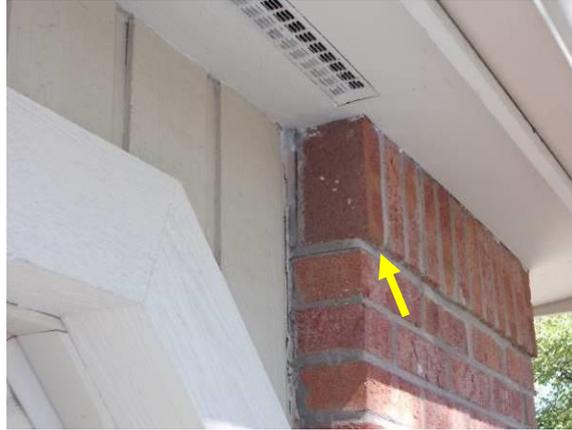
The brick siding appeared to be in generally serviceable to good condition. We did note isolated bricks that have cracking in their mortar joints. This is most noticeable at the headers of garage doors from a small amount of long term sag. Also, there are areas of isolated surface spalling of bricks.

*Cracking Mortar Joint*

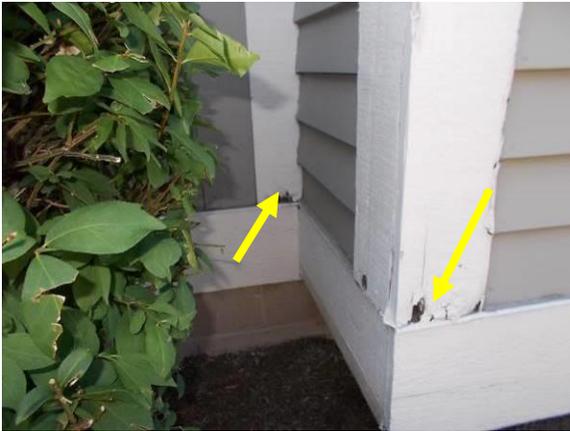
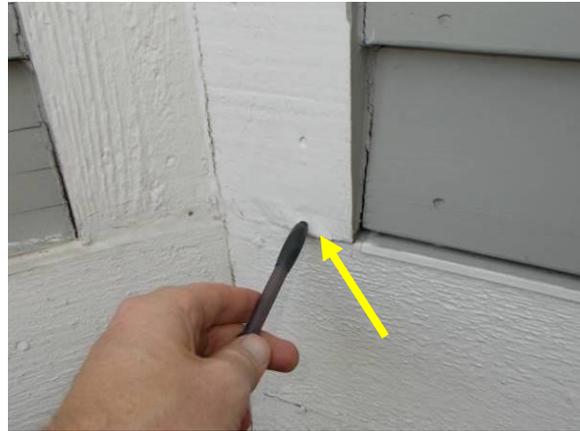
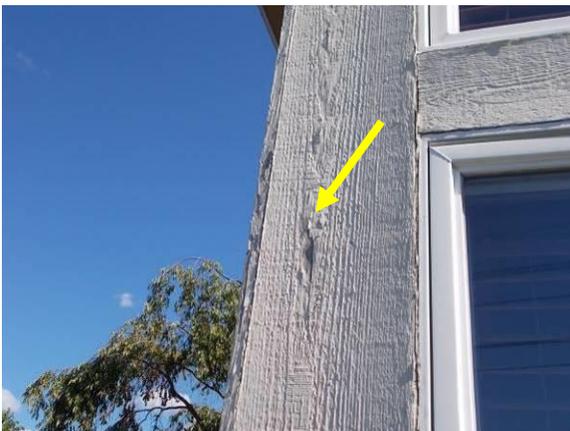
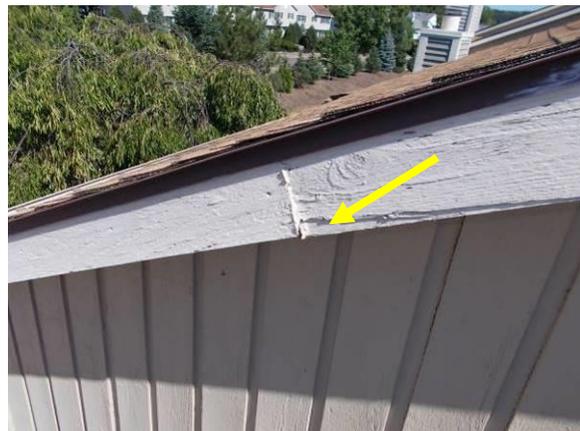
*Examples of Trim Rot and Deterioration*

The areas heaviest rot and deterioration appear on the chimney enclosures. Also, we noted damage or broken trim in upper eaves. As is typical with most buildings in the complex, we noted a fair amount of rot that is not readily visible, since it has been painted over.

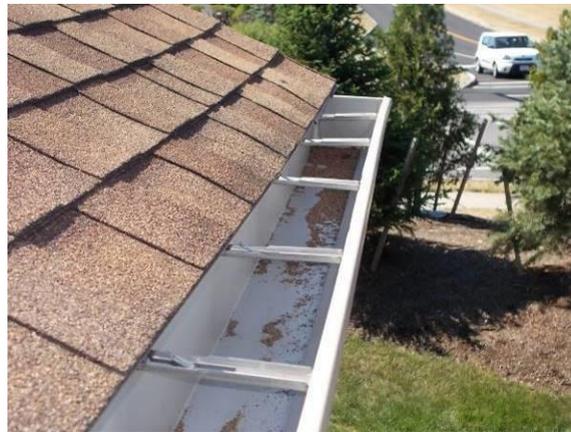
There are signs of wear and age on the roof surface. This is most evident in some damage to roof shingles as well as the amount of granules that appear to have come loose from the shingles.

*Roof Granules in Gutter*

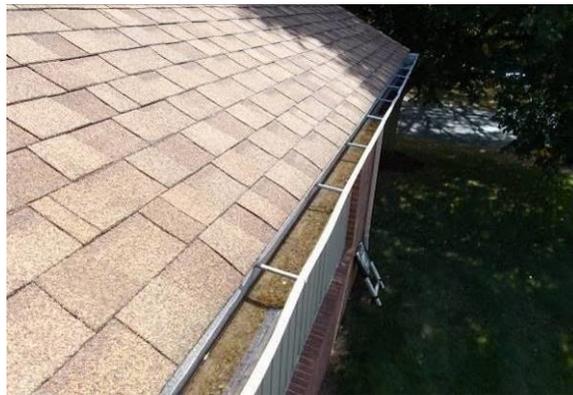
There is a section of gutter on unit #15 that appears to be pitched improperly. We noted standing water in this gutter. The gutter does not appear to be overly clogged with debris so the gutter should be properly re-mounted.

*Improperly Pitched Gutter*

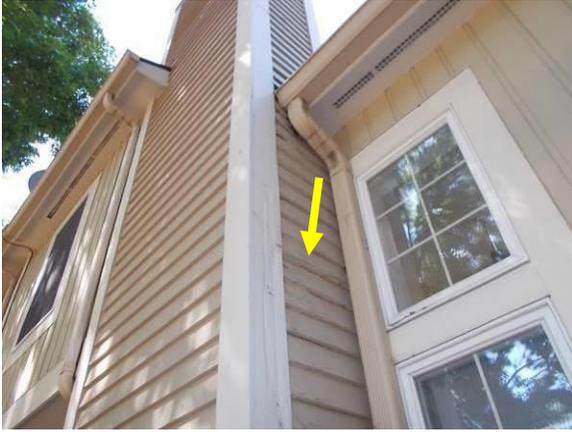
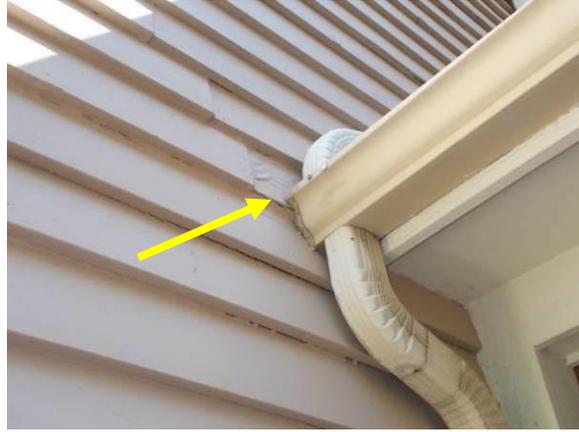
We noted areas of deteriorated and rotted clapboard siding, most notably under or near areas of gutters that appear to be leaking.

*Rot at Gutter Ends*

*(Kick-out flashing is recommended at roof and siding interfaces above these gutter ends)*

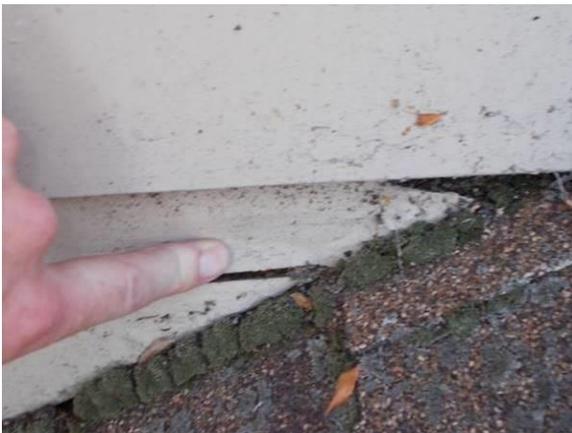
As is typical with most buildings, siding deterioration is concentrated around chimney enclosures. We noted two chimney enclosures that have been previously vinyl sided.

*Rot at Roof Interface & Chimney Enclosure*

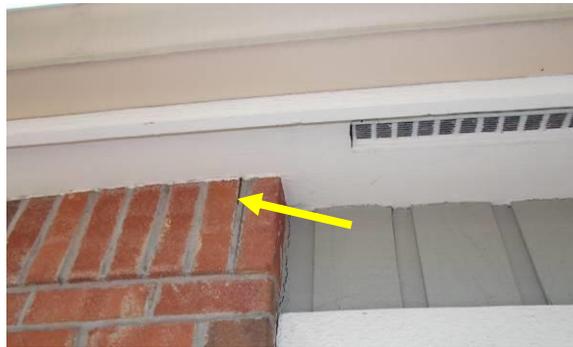
*Crack in Mortar Joint at Garage Header*

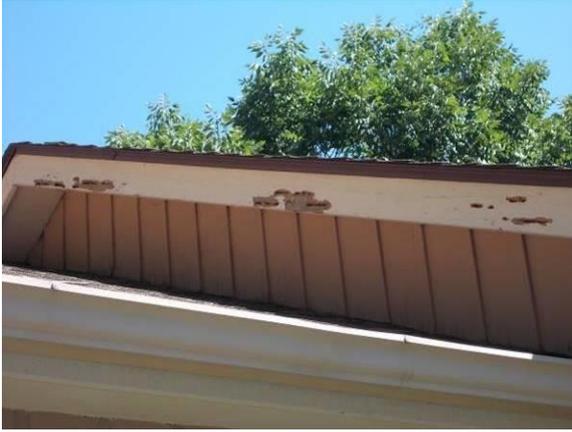
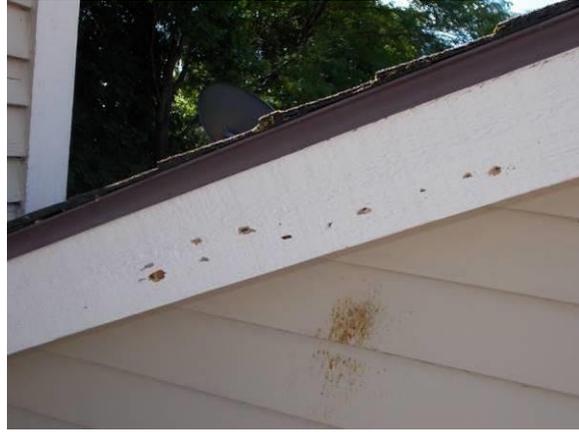
In relation to damage caused by leaking gutters on the horizontal siding, we also noted rot and damage to trim due to leaking gutters. Also, we noted a relatively large amount of insect damage to the trim on this building.

*Insect Damage to Trim (Carpenter Bees)*

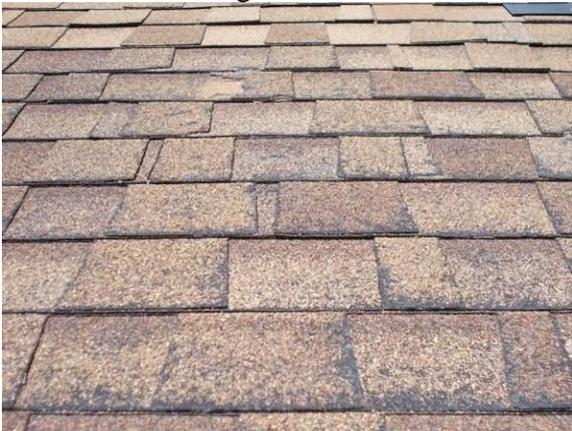
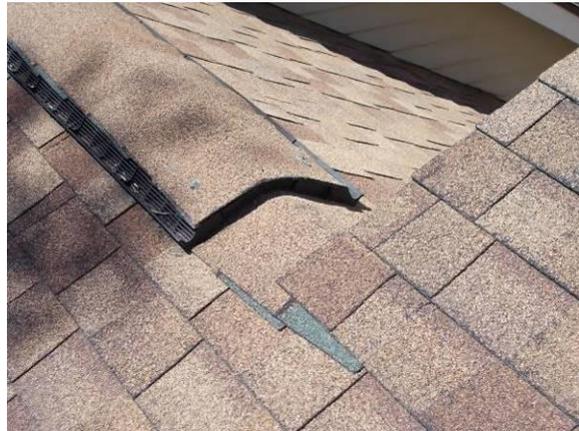
Signs of wear were noted on the roof surface, such as missing granules from the shingle surfaces. We also noted areas of moss growth. While this is not necessarily a sign of advanced deterioration, cleaning off moss is recommended.

*Roof Surface with Significant Granule Erosion*

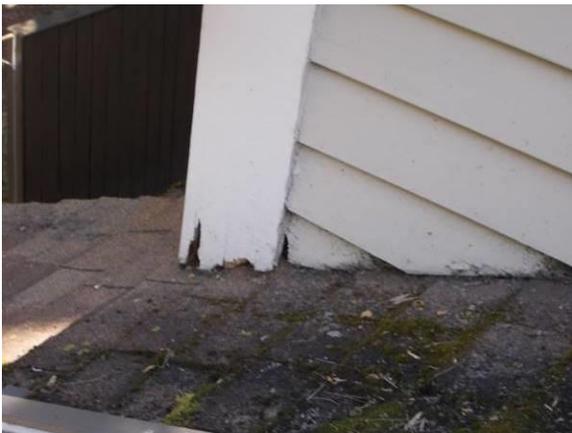
*Moss Growth and Trim Damage*

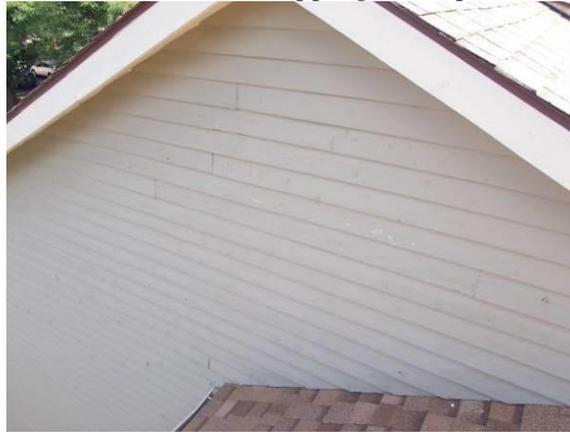
*Paint or Stain Showing Signs of Wear*

Portions of the paint on the horizontal siding of this building are showing signs of wear. This is most likely due to weather exposure.

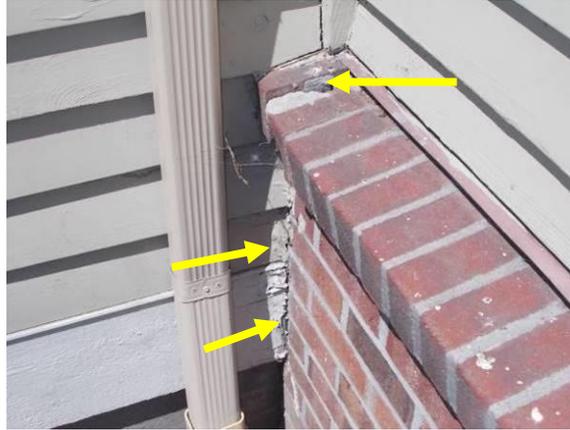
The brick siding on this building appears to be in generally good condition. We noted at least one area of isolated damage to the brick water table and repair is recommended.

*Damaged Brick with Deteriorated Siding and Trim*

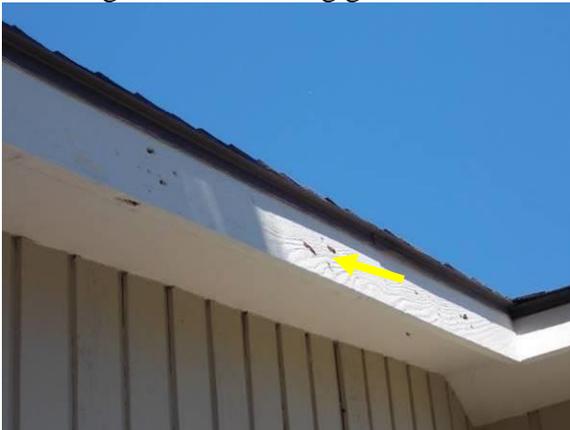
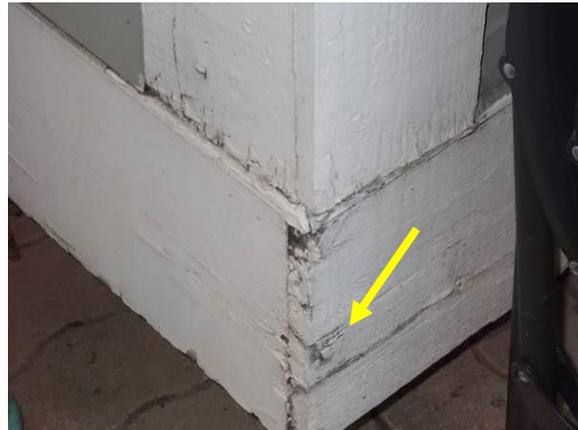
We noted areas with insect damage to the trim. Also, there are areas of trim that appear to have been damaged due to leaking gutters.

*Insect Damage (Carpenter Bees) and Area of Deterioration at Chimney Enclosure*

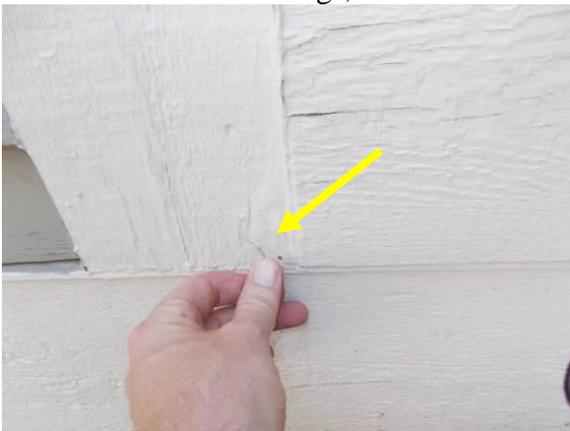
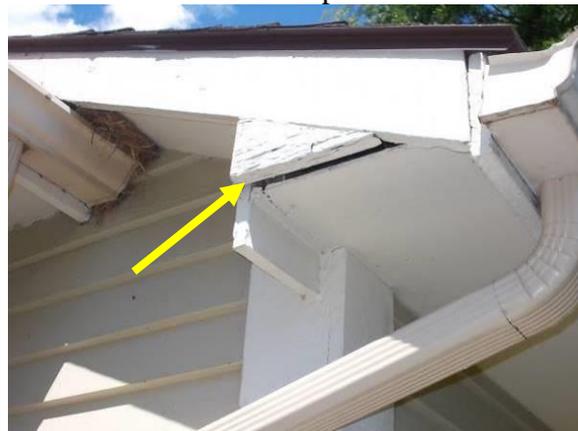
As noted with other buildings, we encountered areas of rot that have been painted over.

*Examples of Rot Behind Coating & Damaged Trim with Gaps*

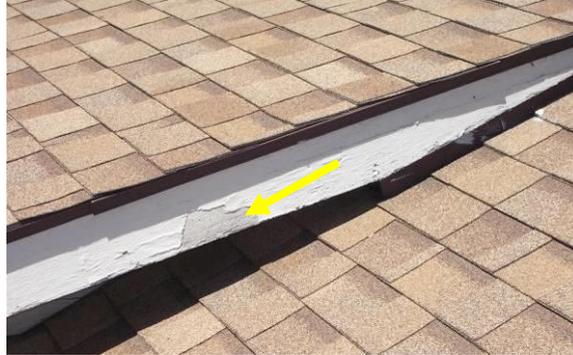
The roof surface appears to be in generally serviceable condition with limited amounts of surface wear noted.

*Roof Surface and Delaminating Paint on Trim*

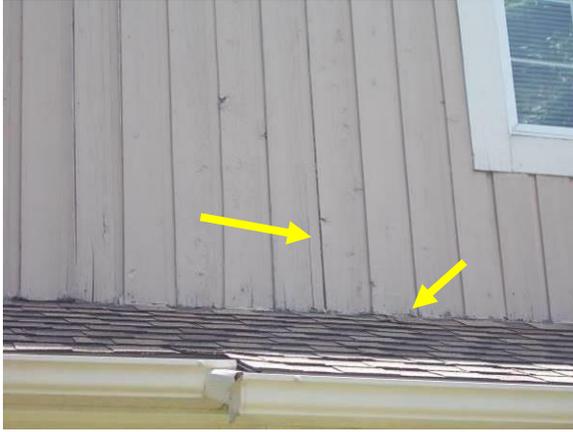
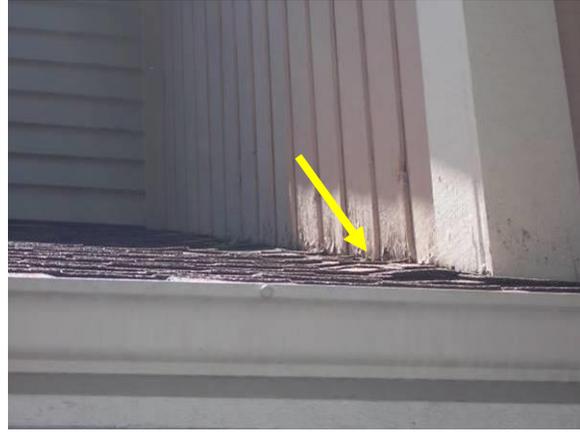
Areas of wear were noted at brick siding water tables. Also, gaps were noted in vertical seams.

*Deterioration at Roof Interface and Opening Joints*

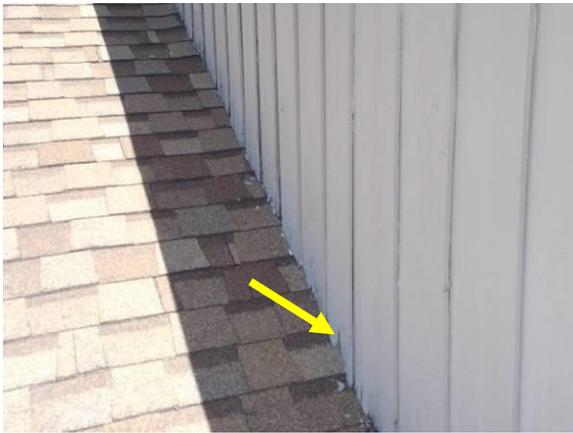
*Examples of Deterioration at Brick and Roof Interfaces*

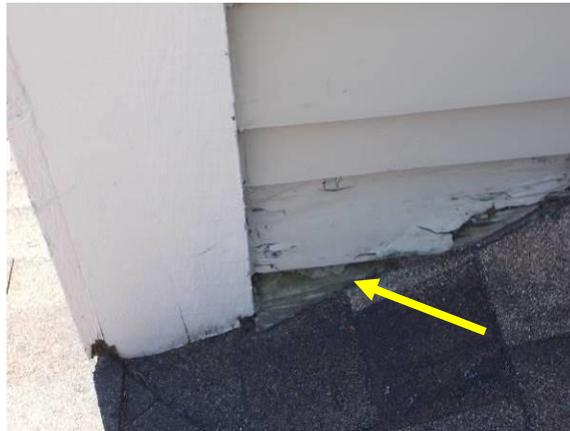
This siding has suffered typical damage at chimney enclosures. Also, we noted areas near gutter ends showing signs of deterioration. This is most likely due to leaks in these gutters along with a lack of kick-out flashing at roof and siding intersections.

*Examples of Deterioration to Clapboards*

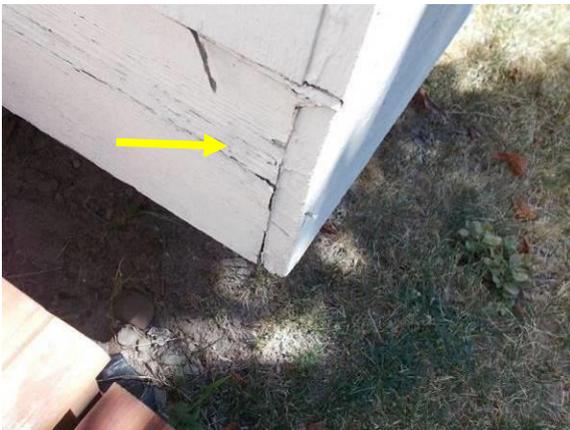
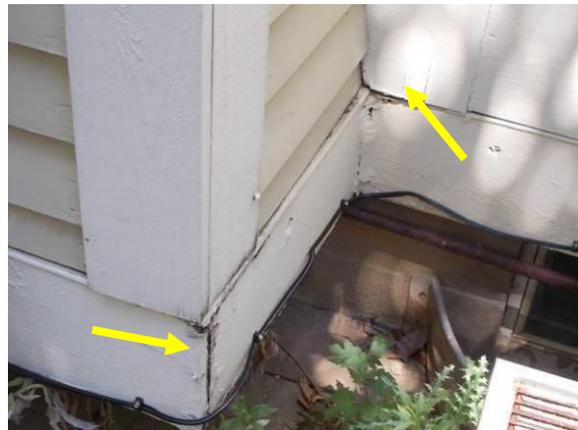
Isolated areas of rot and damage were noted to the trim. These were most prevalent at chimney surrounds. Also, exterior window trim and soffits were showing signs of deterioration. It is always possible to discover additional deterioration behind trim and siding, for all buildings, if removing and replacing materials.

*Rot to Trim on Chimney Enclosures*

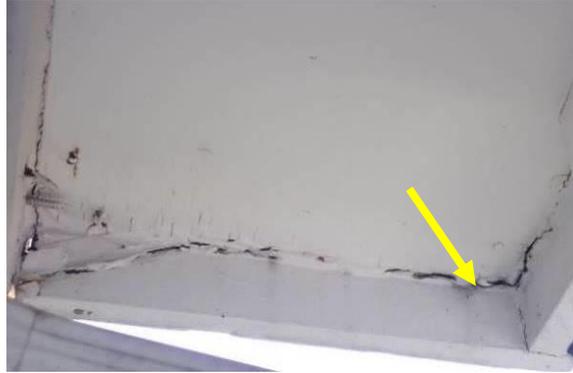
*Rot to Trim and to Soffits*

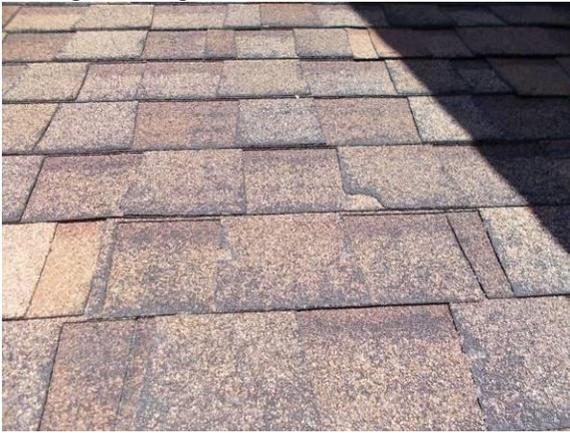
An above average amount of deterioration was noted on the shingle surfaces. Also, some areas of damaged shingles were encountered.

*Example of Roof Condition (Advanced Wear on this Building)*

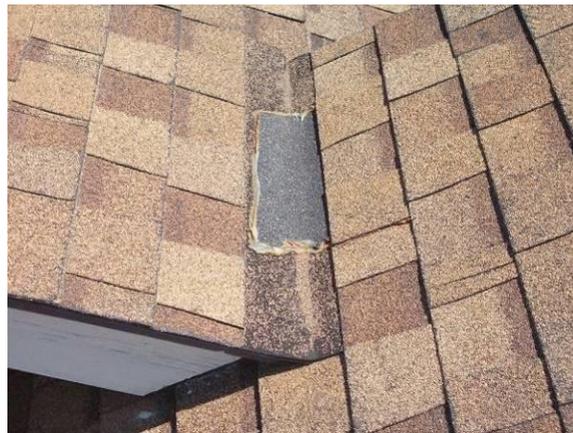
We noted a small valley that has been patched. This is most likely an indication of previous roof leakage.

*Patched Valley/Intersection*

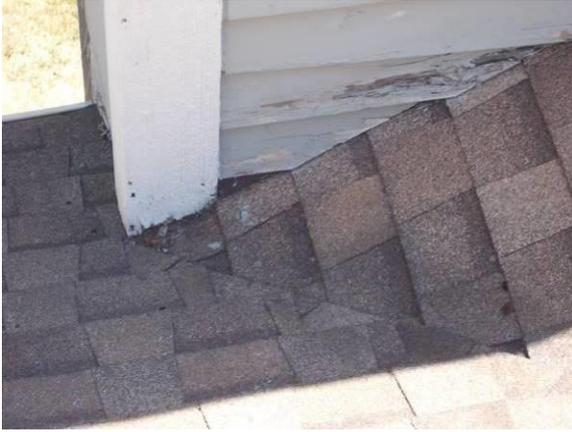
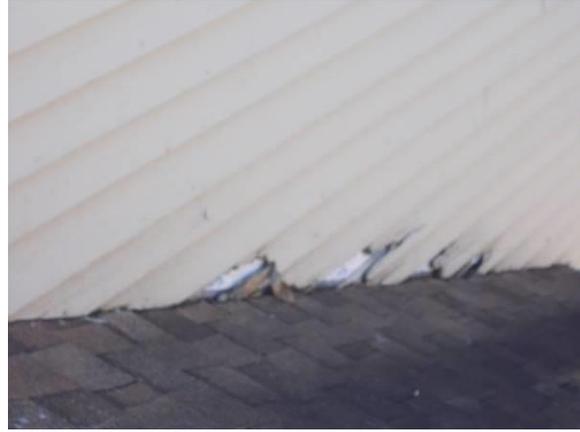
We noted areas of more severe damage to the clapboard siding. These are most notable at roof interfaces and on chimney closures. Better flow control of water from roofs is necessary in these areas along with better intersection and flashing details.

*Examples of Deteriorated Clapboards*

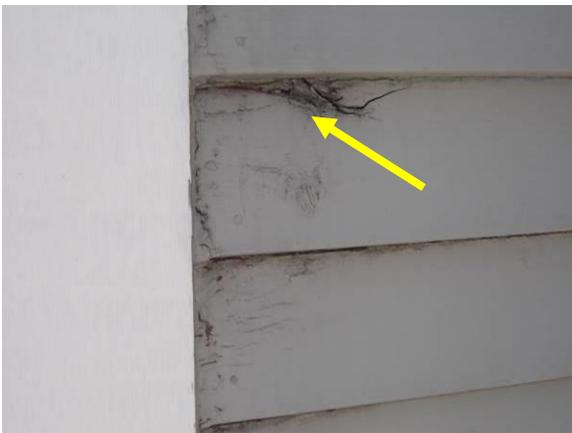
*Examples of Deteriorated Clapboards*

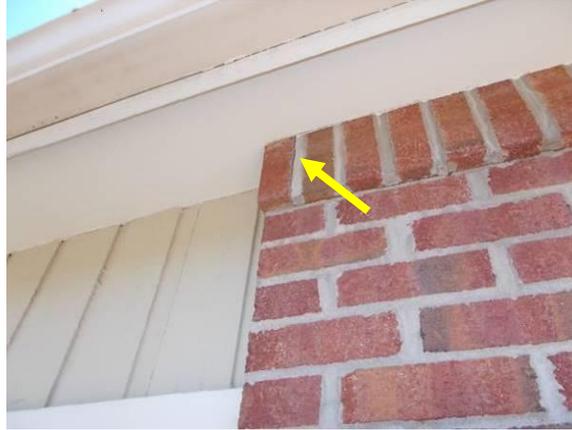
The brick veneer appeared to be in generally good condition. There were some minor isolated cracks noted in mortar joints. These are most notable at the headers of garage door openings from a small amount of long term sag.

*Cracked Mortar Joint*

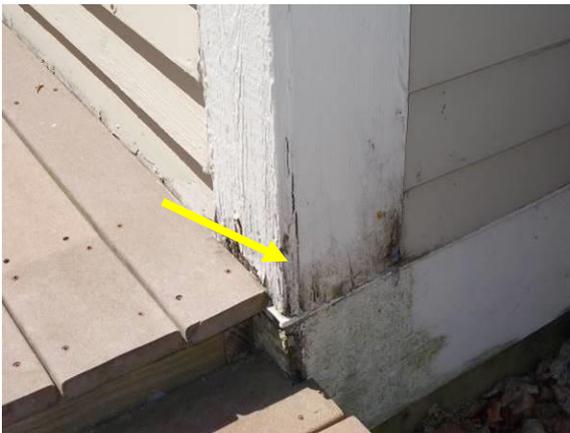
We noted areas of rotted or damaged trim around most chimney enclosures. Also, areas of isolated damage were noted.

*Examples of Deteriorated Trim*

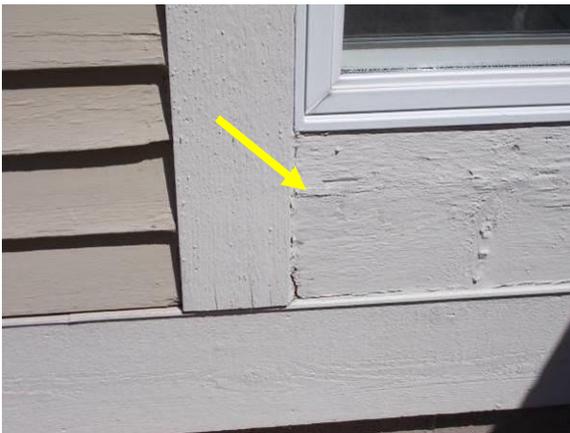
*Examples of Deteriorated Trim*

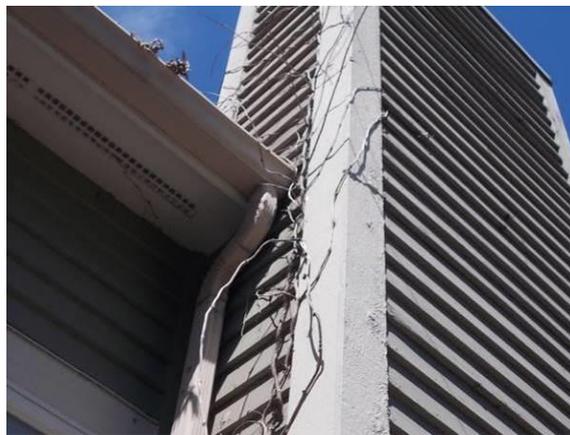
*Vine Growth*

We noted vine growth on a chimney enclosure. It is recommended that vegetation be removed as its growth can become problematic to siding and trim.

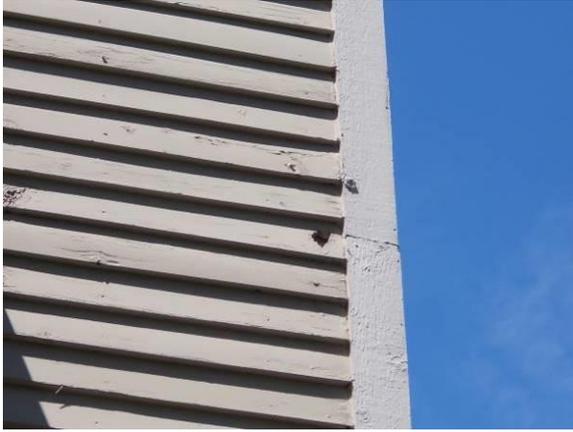
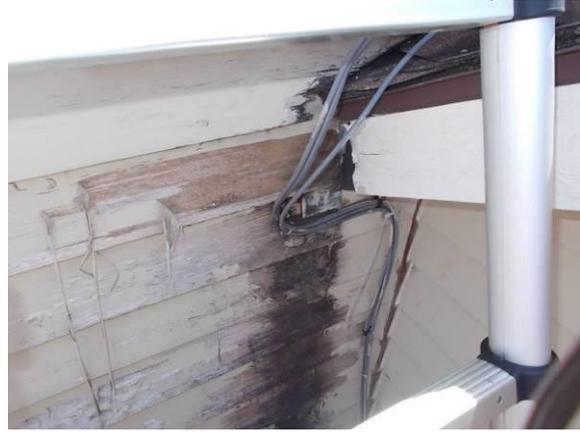
Areas of deteriorating and delaminated paint/stain were noted. These are in areas that appear to be directly affected by water damage as well weathering. Isolated areas of damage were also noted on chimney enclosures as well as near roof interfaces.

*Weathered and Damaged Siding & Paint/Stain and Siding with Water Damage*

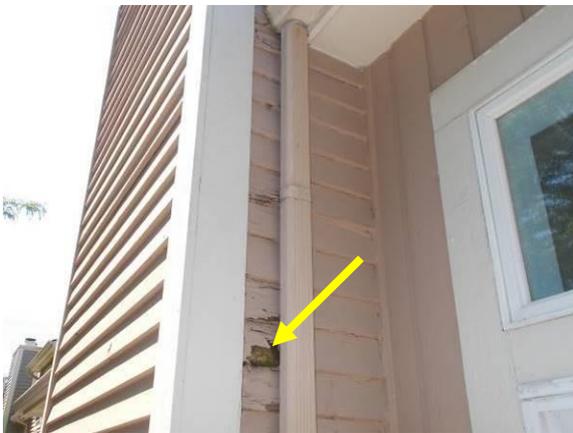
*Water Damaged Clapboards & Missing Vinyl Siding on Chimney Enclosure*

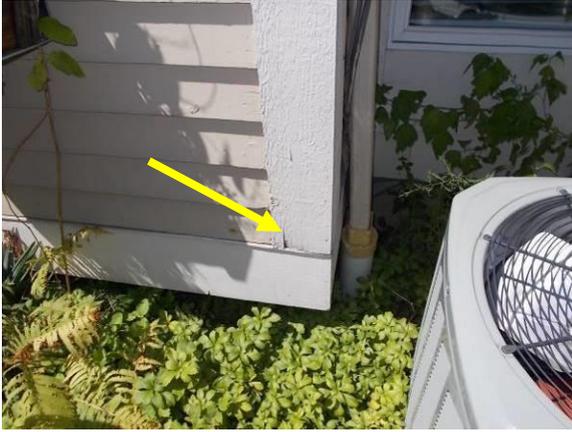
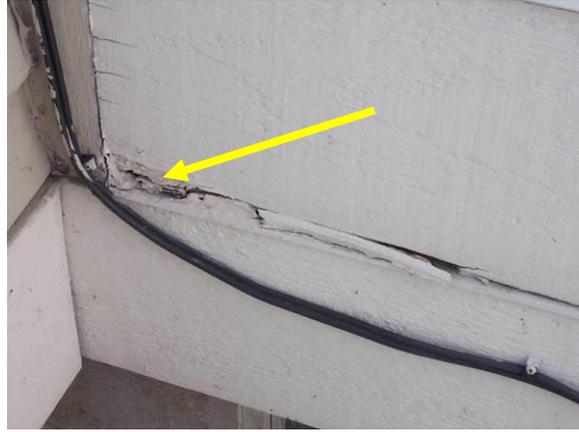
As with most buildings, areas of isolated trim damage can be found on chimney surrounds. Also, we suspect there are areas with leaking gutters and a lack of kick-out flashing causing trim damage. We noted evidence of insect damage along various portions of the trim as well.

*Trim Rot and Damage*

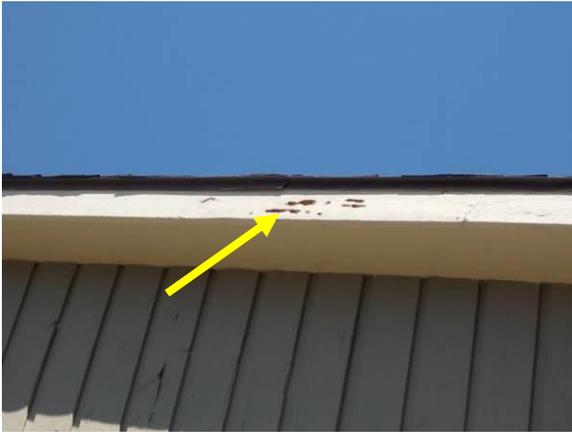
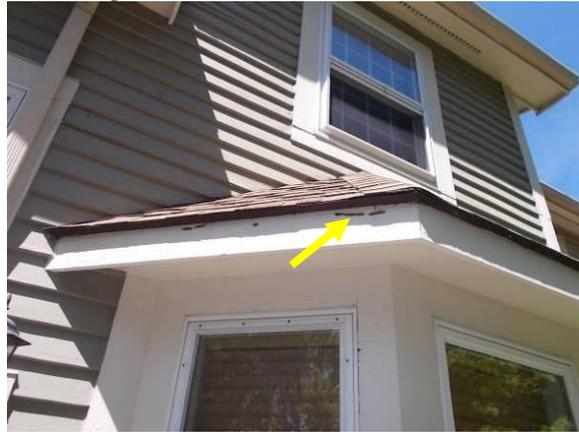
*Examples of Deteriorated Trim & Insect (Carpenter Bee) Damage*

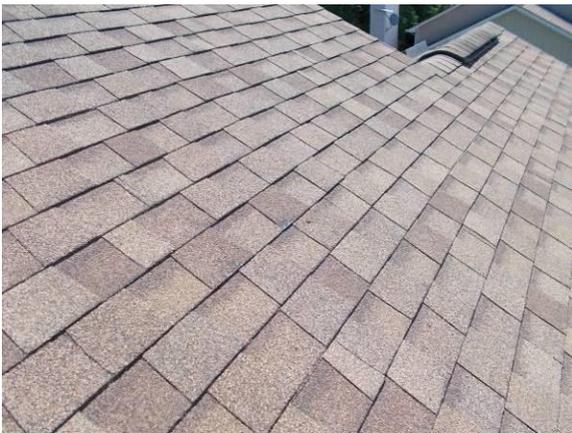
The roof surface appeared to be in average condition in comparison with other buildings. Some amount of deterioration and granule loss was noted.

*Roof Surface*

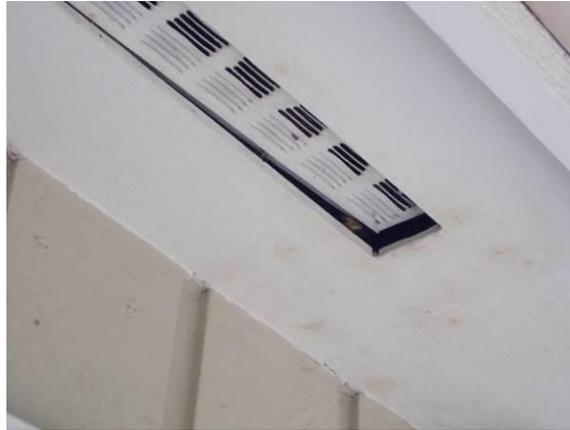
We noted that the soffit vent on unit #83 is damaged and presenting an entrance point for pests.

*Soffit Vent to Repair on Unit 83*

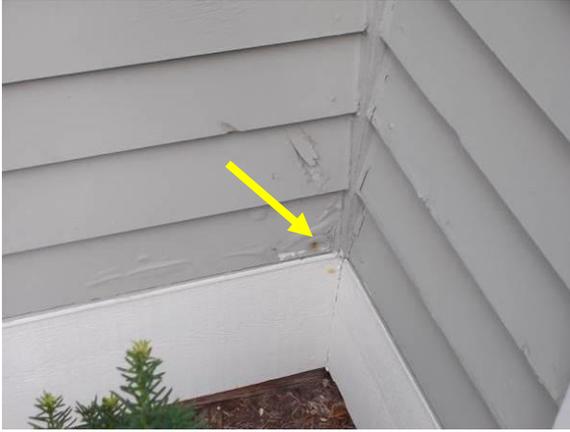
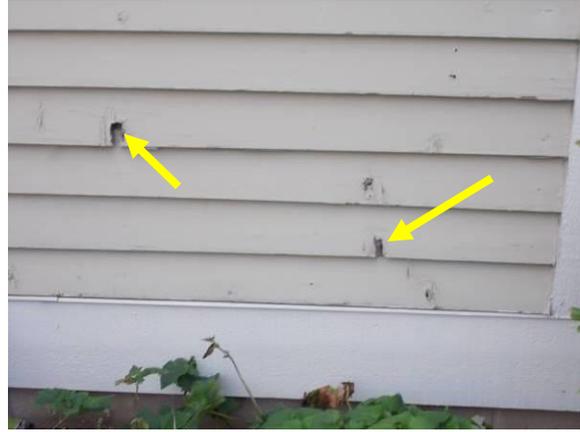
We noted that four of the chimneys have been retrofitted with vinyl siding. Because of this we suspect an above average amount of rot and deterioration most likely occurred in these areas. We noted areas with damage to the siding caused by defects in the wood, most notably some knots becoming loose and falling out.

*Examples of Deterioration & Damage Due to Wood Quality*

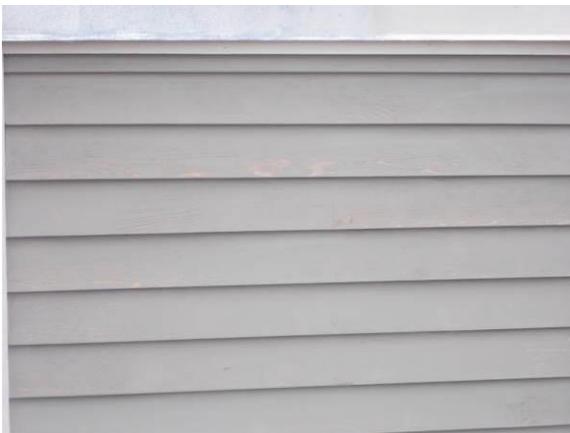
We noted isolated areas on the clapboard siding that are showing signs of paint or stain delamination. These appear to be caused by a combination of water penetration as well as weathering.

*Examples of Delaminating Paint/Stain*

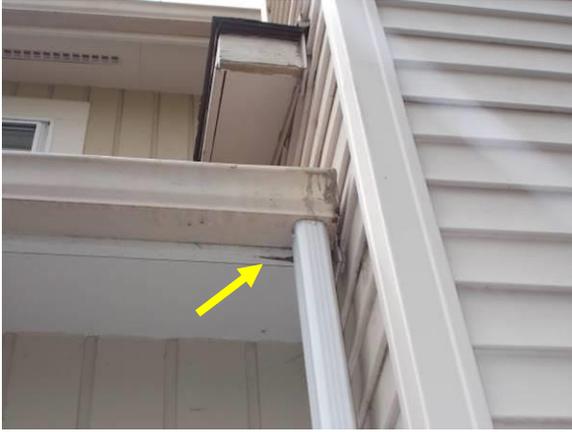
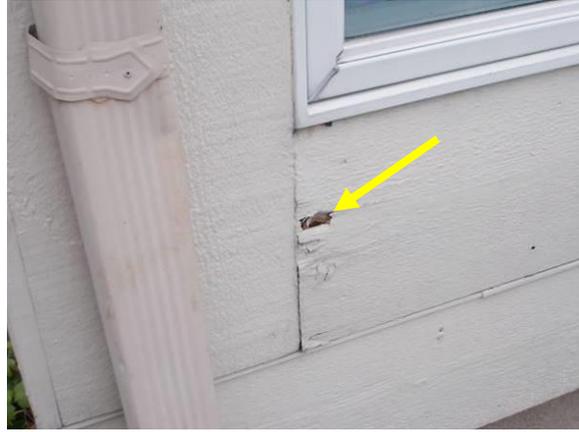
We noted multiple areas of deteriorated trim at gutter ends. This indicates that some amount of leakage is most likely occurring and water is bypassing gutter ends from a lack of kick-out flashing.

*Examples of Damage to Trim and Paint/Stain*

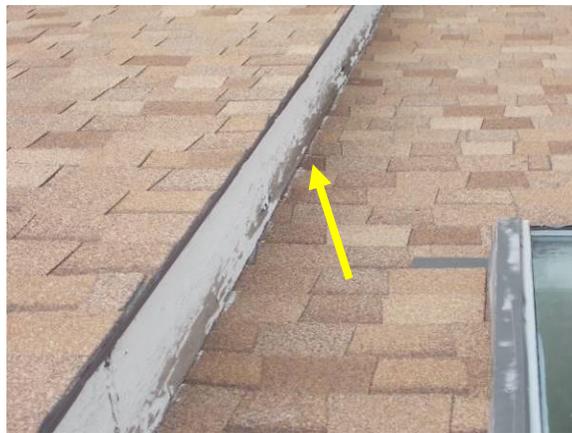
*Examples of Damage to Trim and Paint/Stain*

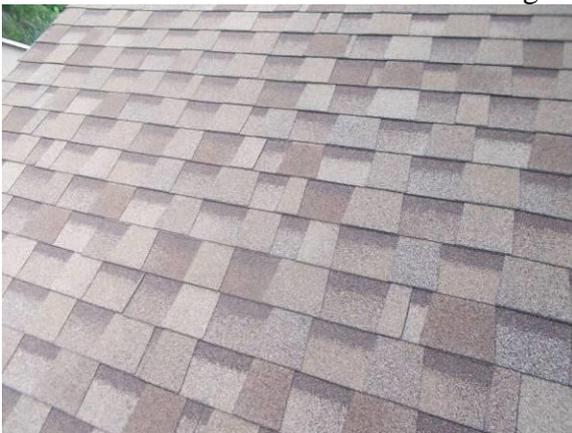
The roof surface appeared to be in better condition as compared to most of the other roof surfaces. We did note at least one missing or damaged shingle. This may be due to a high wind weather event or an isolated incident causing the damage.

*Roof Surface and Damaged Shingle*

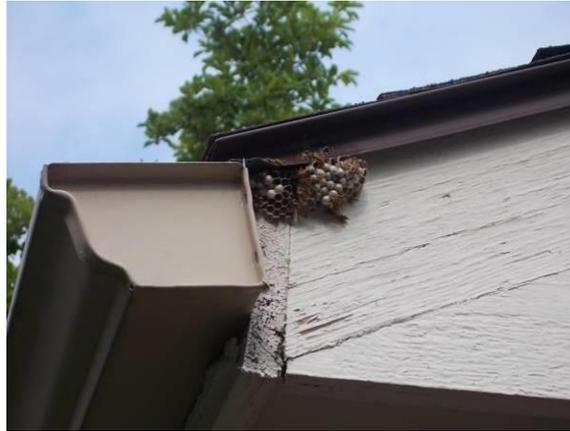
We saw an active insect nest on the right side of unit #111 adjacent to the garage. The homeowner was notified at the time of inspection.

*Insect Nest (wasps)*

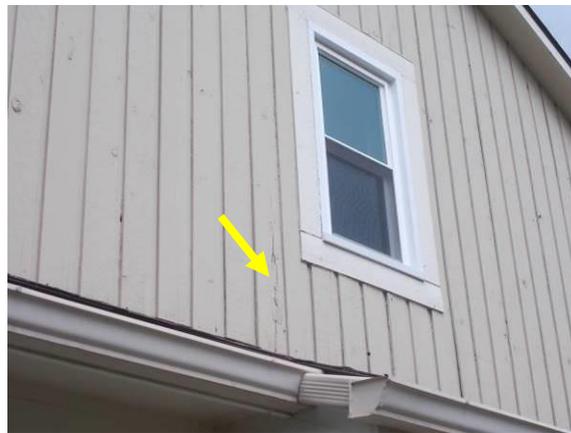
We noted an above average amount of warping and opening joints in the vertical siding. Also, as is typical with the other buildings, deterioration was noted at the base of the siding where it comes in contact with brick ledges and roof surfaces.

*Opening Joints and Deterioration*

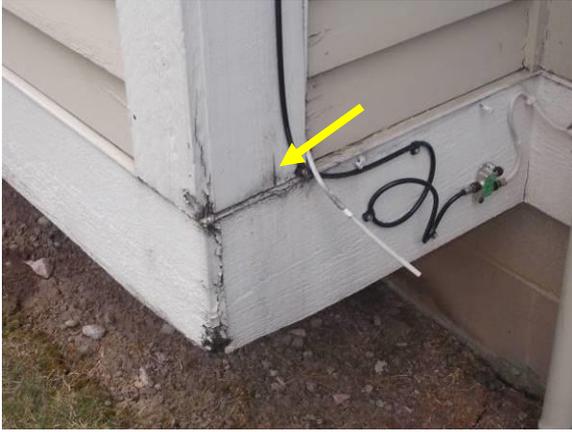
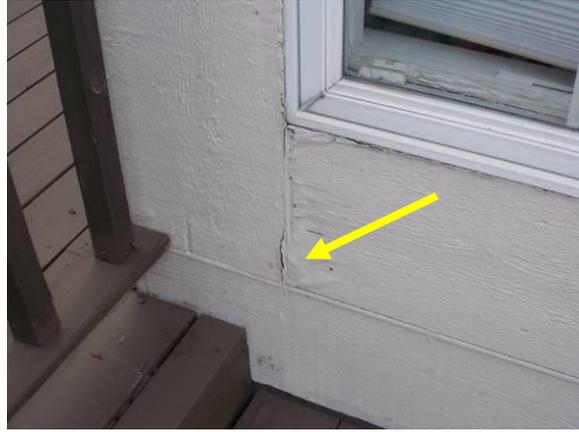
Isolated areas of damage were noted. These areas include chimney surrounds as well as lower portions of trim under windows. Some trim along roof surfaces is showing above average amounts of damage.

*Examples of Trim Damage and Deterioration*

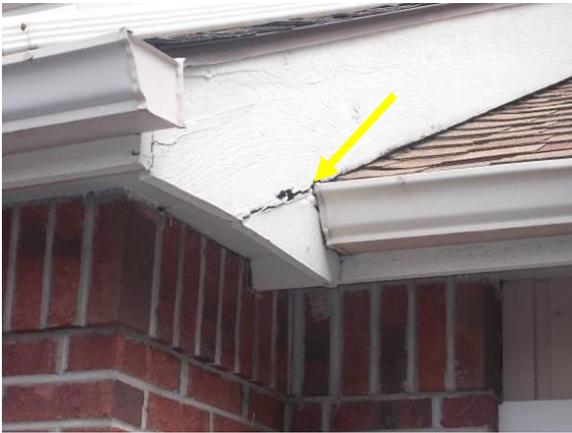
*Examples of Trim Damage and Deterioration*

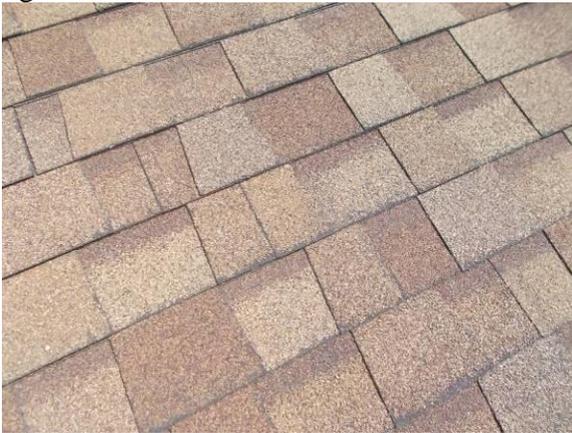
The roof surface appears to be in below average condition. We noted a damaged and missing shingle above unit #155.

*Example of Worn Shingle Surfaces and a Missing Shingle Tab/Edge*

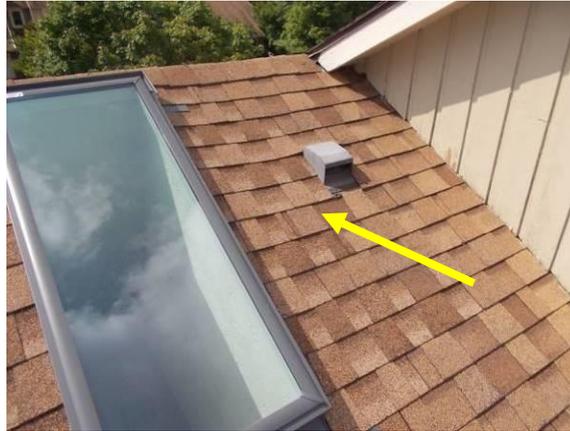
While walking the roof we noted an area adjacent to the skylight above unit #143 that was soft underfoot. This could be due to past or present leakage in this area. We suggest that the area be inspected for signs of active leakage. When reroofing or repair occurs, the sheathing may need replacement in this area and a small amount of reinforcement could be required.

*Soft Area of Roof*

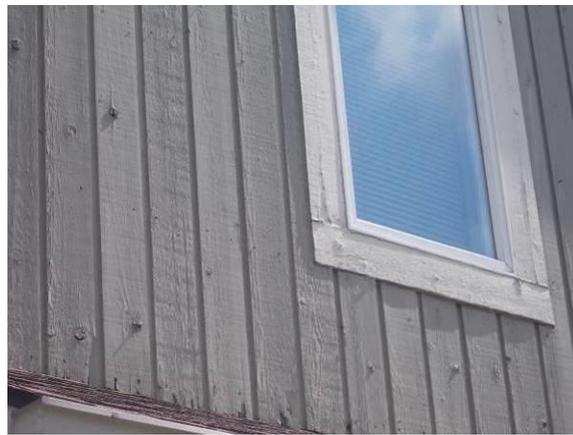
Deterioration was noted at interfaces of different materials. Also, portions of the siding appear to be worn due to weather.

*Signs of Deterioration and Wear*

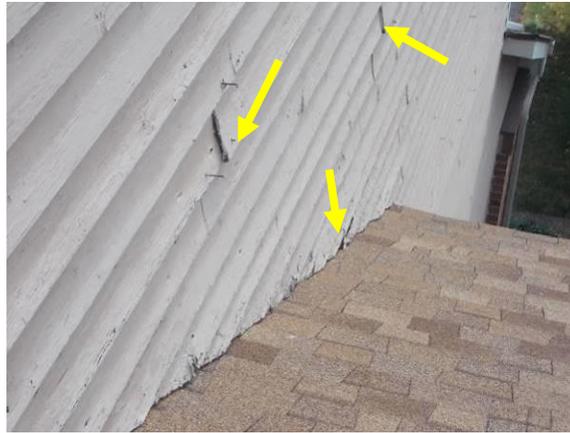
Portions of the paint or stain on the horizontal siding of this building are showing signs of wear. This is most likely due to weather exposure. Siding is cupping and curling and nails are coming loose from the siding.

*Wear and Damage to Siding*

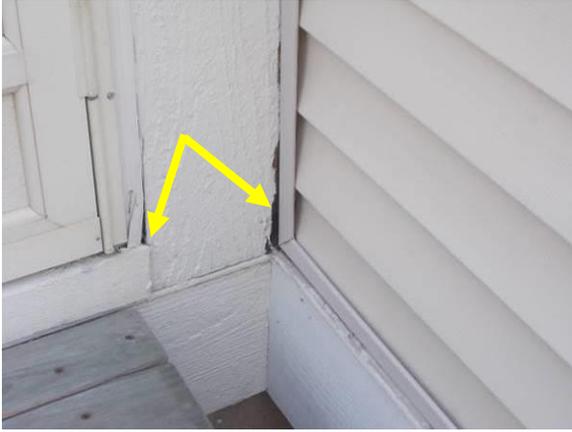
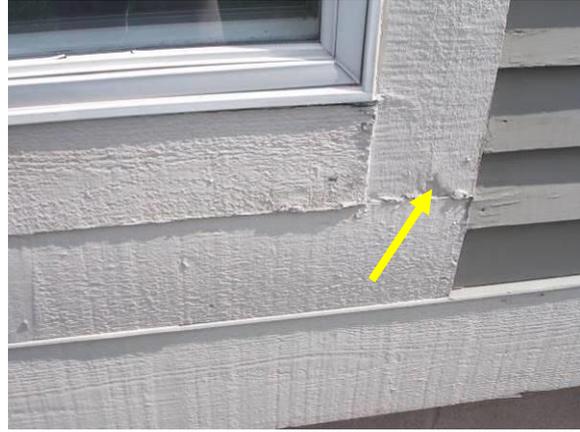
As with most buildings, areas of isolated trim damage can be found around the chimney surrounds. Also, there are areas with leaking and bypassed gutters causing trim damage. We noted evidence of insect damage on various portions of the trim, including some window trim.

*Examples of Trim Deterioration*

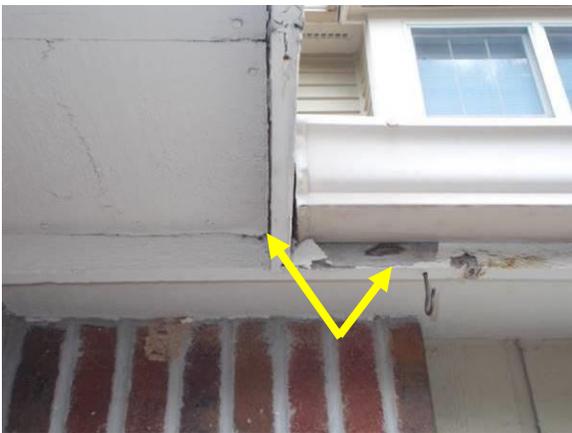
*Examples of Trim Deterioration*

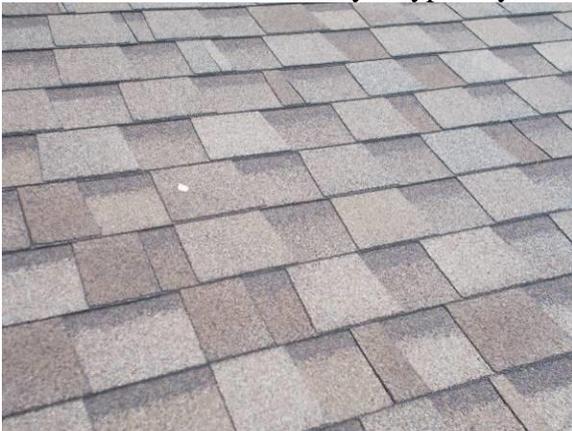
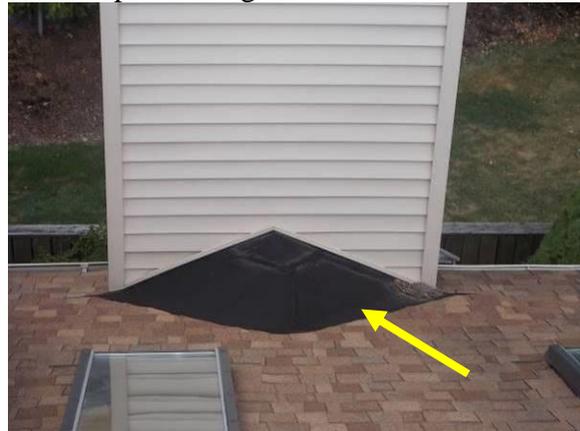
The roof surface appeared to be in generally serviceable condition. The shingles appeared to be in better than average condition in relation to the other buildings. However, we did note a repaired cricket at one chimney. Typically, this indicates past leakage.

*Example of Shingle Condition & Repaired Roof/Chimney Cricket*

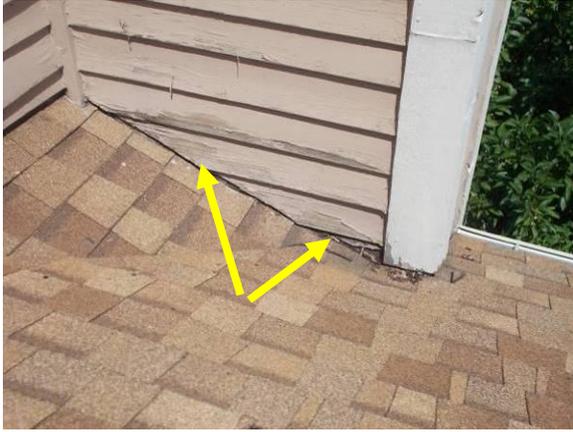
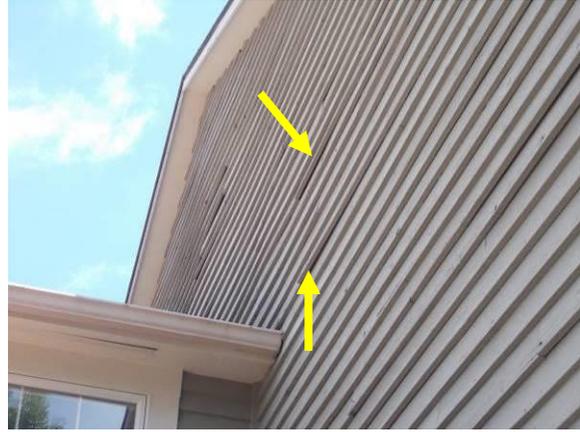
Isolated areas of damage were noted on chimney enclosures as well as at roof interfaces. We noted areas of siding pulling away from the wall sheathing.

*Deterioration and Paint Delamination & Cupped and Warped Clapboards*
