RE: Brittany Commons  
Rochester, NY 14618

### **INTRODUCTION**

We performed a limited visual inspection of the exterior siding and roofing for 14 of the 19 buildings of the subject townhouse complex. This was to provide a professional opinion as the condition and the expected remaining life of the siding and the roofs. These inspections were performed from the ground and with the use of a 14 foot telescoping ladder to view and walk many of the roofs. We did not directly walk a few of the less accessible roofs towards the center portions of the buildings, but we walked the roofs on each end of the subject buildings as well as several of the adjacent accessible roofs.

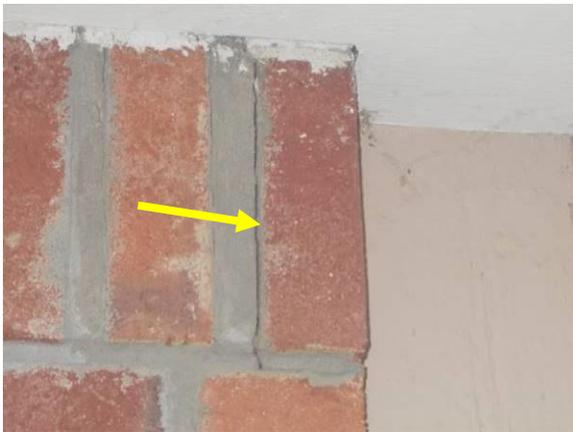
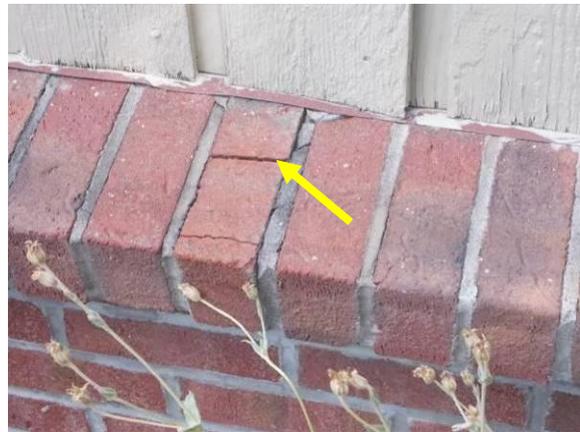
The brick appeared to be in generally serviceable condition. As with many buildings, we found isolated areas of cracked mortar joints at garage door opening corners. Isolated damaged bricks were also noted.

*Cracked Mortar Joint at Header & Damaged Brick*

The brick siding appears to be in serviceable condition. Isolated areas of cracking or separation from wood siding should be repaired as necessary. Damaged bricks should be replaced and small cracks that open more can be caulked or repointed. It is important to maintain these to help prevent additional deterioration. We recommend that this brick siding be kept in service, since it is in generally good condition overall and is a low-maintenance siding.

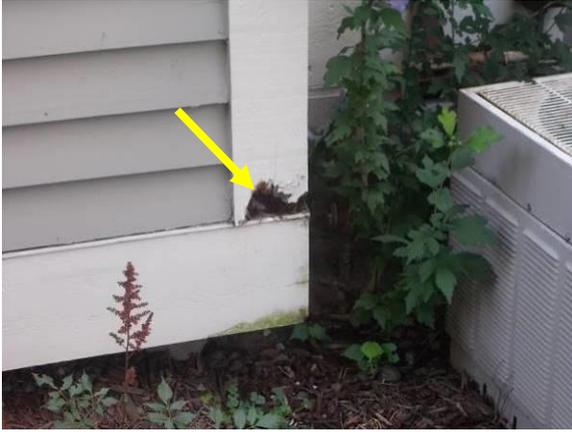
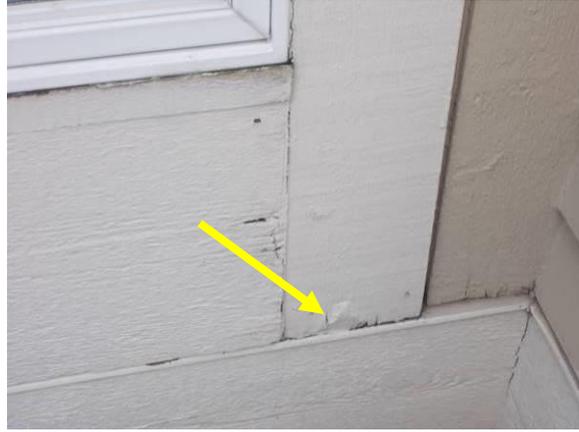
We noted areas of rotted or damaged trim around portions of most chimney enclosures. Also, areas of other trim damage were found.

*Examples of Damaged and Deteriorated Trim*

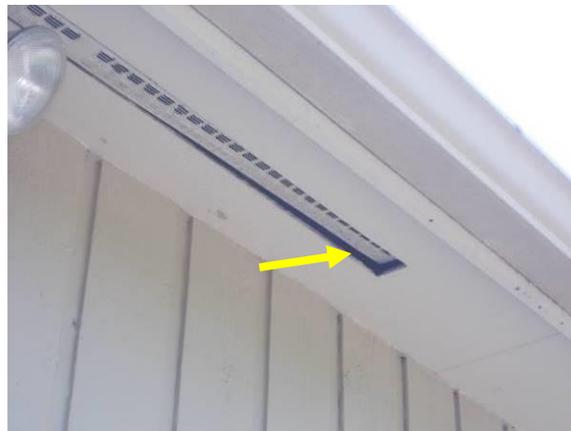
*Gaps around Soffit Vent*

We noted a soffit vent that is not properly installed. This should be reset in the soffit to reduce the risk of unwanted pest entry or nesting.

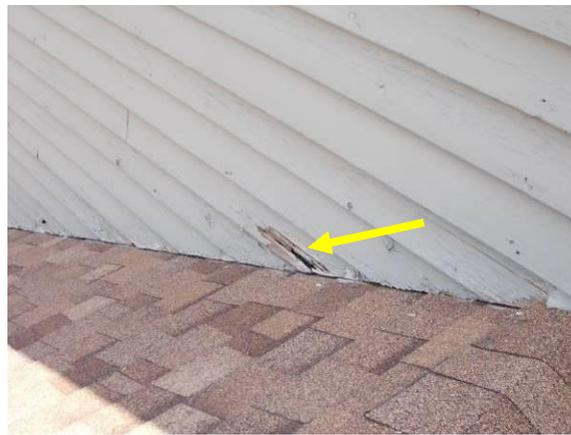
Areas of more severe damage were noted. These are typically isolated to the chimney enclosures that have not yet been sided with vinyl. Also, some cupping to the siding was noted on exposed surfaces.

*Examples of Damage and Deterioration*

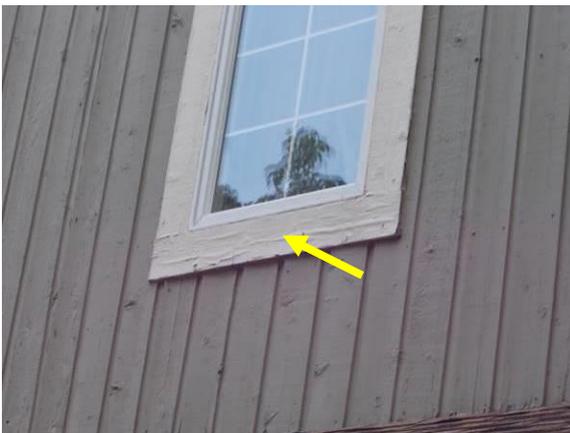
We noted areas of rotted or damaged trim around portions of most chimney enclosures. Also, areas of isolated deterioration and insect damage were noted.

*Examples of Rot in Need of Repair and Gaps in Trim*

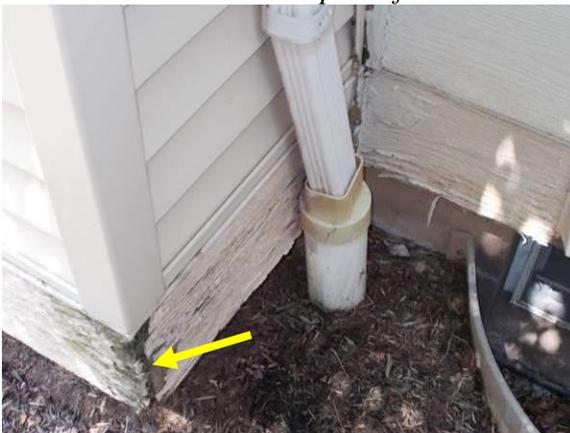
*Examples of Rot in Trim & Insect Damage (Carpenter Bees)*

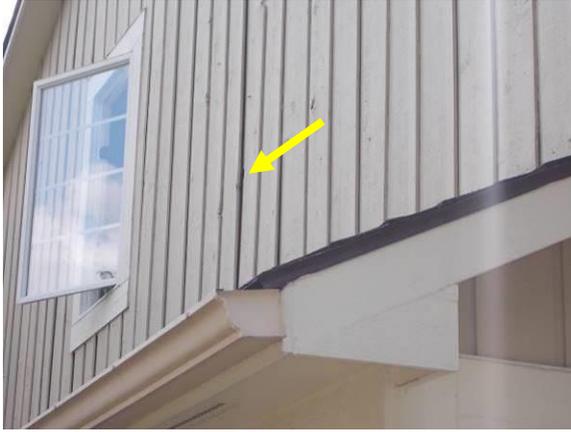
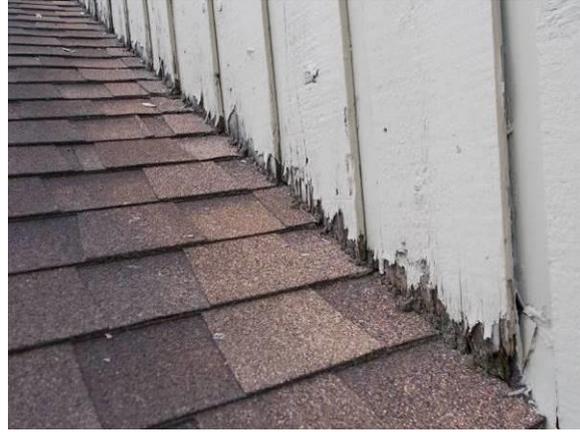
Typical to most buildings, rot and deterioration was noted at intersections with differing materials. Also, areas of opening vertical joints are present.

*Gaps in Vertical Joints & Significant Damage at Roof Surfaces*

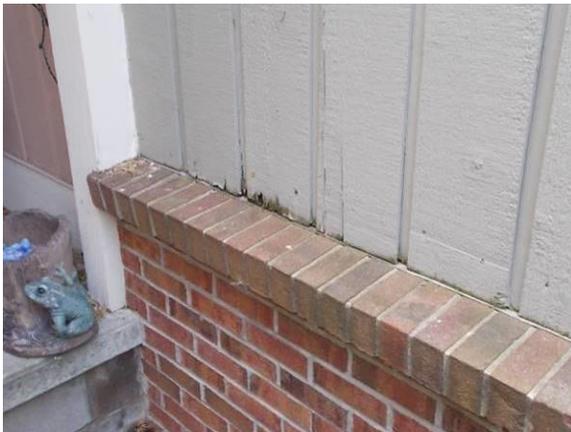
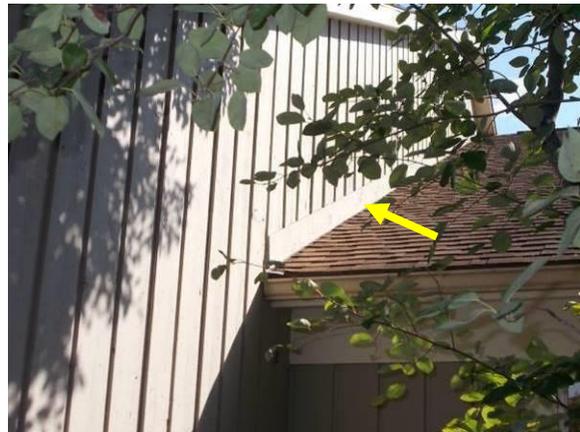
A repair to the intersection of the vertical siding and the roof of unit #176 was noted.

*Deterioration at Brick Ledge & Repair to Lower Portion of Siding at Roof Surface*

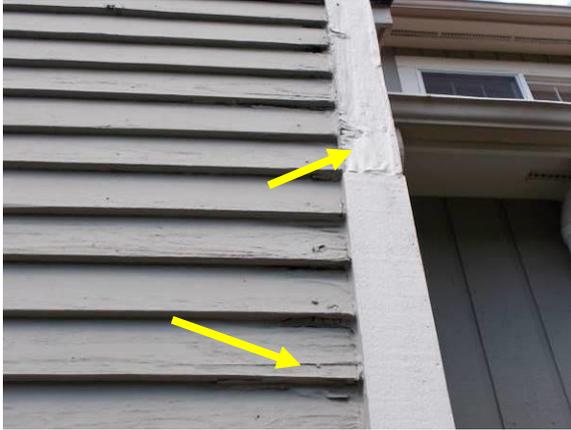
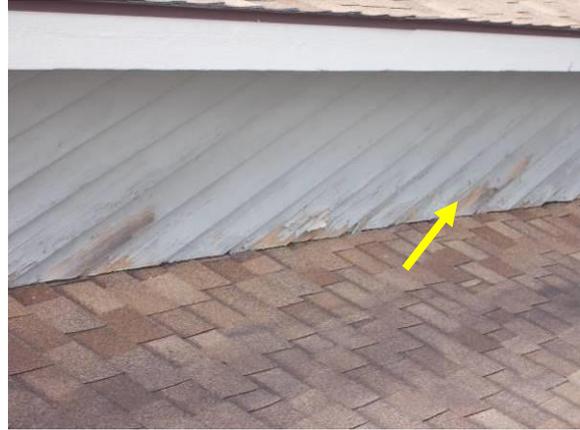
We noted isolated areas of severe rot and damage to horizontal siding on this building. Portions of chimney enclosures contain the most concentrated deterioration. Also, areas of siding are showing weathering where exposed to an above average amount of sunlight.

*Rotted Trim and Severely Weathered Siding*

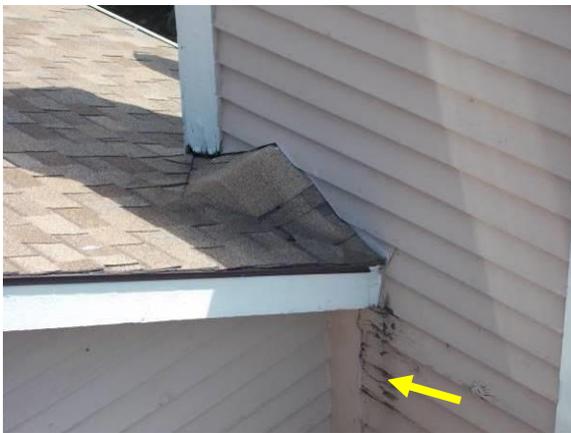
*Examples of Deterioration to Siding and Paint/Stain*

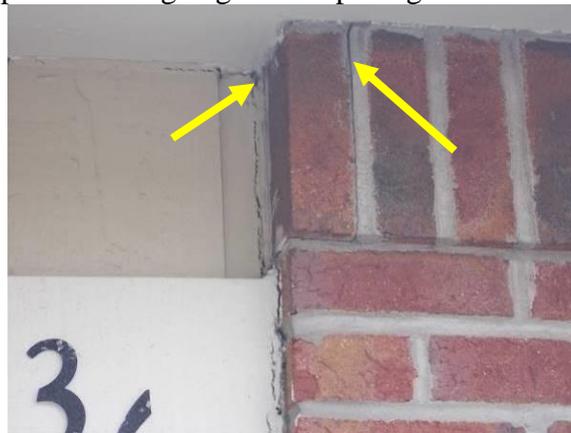
The brick veneer appears to be in generally good condition, with the exception of some minor, thin cracks noted at the top corners of garage door openings.

*Cracking at Garage Header and Areas to Seal*

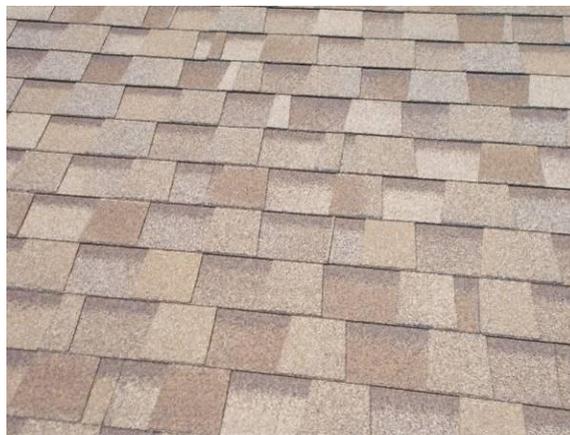
The roof surface appeared to be of average quality in comparison with other buildings. Some typical deterioration and granule loss was noted.

*Example of Roof Surface*
