PRO-ENGINEERED INSPECTIONS

RE: Brittany Commons  
Rochester, NY 14618

### **INTRODUCTION**

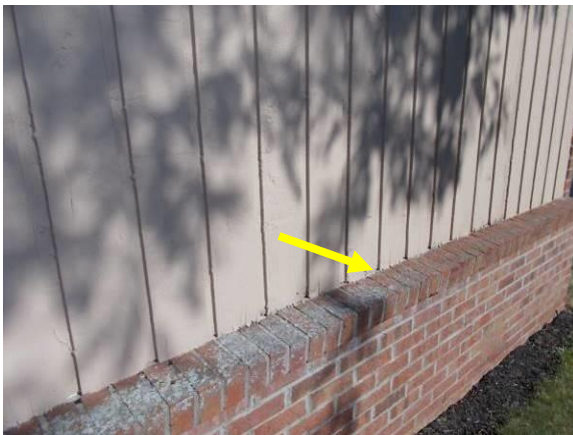
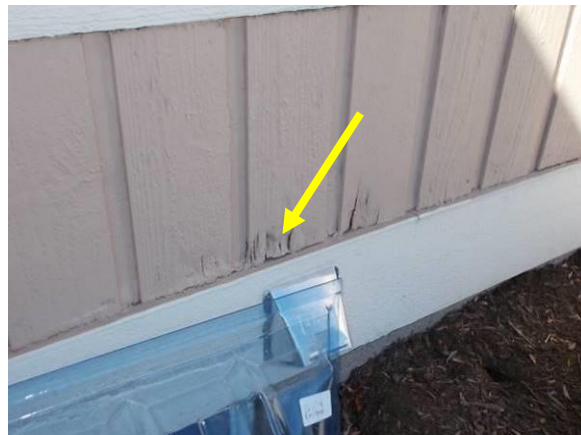
We noted many areas of deteriorated or rotted siding around the building. This is most evident where the vertical siding is in contact with the brick siding's water table or with the roof surface. Typically, this deterioration is an indication of improper flashing.

*Deterioration at Water Table & Area of Rot*

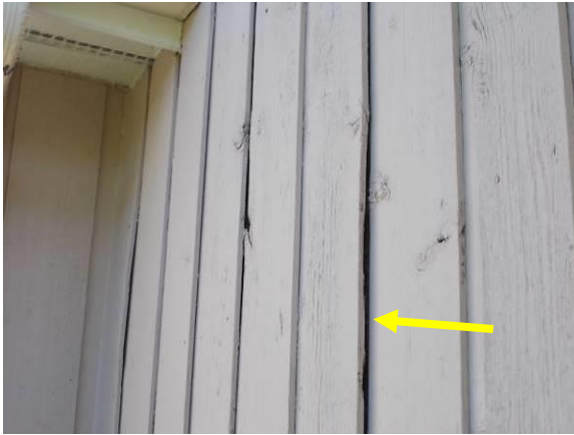
There are several areas around the building that have developed gaps between the vertical laps. These gaps can be an access point for unwanted moisture or pests.

*Opening Gap & Deterioration at Roof Surface*

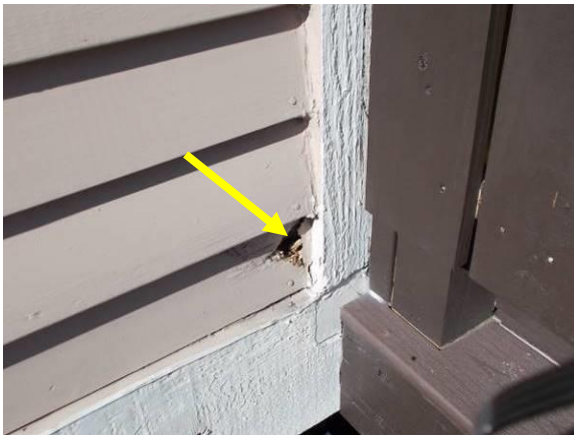
The horizontal clapboard wood siding has suffered isolated deterioration in areas in contact with roof surfaces. Also, there is deterioration to the siding on most of the chimney enclosures. This appears to be caused by improper flashing along with awkward roof angles and intersections, causing excessive contact with roof run-off.

*Rot in Clapboards*

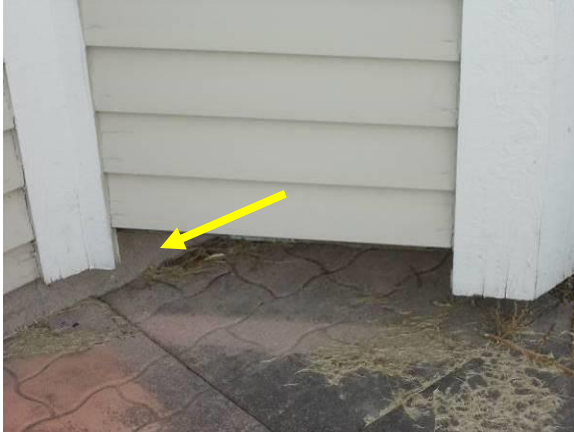
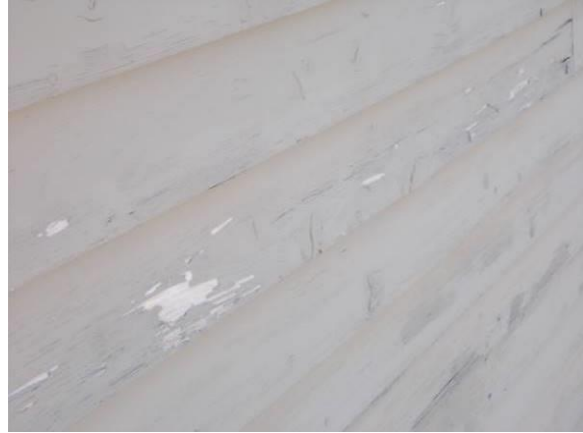
We noted a missing clapboard on a rear bay window of the building. Also, we noted that the chimney enclosure of unit #11 has replacement vinyl siding.

There are areas of worn and peeling paint. This is most evident in south-facing areas with direct sun exposure.

*Missing Clapboard & Paint Delamination*

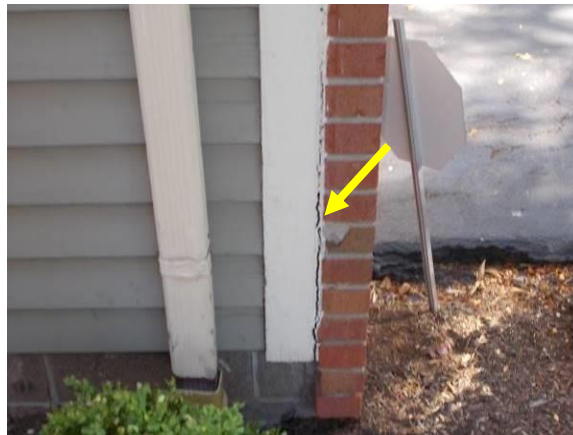
The brick siding appeared to be in generally good condition. We did note an area adjacent to wood siding with a gap. Keeping areas such as this caulked and sealed is recommended. This will help to keep unwanted pests from entering behind the siding.

*Seal Gap*

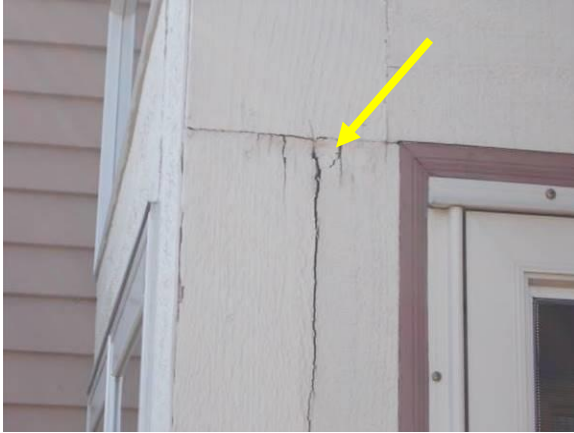
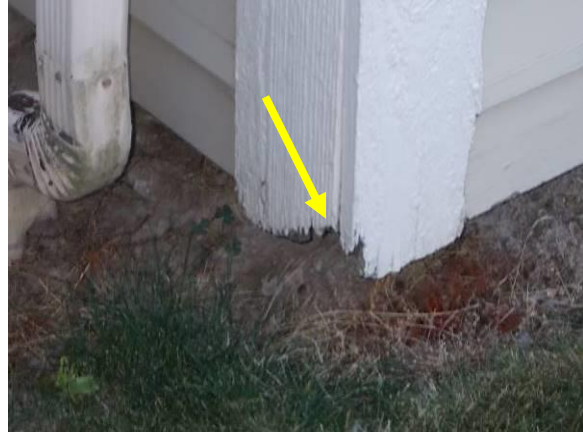
Areas of rot and deterioration were noted sporadically throughout the trim. These were most evident in lower corners of chimney surrounds. Also, we noted deteriorated or rotted trim at the lower corners of some window surrounds.

*Trim with Rot and Damage*

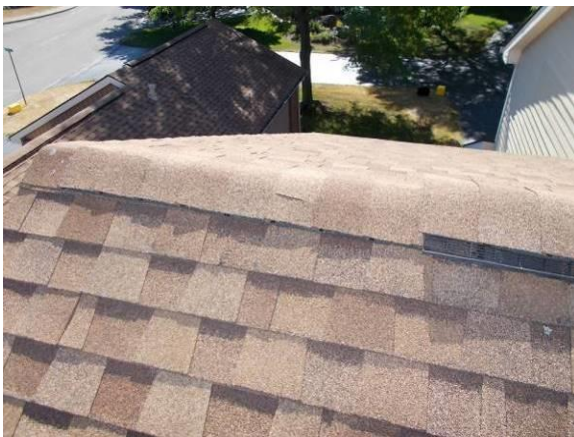
*Roof Surface with Some Damage*

We did note some areas of isolated shingle damage. These damaged areas can be more prone to roof leakage. Damaged shingles can be replaced as needed.

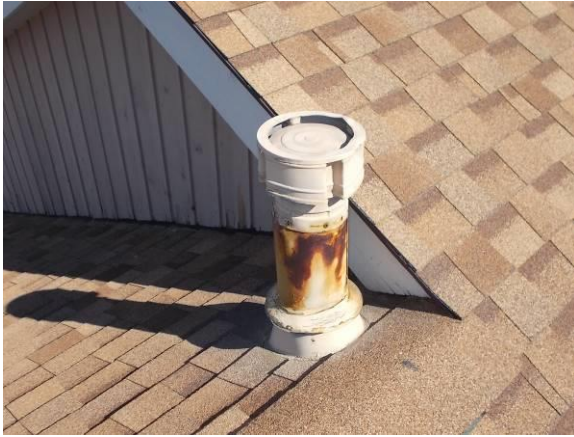
We noted the majority of the steel flue pipes penetrating the roof are rusty. Some amount of painting, repair or replacement may become necessary as deterioration continues.

*Rusted B-Vent and Paint on Front Door*

We noted peeling paint on the front door assembly of one of the units. Preparing, priming, and repainting this is recommended.

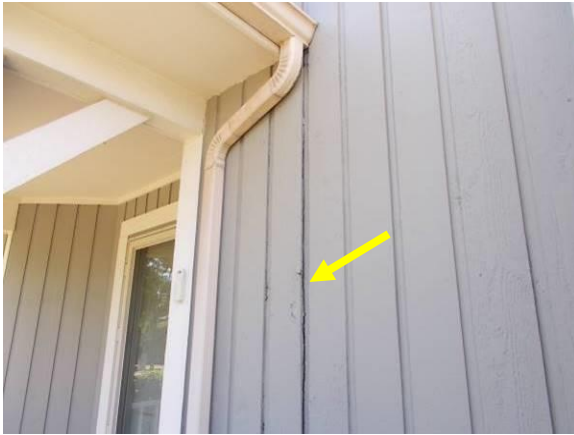
The vertical siding on this building is showing signs of damage and wear in typical areas. These include intersections with brick water tables as well as areas that are in contact with roof surfaces. We also noted areas of opening vertical seams.

*Open Seam in Vertical Siding & Deteriorated Siding and Trim*

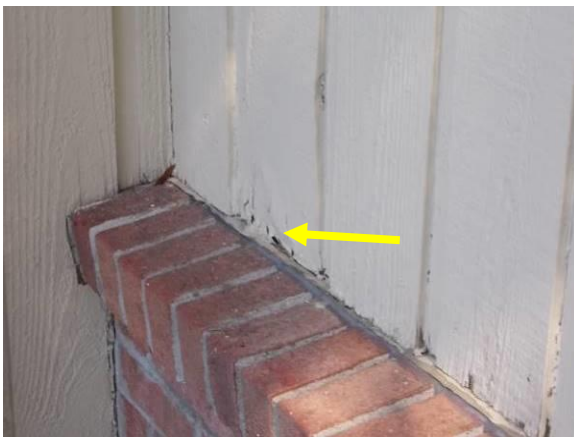
*Rot and Deterioration at Water Table/Brick Ledge*

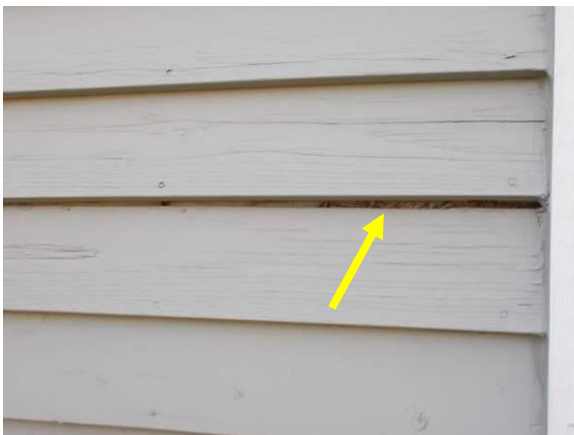
*Damaged Siding & Rot at Gutter End Cap (lack of kick-out flashing above gutters)*

We noted isolated areas of severe rot and damage to horizontal siding on this building. Portions of chimney enclosures have suffered the most concentrated rot and damage. We noted that three of the chimney enclosures on this building have replacement vinyl siding installed already.

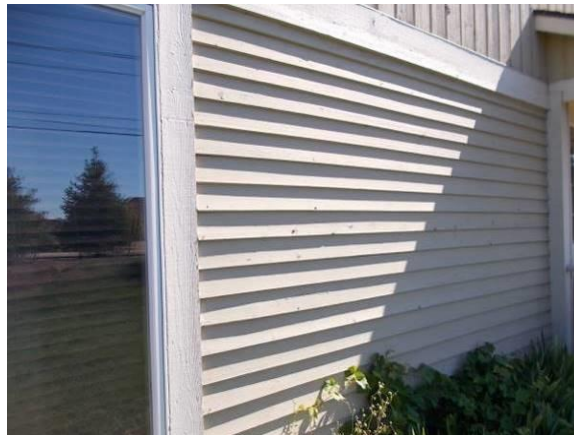
The paint on the south facing portion of the building is showing signs of weathering and deterioration. This is most likely due to the sunlight and weather that it is exposed to.

*Weathered Siding*

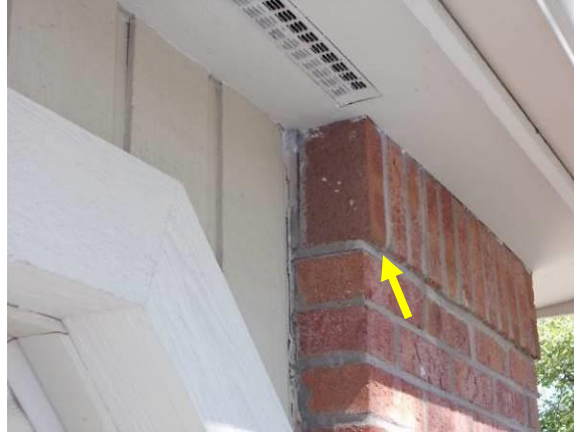
The brick siding appeared to be in generally serviceable to good condition. We did note isolated bricks that have cracking in their mortar joints. This is most noticeable at the headers of garage doors from a small amount of long term sag. Also, there are areas of isolated surface spalling of bricks.

*Cracking Mortar Joint*

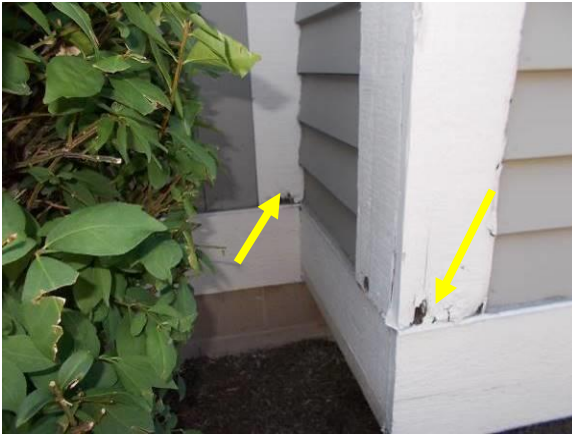
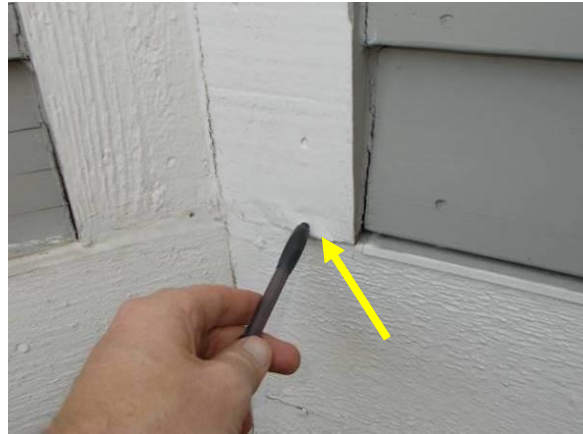
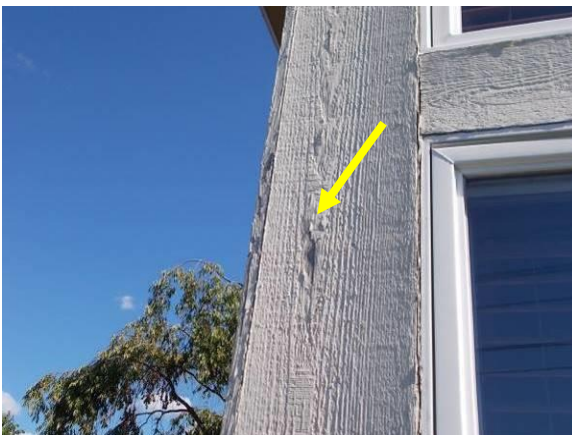
*Examples of Trim Rot and Deterioration*

The areas heaviest rot and deterioration appear on the chimney enclosures. Also, we noted damage or broken trim in upper eaves. As is typical with most buildings in the complex, we noted a fair amount of rot that is not readily visible, since it has been painted over.

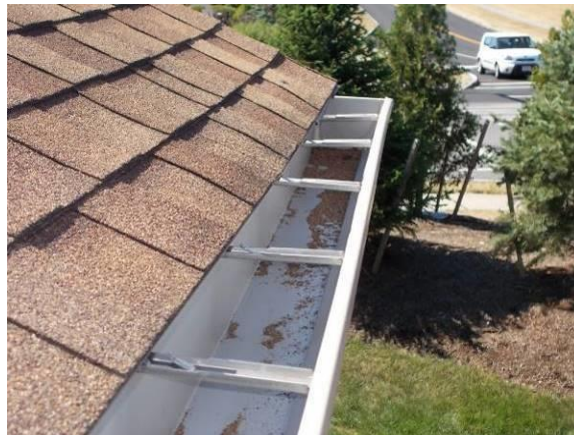
There are signs of wear and age on the roof surface. This is most evident in some damage to roof shingles as well as the amount of granules that appear to have come loose from the shingles.

*Roof Granules in Gutter*

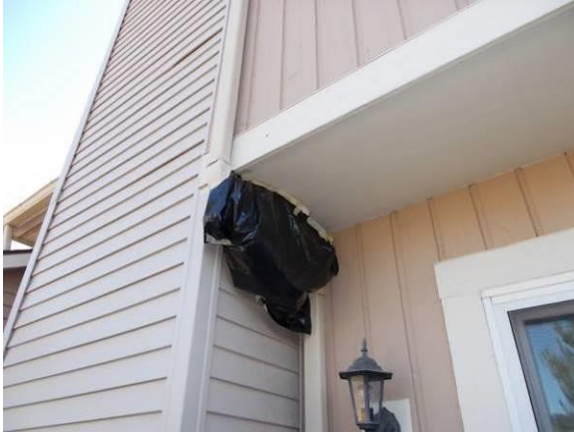
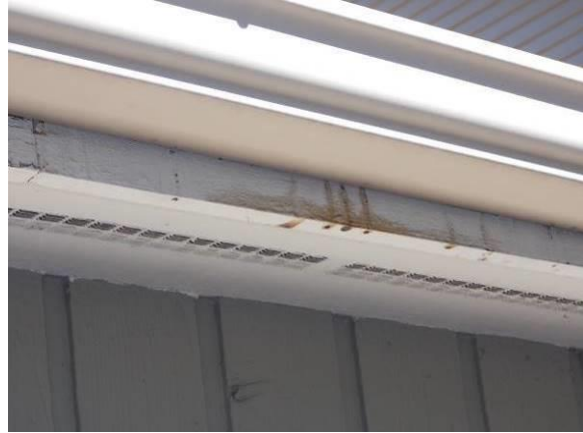
We noted a section of gutter downspout on the rear of the building that is wrapped in a garbage bag. We suspect this is due to leakage and a more permanent repair should be made.

We noted evidence of leakage behind a gutter on the front of the building. These stains are typically an indication of leakage due to improperly installed gutters (not properly behind the roof drip edge) or ice damming and related leakage.

*Gutter Downspout Wrapped in Garbage Bag & Staining Behind Gutter*

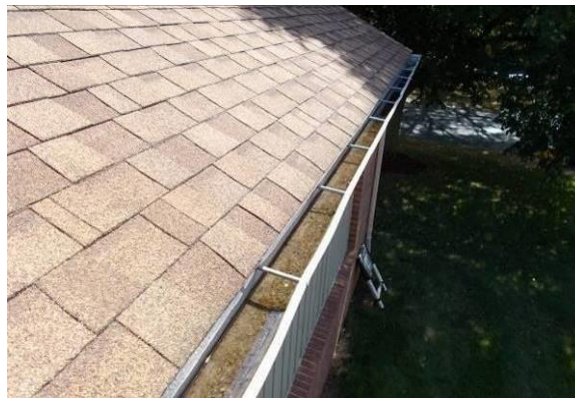
There is a section of gutter on unit #15 that appears to be pitched improperly. We noted standing water in this gutter. The gutter does not appear to be overly clogged with debris so the gutter should be properly re-mounted.

*Improperly Pitched Gutter*

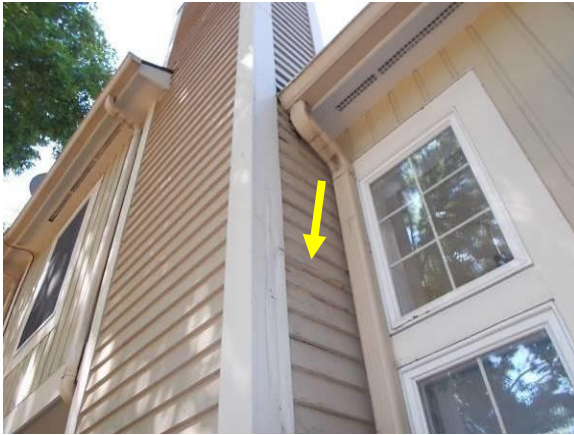
We noted areas of deteriorated and rotted clapboard siding, most notably under or near areas of gutters that appear to be leaking.

*Rot at Gutter Ends*

*(Kick-out flashing is recommended at roof and siding interfaces above these gutter ends)*

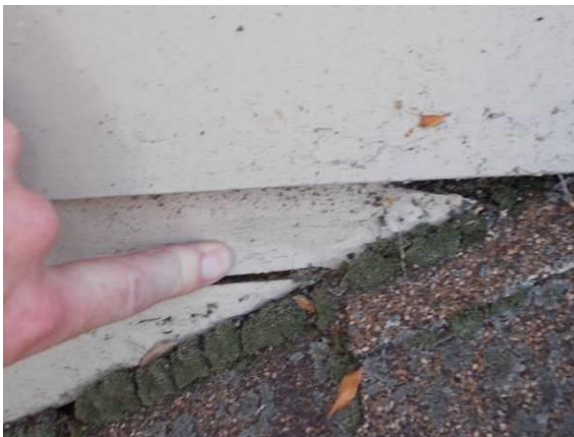
As is typical with most buildings, siding deterioration is concentrated around chimney enclosures. We noted two chimney enclosures that have been previously vinyl sided.

*Rot at Roof Interface & Chimney Enclosure*

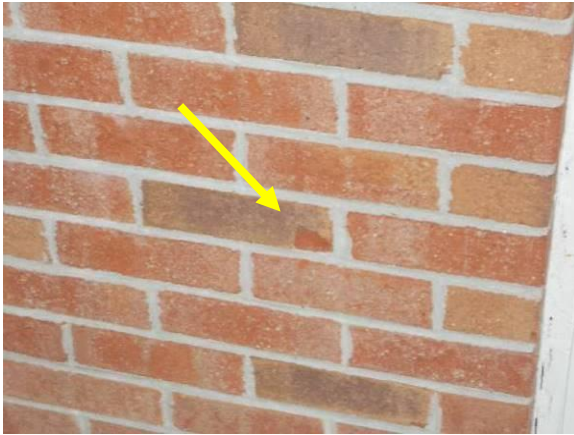
Brick on this building appeared to be in serviceable to good condition. We did note areas of isolated spalling. Also, there are areas in need of caulking and sealing between the veneer and adjacent siding or trim to eliminate gaps where pests could enter or nest.

*Spalled Brick & Area to Seal Around Brick Veneer*

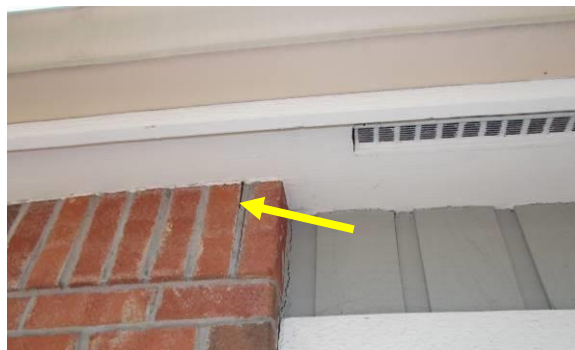
*Crack in Mortar Joint at Garage Header*

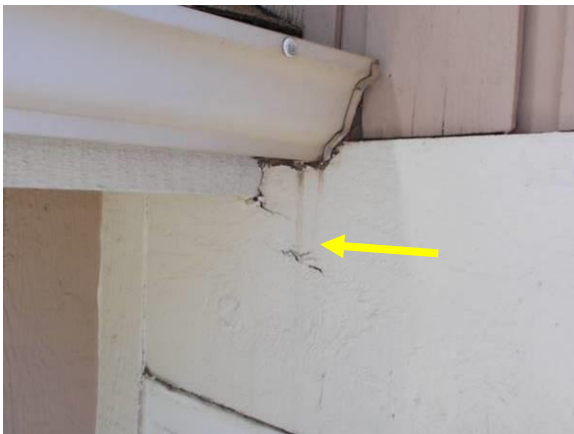
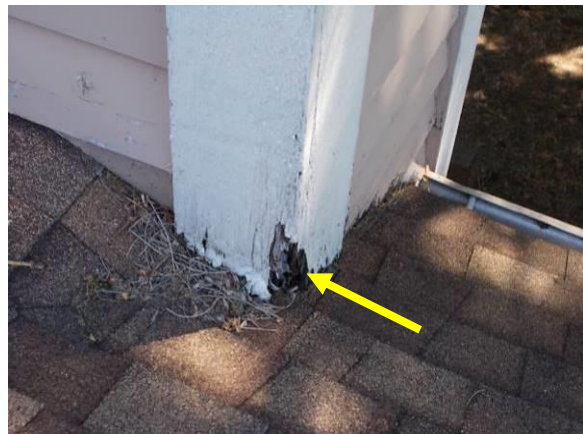
In relation to damage caused by leaking gutters on the horizontal siding, we also noted rot and damage to trim due to leaking gutters. Also, we noted a relatively large amount of insect damage to the trim on this building.

*Trim Damaged from Leaking Gutter & Trim Damage at Chimney Enclosure*

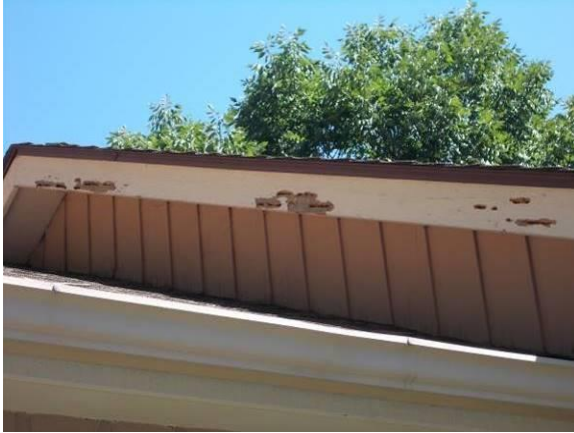
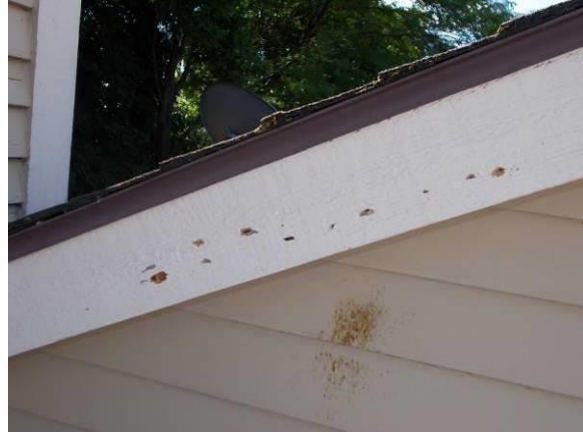
*Insect Damage to Trim (Carpenter Bees)*

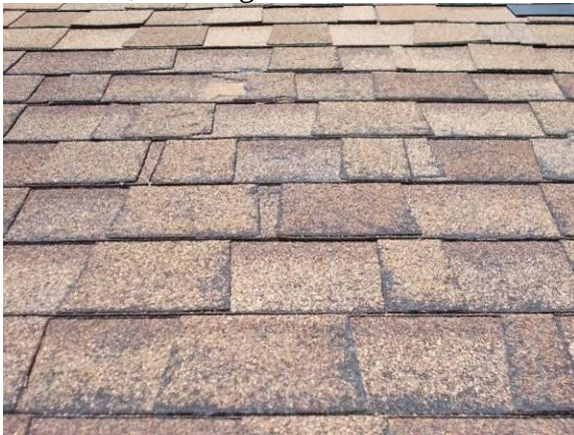
Signs of wear were noted on the roof surface, such as missing granules from the shingle surfaces. We also noted areas of moss growth. While this is not necessarily a sign of advanced deterioration, cleaning off moss is recommended.

*Roof Surface with Significant Granule Erosion*

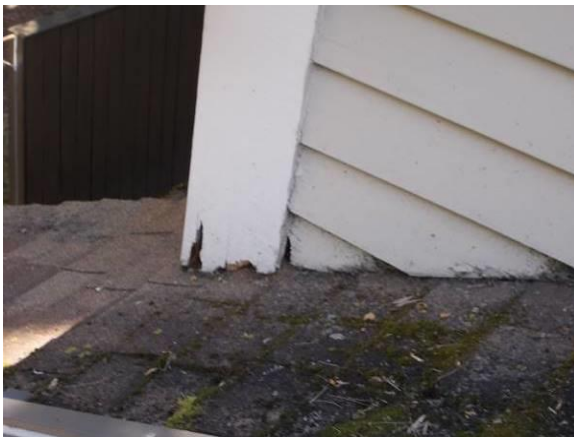
*Moss Growth and Trim Damage*

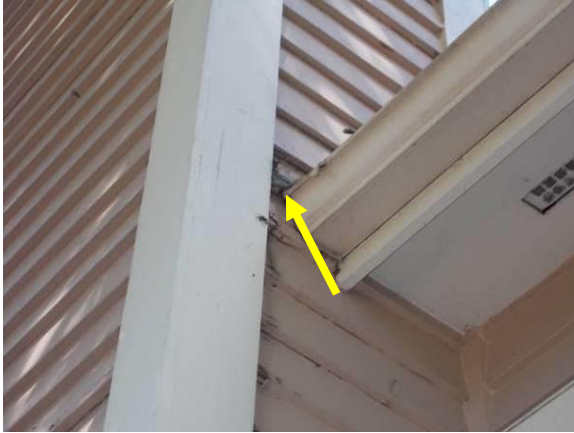
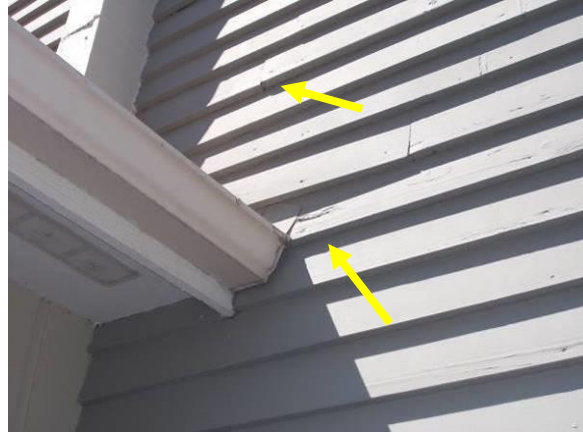
This siding has isolated damage to chimney enclosures as well as cupping and twisting of clapboards. This is an indication of deterioration and weathering.

*Deterioration and Cupping to Clapboards*

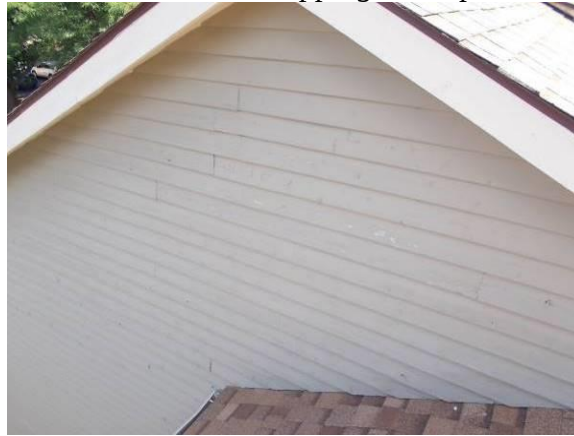
*Paint or Stain Showing Signs of Wear*

Portions of the paint on the horizontal siding of this building are showing signs of wear. This is most likely due to weather exposure.

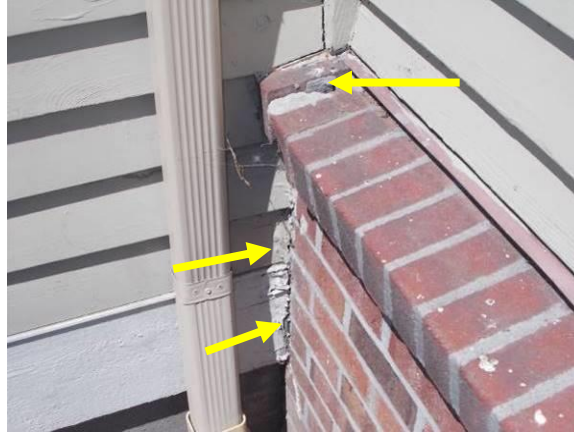
The brick siding on this building appears to be in generally good condition. We noted at least one area of isolated damage to the brick water table and repair is recommended.

*Damaged Brick with Deteriorated Siding and Trim*

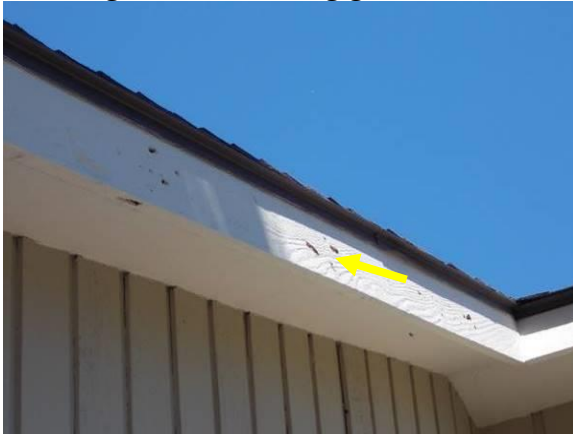
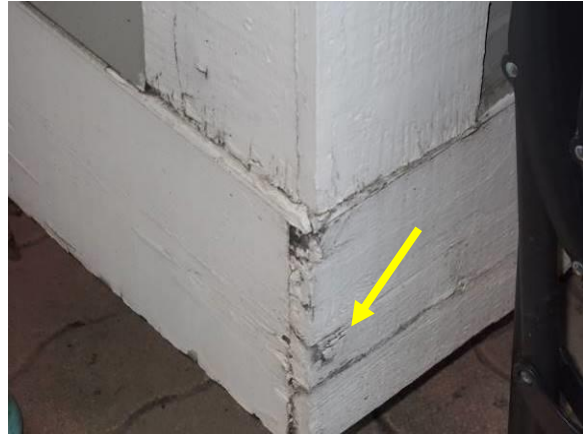
We noted areas with insect damage to the trim. Also, there are areas of trim that appear to have been damaged due to leaking gutters.

*Insect Damage (Carpenter Bees) and Area of Deterioration at Chimney Enclosure*

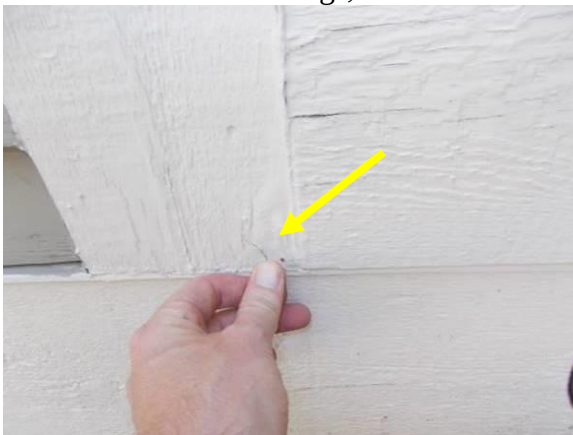
As noted with other buildings, we encountered areas of rot that have been painted over.

*Examples of Rot Behind Coating & Damaged Trim with Gaps*

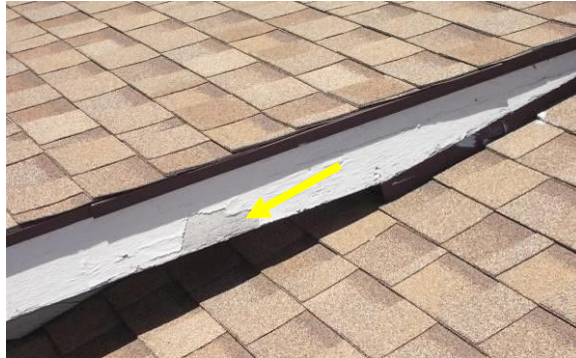
The roof surface appears to be in generally serviceable condition with limited amounts of surface wear noted.

*Roof Surface and Delaminating Paint on Trim*

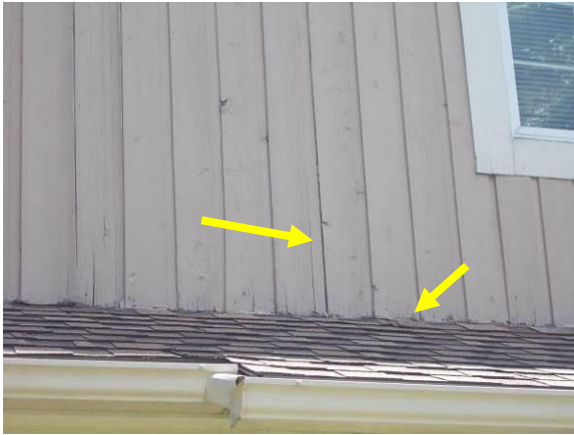
Areas of wear were noted at brick siding water tables. Also, gaps were noted in vertical seams.

*Deterioration at Roof Interface and Opening Joints*

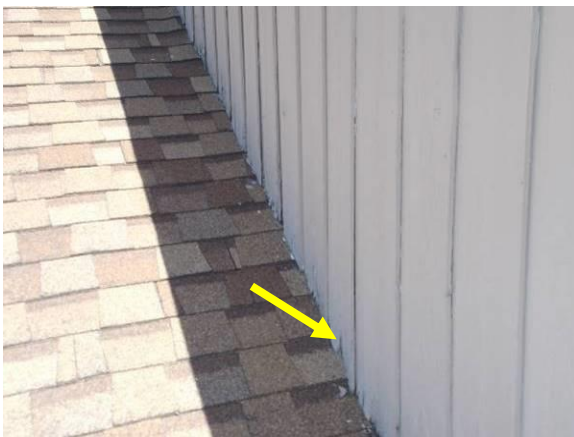
*Examples of Deterioration at Brick and Roof Interfaces*

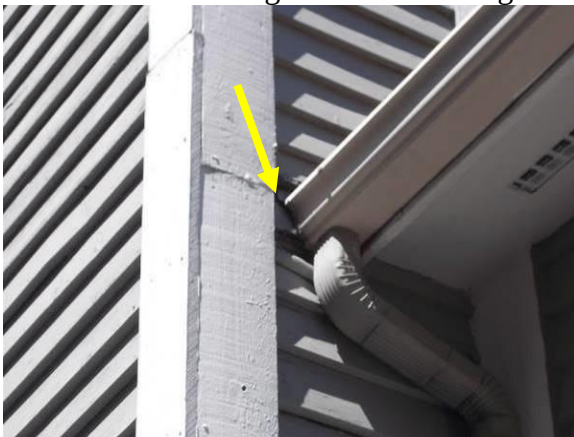
This siding has suffered typical damage at chimney enclosures. Also, we noted areas near gutter ends showing signs of deterioration. This is most likely due to leaks in these gutters along with a lack of kick-out flashing at roof and siding intersections.

*Examples of Deterioration to Clapboards*

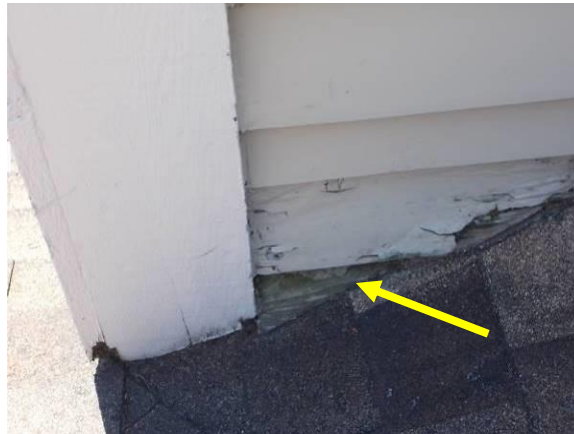
*Examples of Deterioration to Clapboards*

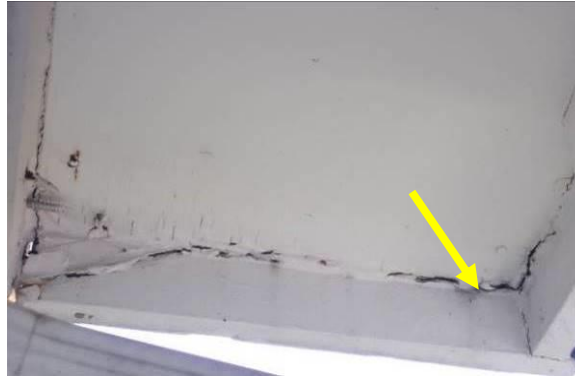
Isolated areas of rot and damage were noted to the trim. These were most prevalent at chimney surrounds. Also, exterior window trim and soffits were showing signs of deterioration. It is always possible to discover additional deterioration behind trim and siding, for all buildings, if removing and replacing materials.

*Rot to Trim and to Soffits*

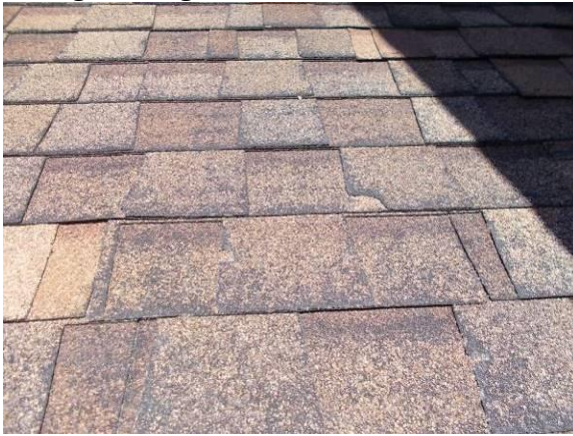
An above average amount of deterioration was noted on the shingle surfaces. Also, some areas of damaged shingles were encountered.

*Example of Roof Condition (Advanced Wear on this Building)*

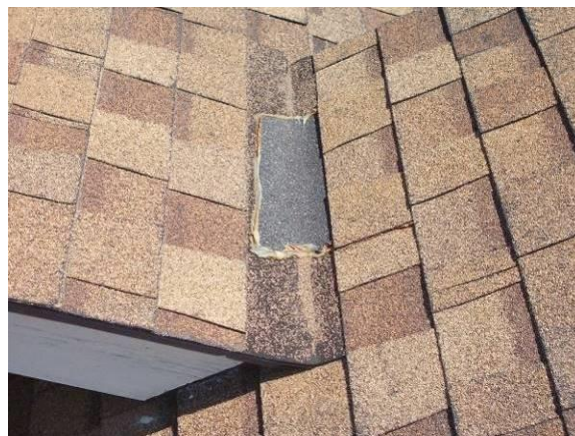
We noted a small valley that has been patched. This is most likely an indication of previous roof leakage.

*Patched Valley/Intersection*

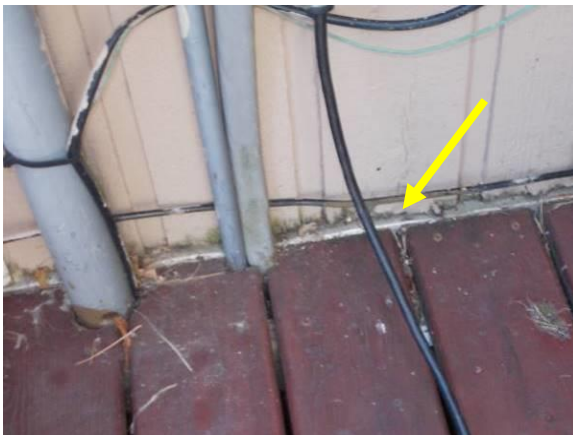
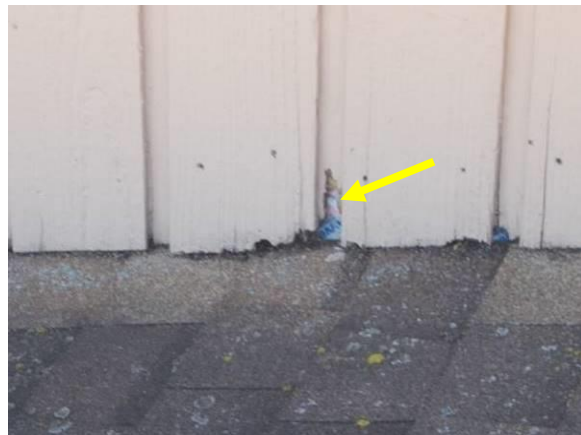
Deterioration was noted at interfaces with differing materials. Also, portions of the siding appear to be worn due to weather.

*Deterioration at Deck & Roof Interfaces*

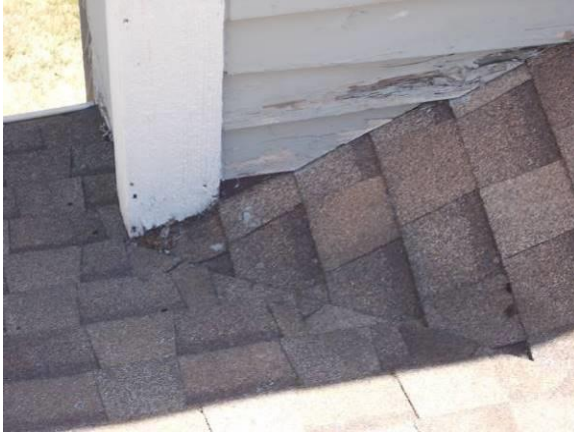
We noted areas of more severe damage to the clapboard siding. These are most notable at roof interfaces and on chimney closures. Better flow control of water from roofs is necessary in these areas along with better intersection and flashing details.

*Examples of Deteriorated Clapboards*

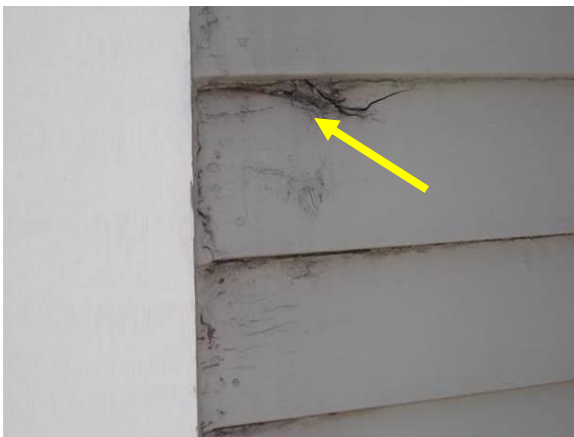
*Examples of Deteriorated Clapboards*

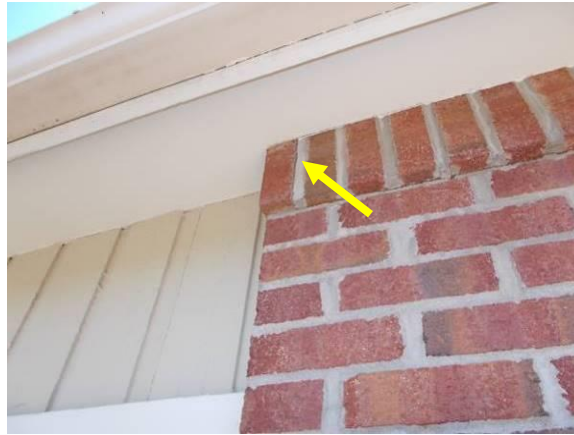
The brick veneer appeared to be in generally good condition. There were some minor isolated cracks noted in mortar joints. These are most notable at the headers of garage door openings from a small amount of long term sag.

*Cracked Mortar Joint*

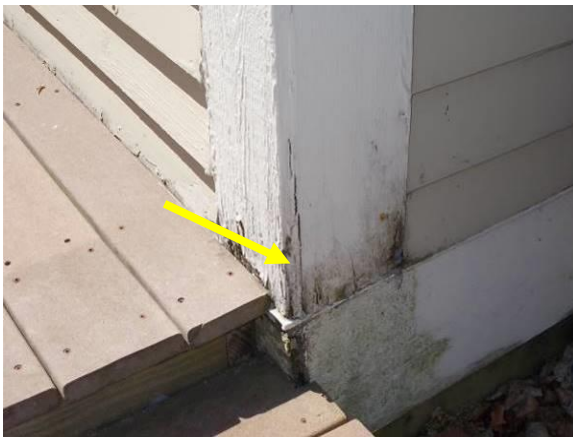
We noted areas of rotted or damaged trim around most chimney enclosures. Also, areas of isolated damage were noted.

*Examples of Deteriorated Trim*

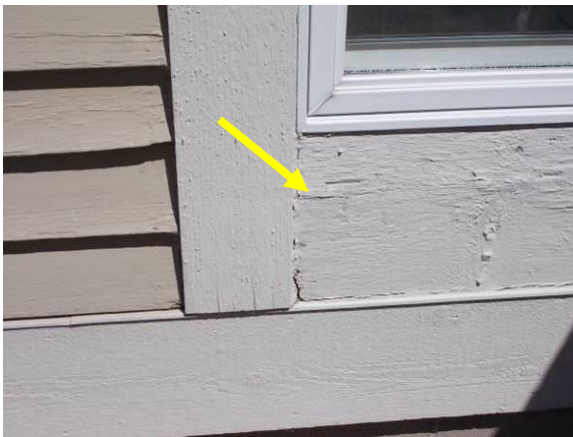
*Examples of Deteriorated Trim*

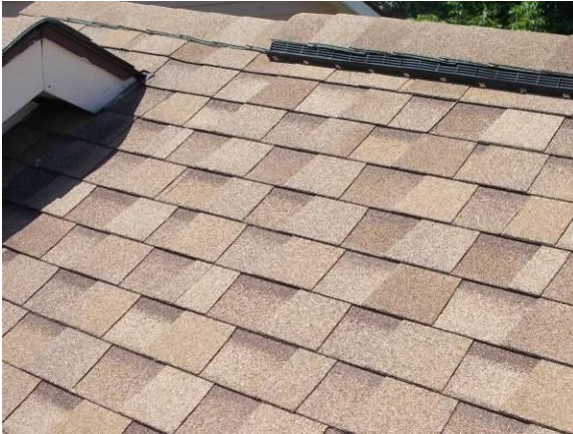
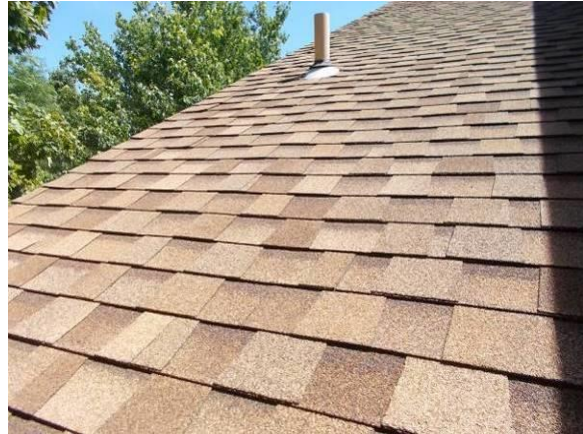
The roof surface appeared to be in generally serviceable condition. The shingles appeared to be in better than average condition in relation to other buildings.

*Roof Surface*

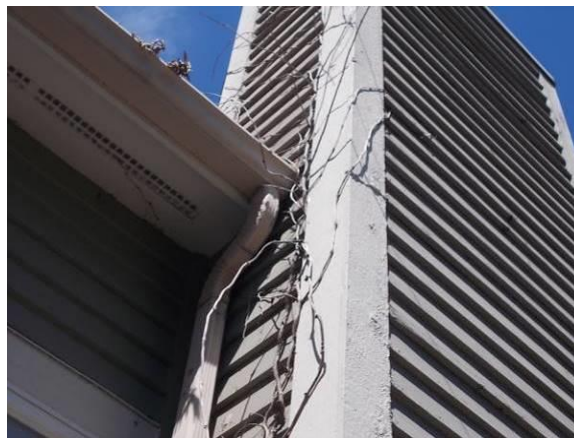
*Vine Growth*

We noted vine growth on a chimney enclosure. It is recommended that vegetation be removed as its growth can become problematic to siding and trim.

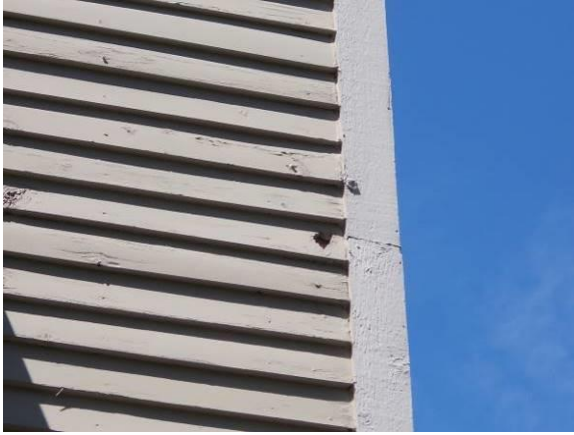
Areas of deteriorating and delaminated paint/stain were noted. These are in areas that appear to be directly affected by water damage as well weathering. Isolated areas of damage were also noted on chimney enclosures as well as near roof interfaces.

*Weathered and Damaged Siding & Paint/Stain and Siding with Water Damage*

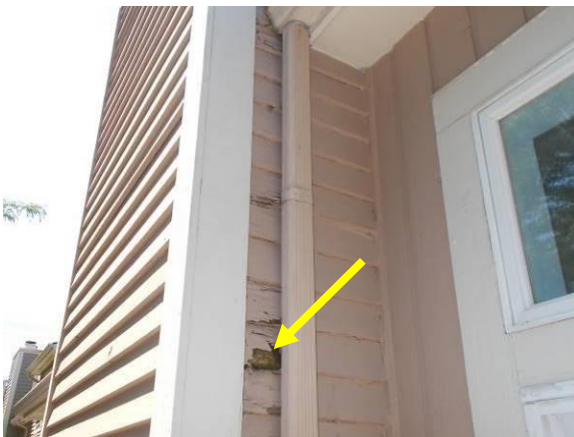
*Water Damaged Clapboards & Missing Vinyl Siding on Chimney Enclosure*

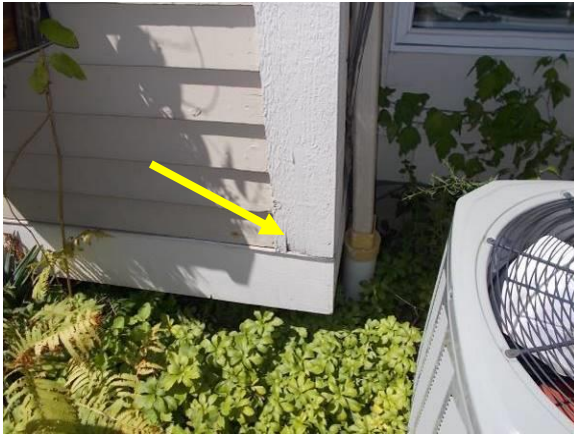
As with most buildings, areas of isolated trim damage can be found on chimney surrounds. Also, we suspect there are areas with leaking gutters and a lack of kick-out flashing causing trim damage. We noted evidence of insect damage along various portions of the trim as well.

*Trim Rot and Damage*

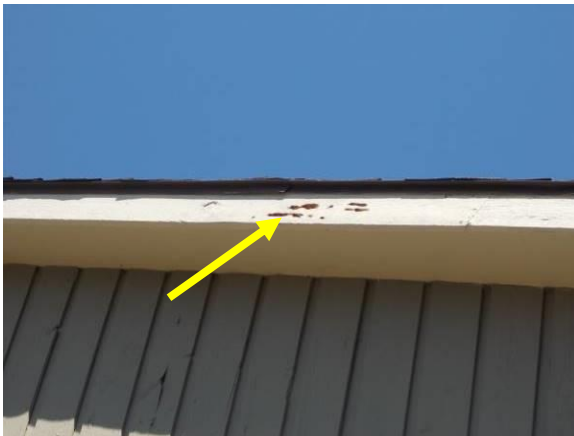
*Examples of Deteriorated Trim & Insect (Carpenter Bee) Damage*

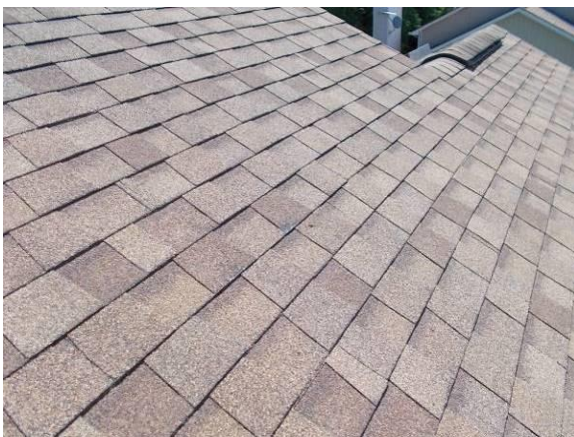
The roof surface appeared to be in average condition in comparison with other buildings. Some amount of deterioration and granule loss was noted.

*Roof Surface*

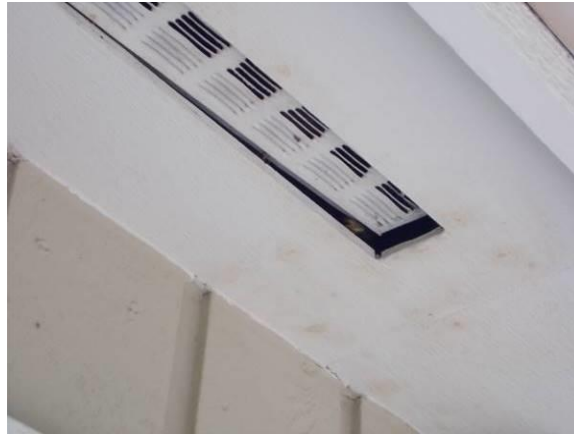
We noted that the soffit vent on unit #83 is damaged and presenting an entrance point for pests.

*Soffit Vent to Repair on Unit 83*

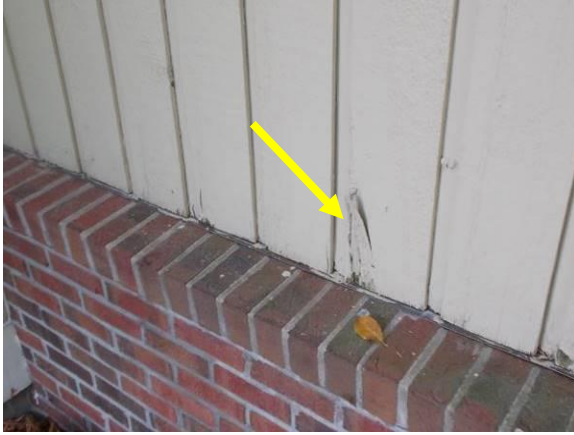
Gaps and openings were noted in various areas of the vertical siding. In relation to other buildings, an average amount of deterioration was noted at brick ledges as well as at interfaces with roof surfaces.

*Examples of Deterioration and Open Joints*

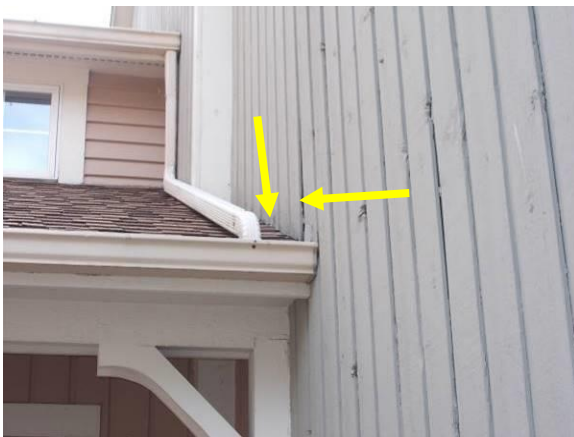
*Examples of Deterioration and Open Joints*

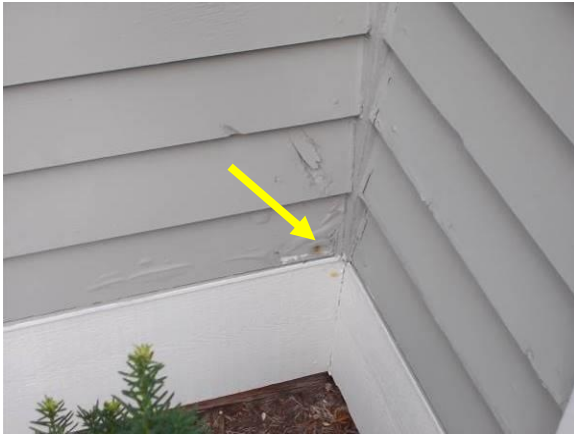
We noted that four of the chimneys have been retrofitted with vinyl siding. Because of this we suspect an above average amount of rot and deterioration most likely occurred in these areas. We noted areas with damage to the siding caused by defects in the wood, most notably some knots becoming loose and falling out.

*Examples of Deterioration & Damage Due to Wood Quality*

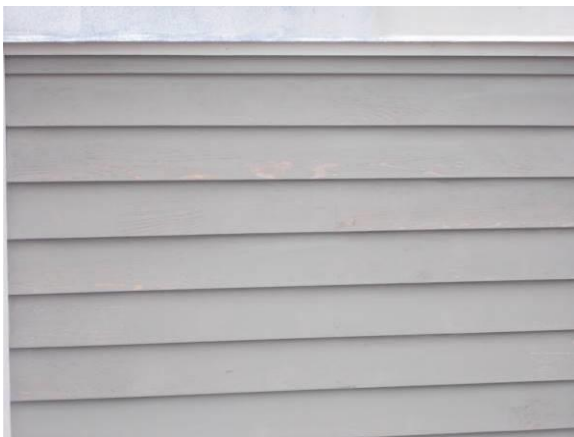
We noted isolated areas on the clapboard siding that are showing signs of paint or stain delamination. These appear to be caused by a combination of water penetration as well as weathering.

*Examples of Delaminating Paint/Stain*

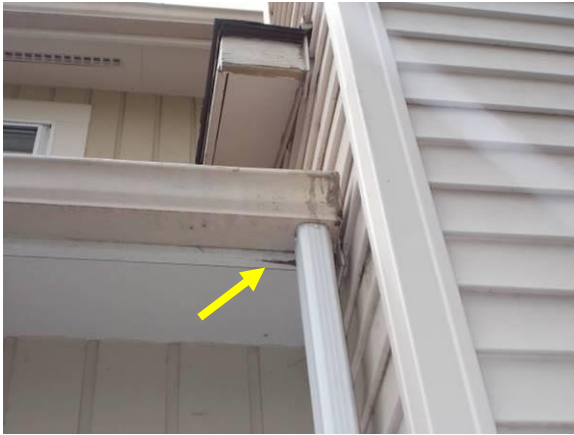
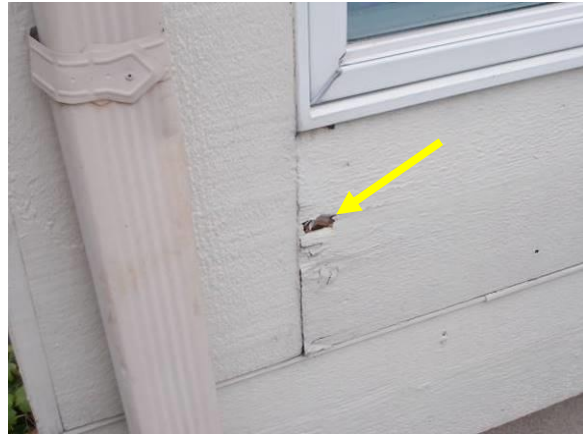
We noted multiple areas of deteriorated trim at gutter ends. This indicates that some amount of leakage is most likely occurring and water is bypassing gutter ends from a lack of kick-out flashing.

*Examples of Damage to Trim and Paint/Stain*

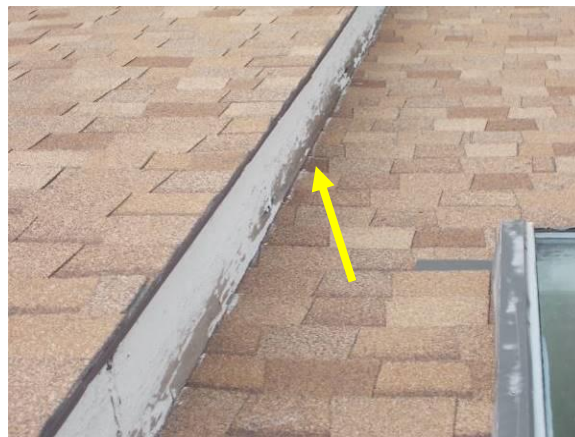
*Examples of Damage to Trim and Paint/Stain*

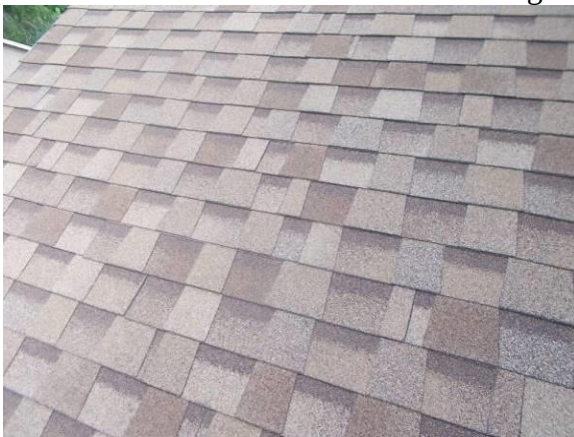
The roof surface appeared to be in better condition as compared to most of the other roof surfaces. We did note at least one missing or damaged shingle. This may be due to a high wind weather event or an isolated incident causing the damage.

*Roof Surface and Damaged Shingle*

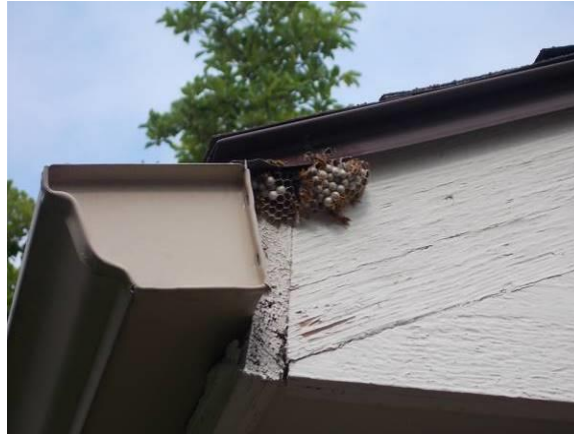
We saw an active insect nest on the right side of unit #111 adjacent to the garage. The homeowner was notified at the time of inspection.

*Insect Nest (wasps)*

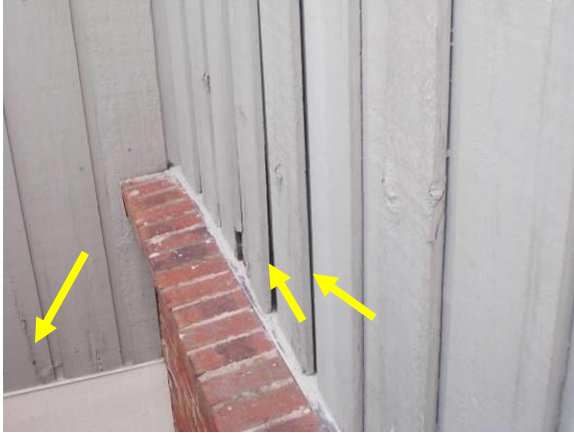
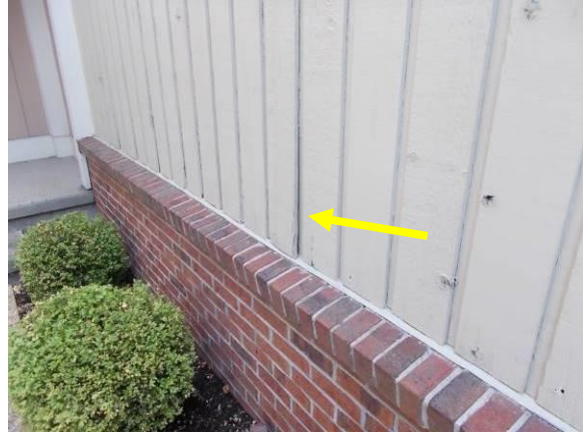
We noted an above average amount of warping and opening joints in the vertical siding. Also, as is typical with the other buildings, deterioration was noted at the base of the siding where it comes in contact with brick ledges and roof surfaces.

*Opening Joints and Deterioration*

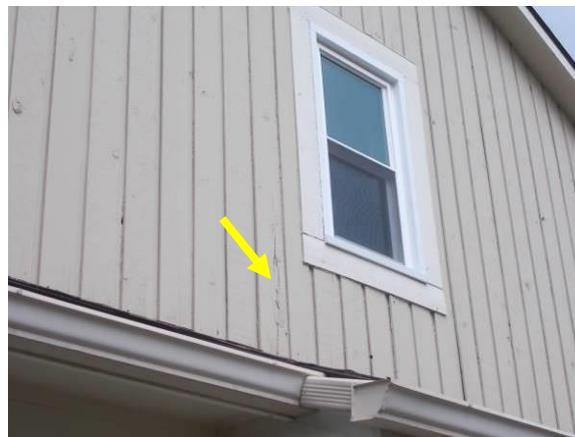
*Opening Joints and Deterioration*

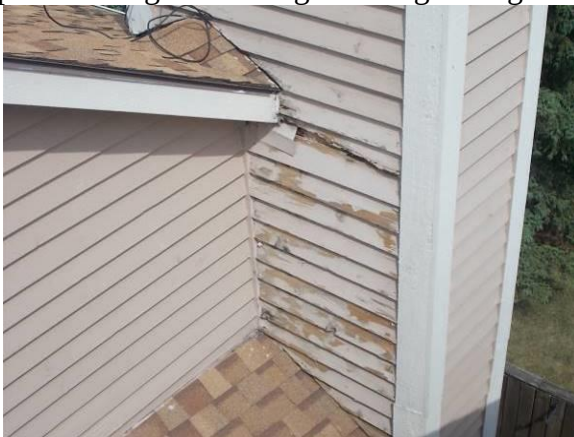
Deterioration was noted to the clapboards and on many areas of chimney surrounds. Also, there appears to be gutter leakage causing damage to the siding.

*Water Damage To Chimney Enclosures*
