PRO-ENGINEERED INSPECTIONS

RE: Brittany Commons  
Rochester, NY 14618

### **INTRODUCTION**

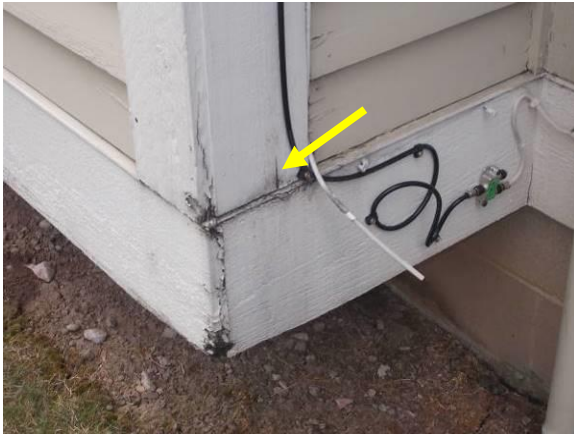
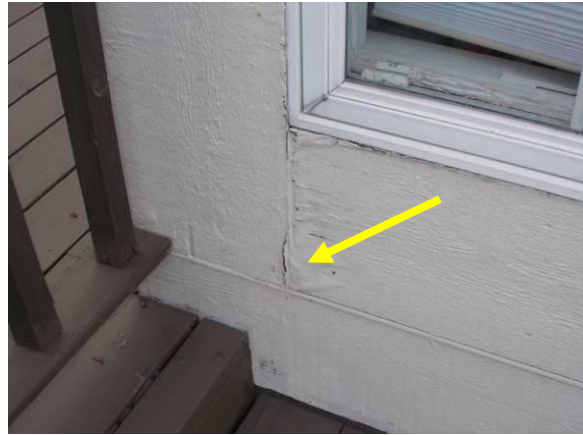
Isolated areas of damage were noted. These areas include chimney surrounds as well as lower portions of trim under windows. Some trim along roof surfaces is showing above average amounts of damage.

*Examples of Trim Damage and Deterioration*

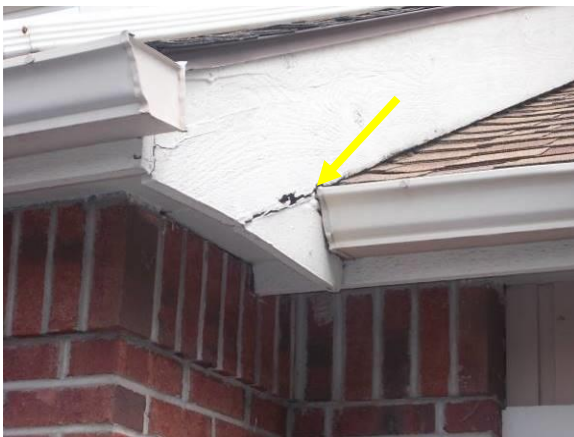
*Examples of Trim Damage and Deterioration*

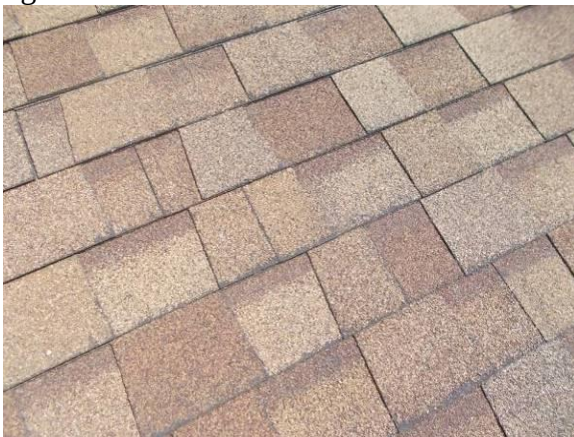
The roof surface appears to be in below average condition. We noted a damaged and missing shingle above unit #155.

*Example of Worn Shingle Surfaces and a Missing Shingle Tab/Edge*

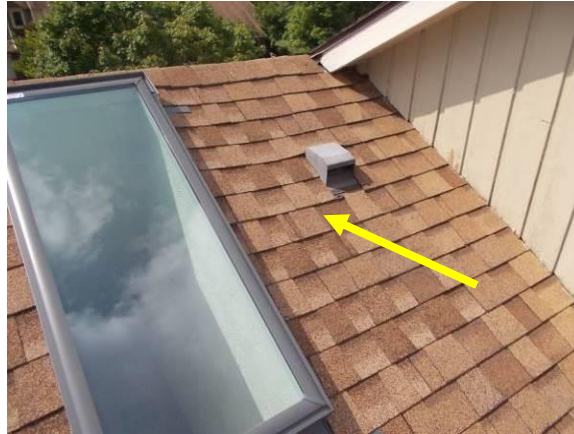
While walking the roof we noted an area adjacent to the skylight above unit #143 that was soft underfoot. This could be due to past or present leakage in this area. We suggest that the area be inspected for signs of active leakage. When reroofing or repair occurs, the sheathing may need replacement in this area and a small amount of reinforcement could be required.

*Soft Area of Roof*

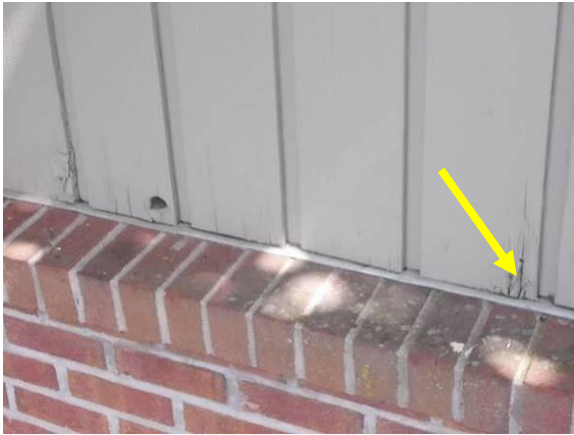
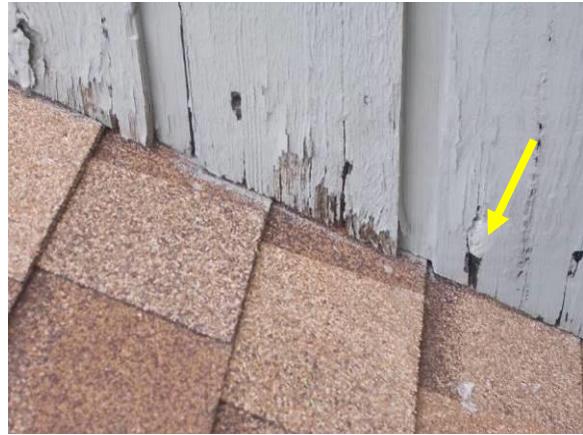
Deterioration was noted at interfaces of different materials. Also, portions of the siding appear to be worn due to weather.

*Signs of Deterioration and Wear*

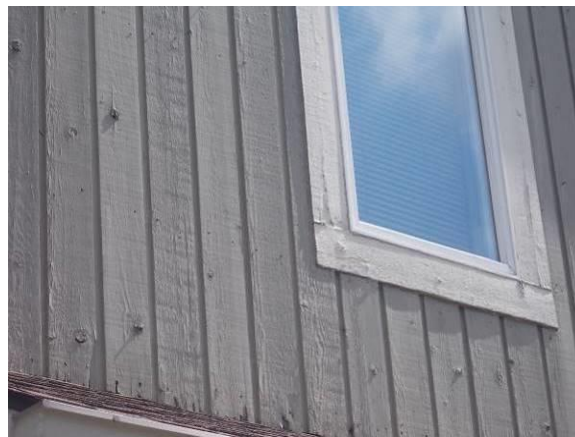
*Signs of Deterioration and Wear*

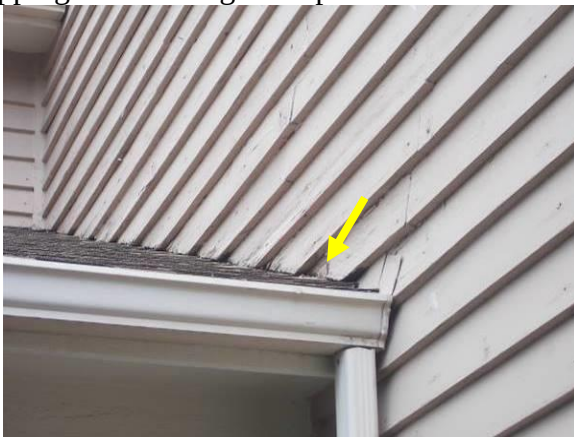
This siding has experienced typical isolated damage around chimney enclosures as well as cupping and twisting of clapboards.

*Examples of Water Damage*

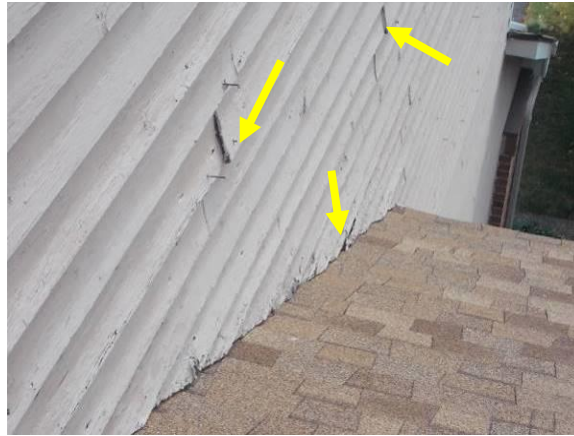
Portions of the paint or stain on the horizontal siding of this building are showing signs of wear. This is most likely due to weather exposure. Siding is cupping and curling and nails are coming loose from the siding.

*Wear and Damage to Siding*

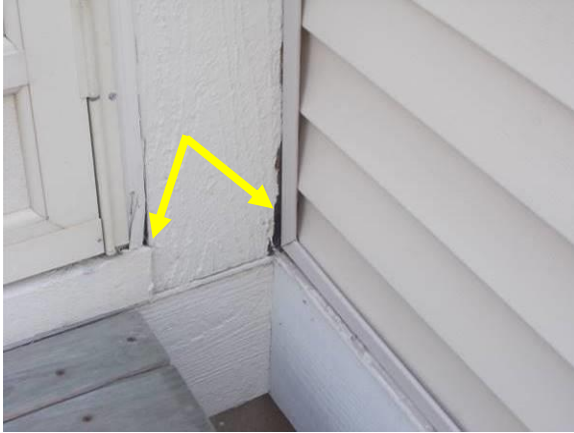
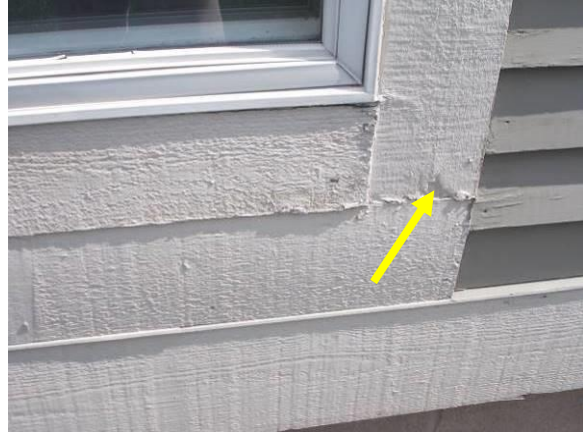
As with most buildings, areas of isolated trim damage can be found around the chimney surrounds. Also, there are areas with leaking and bypassed gutters causing trim damage. We noted evidence of insect damage on various portions of the trim, including some window trim.

*Examples of Trim Deterioration*

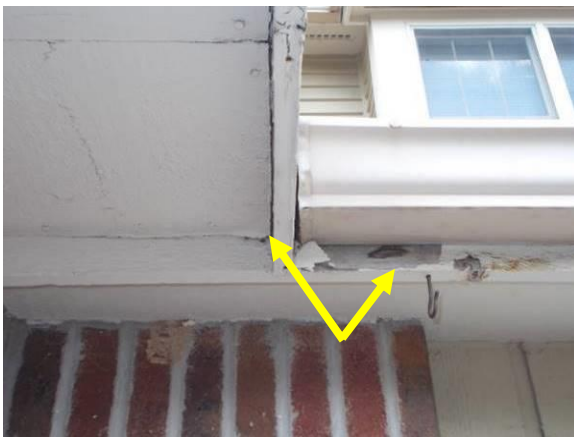
*Examples of Trim Deterioration*

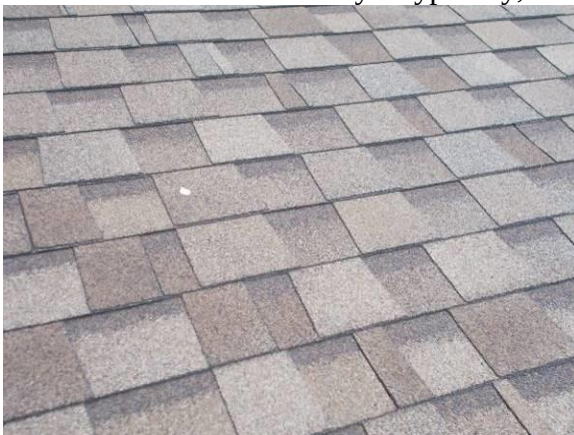
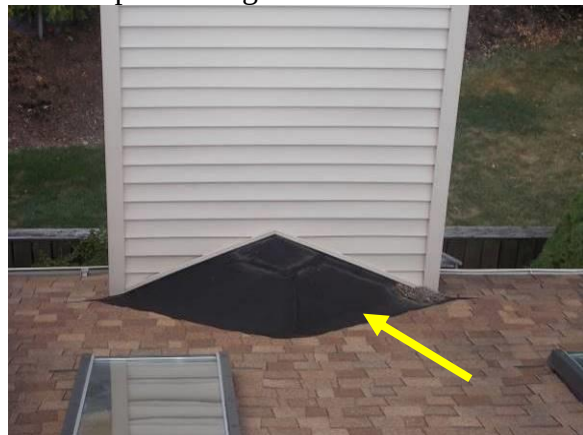
The roof surface appeared to be in generally serviceable condition. The shingles appeared to be in better than average condition in relation to the other buildings. However, we did note a repaired cricket at one chimney. Typically, this indicates past leakage.

*Example of Shingle Condition & Repaired Roof/Chimney Cricket*

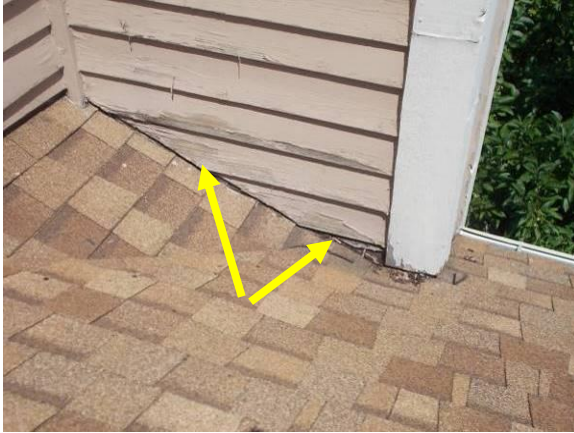
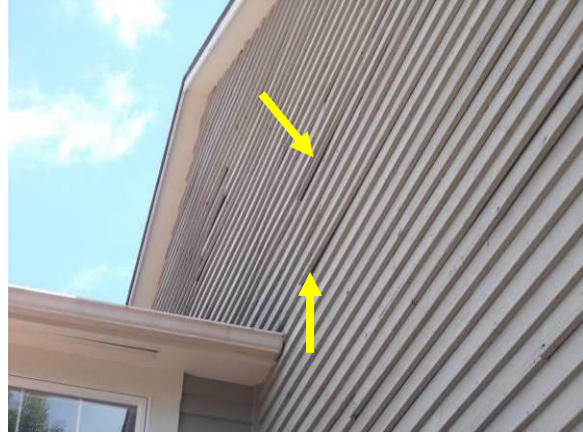
Isolated areas of damage were noted on chimney enclosures as well as at roof interfaces. We noted areas of siding pulling away from the wall sheathing.

*Deterioration and Paint Delamination & Cupped and Warped Clapboards*

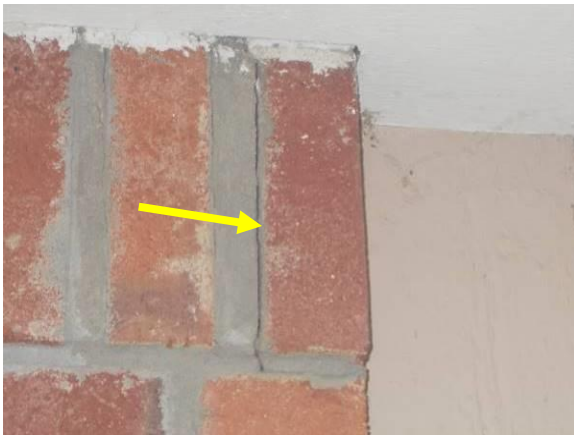
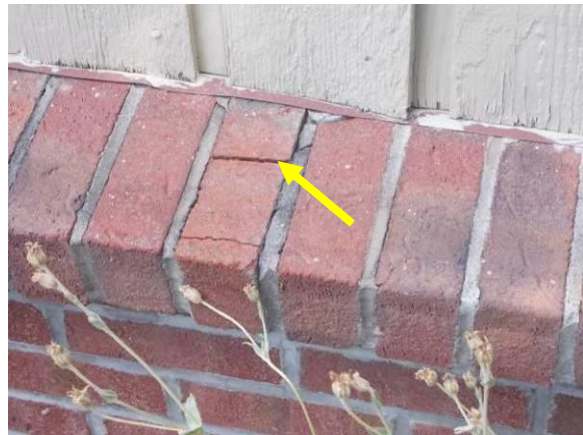
The brick appeared to be in generally serviceable condition. As with many buildings, we found isolated areas of cracked mortar joints at garage door opening corners. Isolated damaged bricks were also noted.

*Cracked Mortar Joint at Header & Damaged Brick*

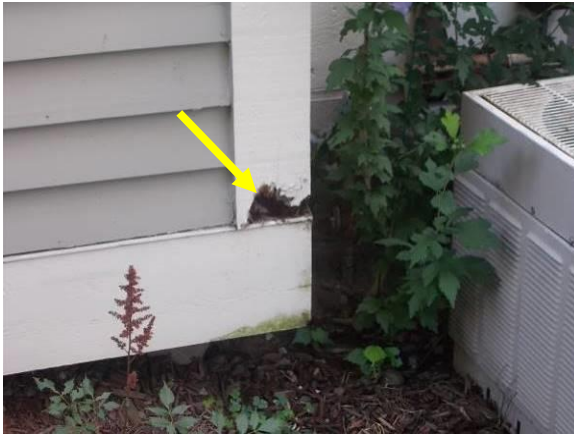
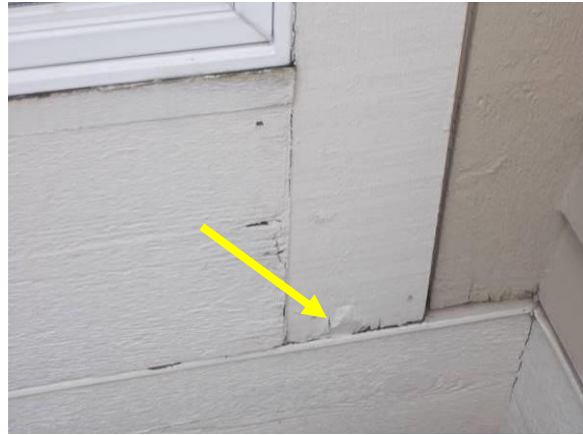
We noted areas of rotted or damaged trim around portions of most chimney enclosures. Also, areas of other trim damage were found.

*Examples of Damaged and Deteriorated Trim*

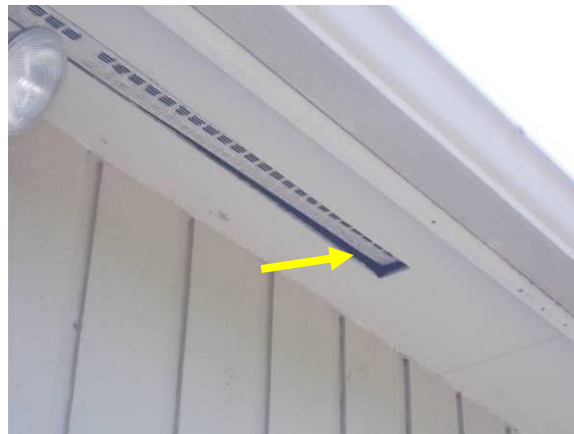
*Gaps around Soffit Vent*

We noted a soffit vent that is not properly installed. This should be reset in the soffit to reduce the risk of unwanted pest entry or nesting.

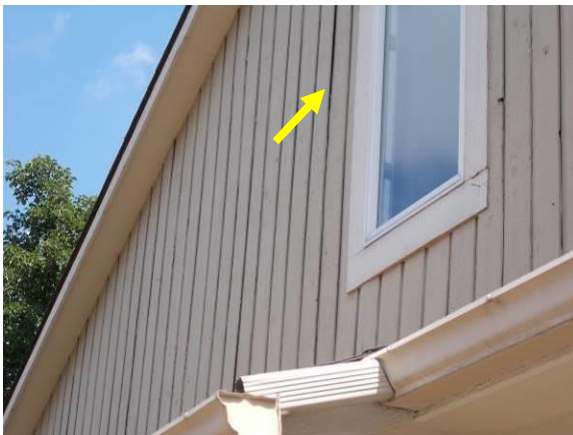
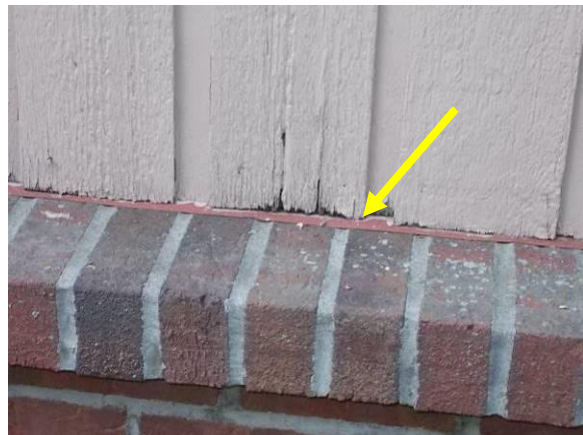
Areas of open vertical joints were noted between siding. Also, there are areas of opening horizontal edges and weathered surfaces.

*Examples of Weathered Siding with Opening Joints & Deterioration at Brick Ledge*

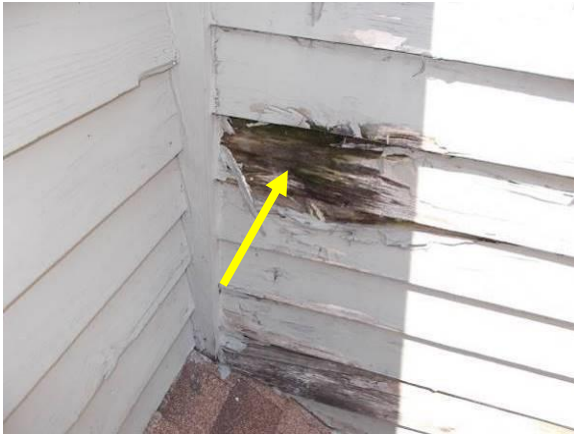
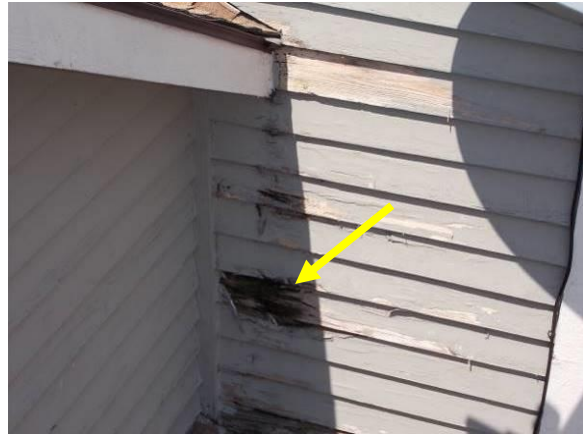
Areas of more severe damage were noted. These are typically isolated to the chimney enclosures that have not yet been sided with vinyl. Also, some cupping to the siding was noted on exposed surfaces.

*Examples of Damage and Deterioration*

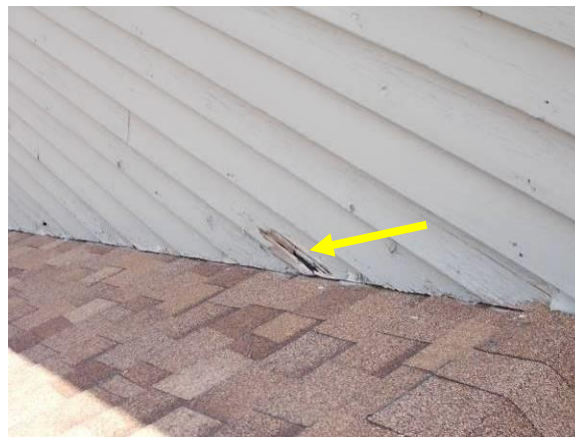
*Examples of Damage and Deterioration*

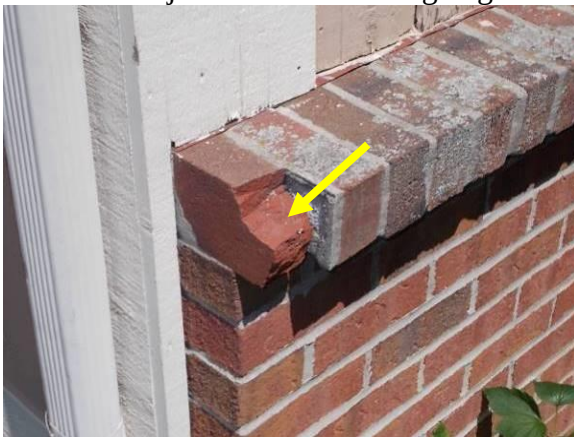
Isolated areas of damage were noted. These includes some broken and spalling bricks. Also, cracked mortar joints exist at some garage door openings.

*Damaged Bricks*

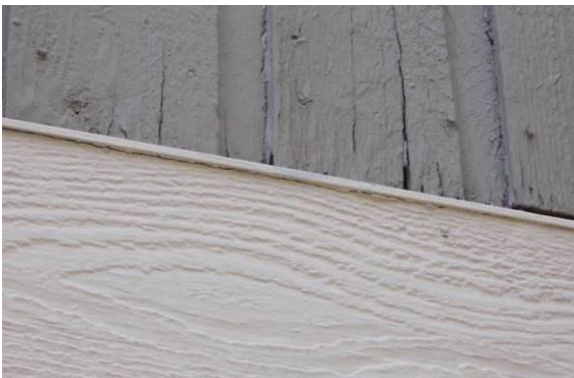
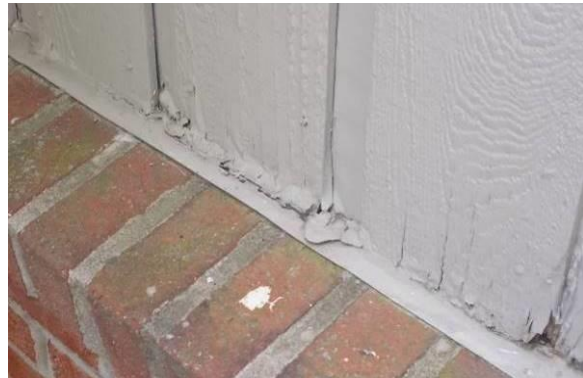
Areas of wear were noted at interfaces of differing materials. Also, gaps were noted along vertical seams.

*Examples of Deteriorated End Grain*

In general, the vertical lap siding is in need of the most repair or replacement in terms of a percentage of overall siding. As noted above, the most severe damage appears to be in clapboard siding, but this is more isolated to small areas (in terms of overall quantity of square feet of siding). The damage to the vertical lap siding is more uniform and widespread throughout. This is most notable in open gaps along seams as well as deterioration to the base of the siding at interfaces with other materials such as brick ledges, roofs, and wood trim. Gaps and openings in

the siding should be sealed to help prevent unwanted pest and water intrusion. However, over time, new gaps will open and existing gaps will reopen and grow. This is due to continued movement during seasonal temperature and humidity fluctuations, and the effects of rain and moisture penetration. The deterioration to the base of this type of siding is most likely due to flashing details at the interface of the dissimilar materials, along with the tendency of the open grain ends of this siding to wick moisture up from capillary action. The end grain of wood is susceptible to wicking and absorbing moisture, especially with this vertical siding. This will lead to faster rates of deterioration. We did note at least two areas of repairs to base of vertical siding. These were on buildings “C” and “S”. These appear to be effective short term solutions. However, the potential for ongoing damage will still be present.

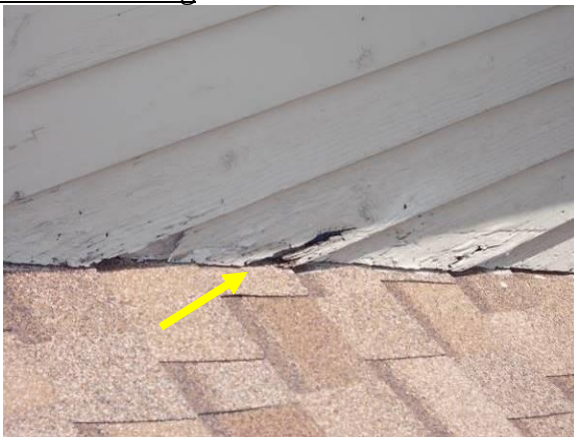
*Examples of Trim Deterioration at Roof Interfaces*

The clapboard siding has suffered deterioration at intersections of different materials. These areas appeared to have the highest concentration of deterioration.

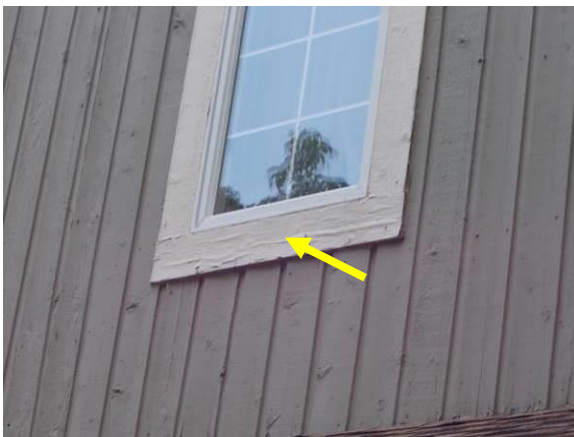
We noted areas of rotted or damaged trim around portions of most chimney enclosures. Also, areas of isolated deterioration and insect damage were noted.

*Examples of Rot in Need of Repair and Gaps in Trim*

In general, the areas in need of most immediate repair and/or replacement are the existing wood chimney enclosures. Continued replacement of these enclosures with a more rot resistant material, such as vinyl siding, is recommended. As noted above, special attention must be paid to the specific flashing needs of each enclosure. Due to the differing roof pitches and angles at each enclosure, the siding is at a high risk for water penetration and proper, improved flashing is critical.

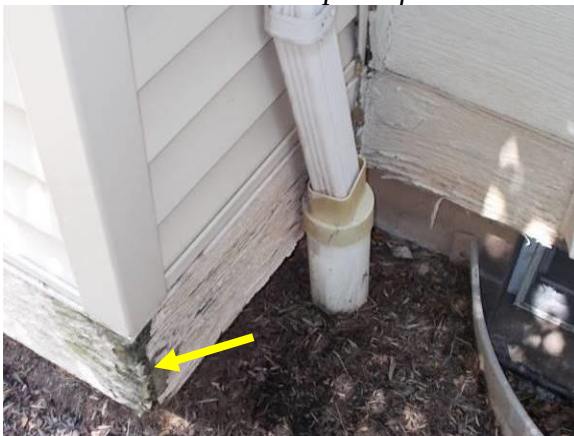
*Examples of Rot in Trim & Insect Damage (Carpenter Bees)*

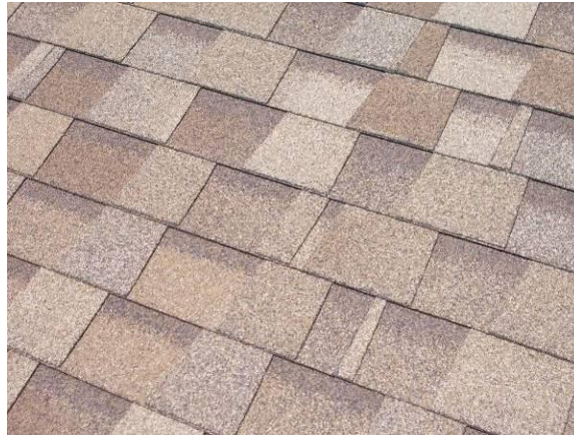
The roof surface appeared to be in above average condition when compared to the other roof surfaces of the complex.

*Roof Surface*

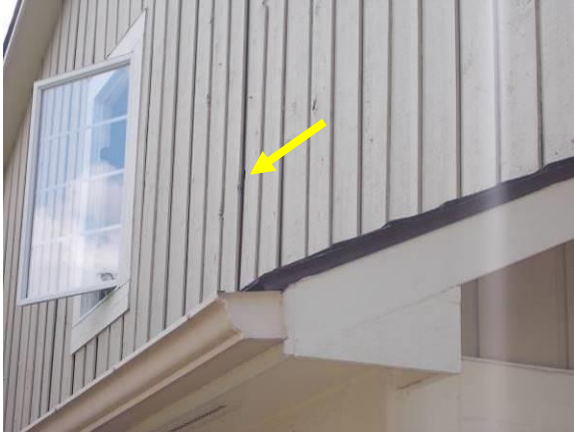
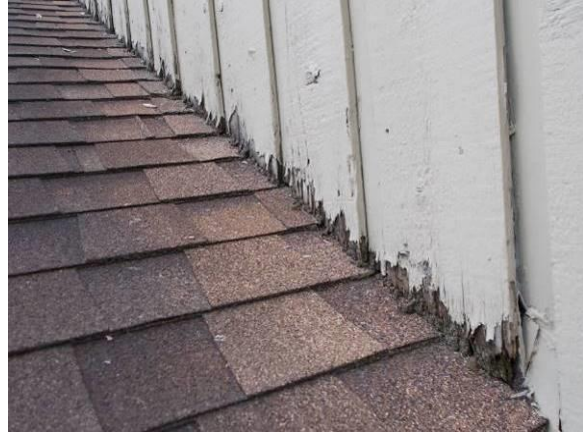
Typical to most buildings, rot and deterioration was noted at intersections with differing materials. Also, areas of opening vertical joints are present.

*Gaps in Vertical Joints & Significant Damage at Roof Surfaces*

Replacement of more of the vertical wood siding is also recommended. Replacement should begin in the most worn areas. Because damage is fairly widespread and relatively consistent it is difficult to prioritize areas. If it is decided not to replace this siding, at a minimum, we recommend modifications to the flashing and trim where the vertical siding intersects differing materials and partial replacement of deteriorated areas and deteriorated bottom portions at intersections. Due to the relatively high number of differing material interfaces as well as varied roof pitches and elevations, special consideration must be paid to the flashing around the siding. Proper flashing will be critical to the performance of any repairs that are made. Even with the installation of a rot resistant material such as vinyl, it is important to ensure that water is kept from behind the siding as much as possible. Moisture penetration can lead to rot of sheathing and framing members. Also, water damaged wood can attract unwanted pests.

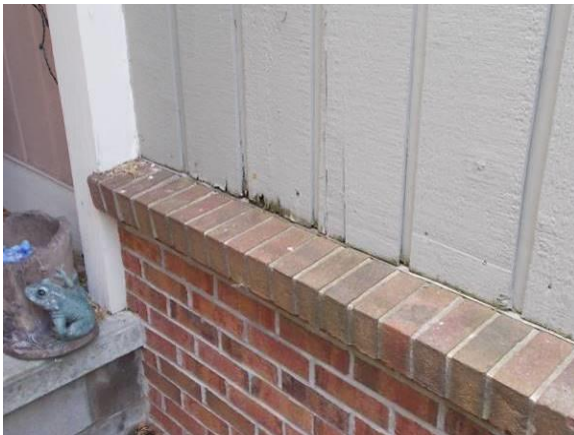
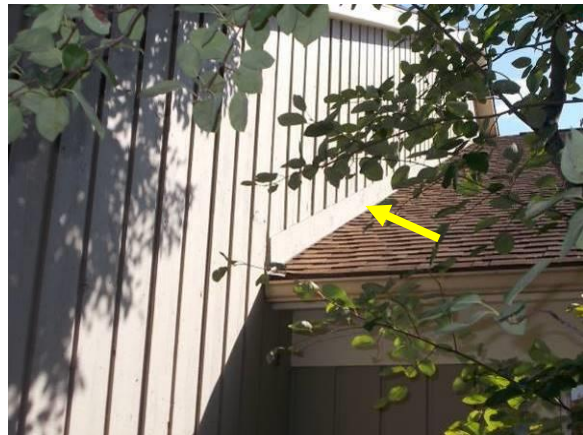
A repair to the intersection of the vertical siding and the roof of unit #176 was noted.

*Deterioration at Brick Ledge & Repair to Lower Portion of Siding at Roof Surface*

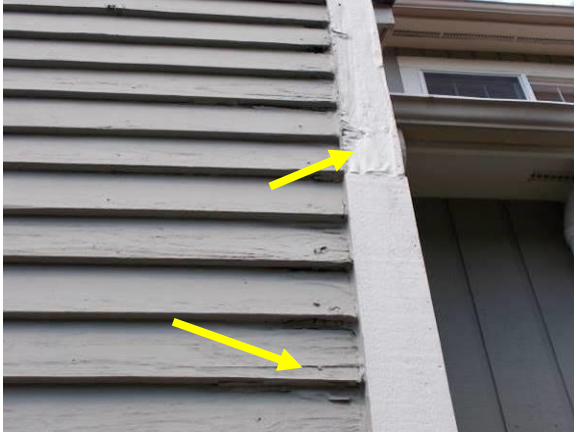
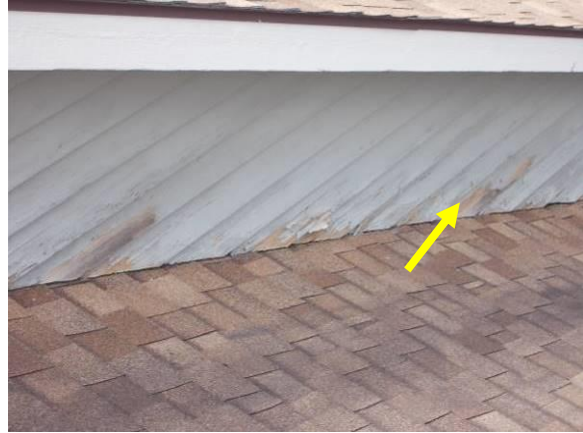
We noted isolated areas of severe rot and damage to horizontal siding on this building. Portions of chimney enclosures contain the most concentrated deterioration. Also, areas of siding are showing weathering where exposed to an above average amount of sunlight.

*Rotted Trim and Severely Weathered Siding*

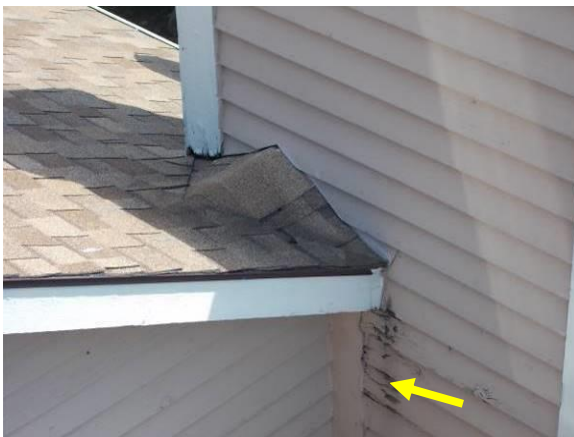
*Examples of Deterioration to Siding and Paint/Stain*

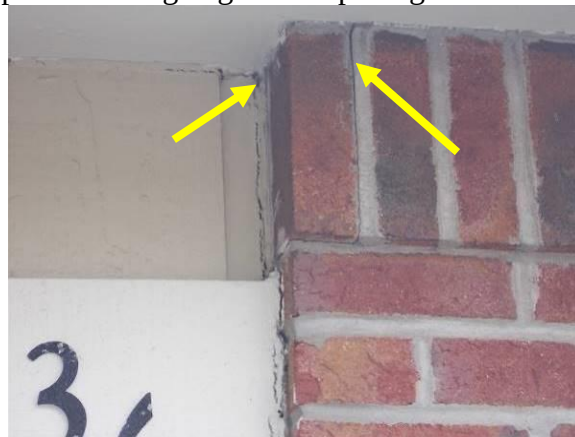
The brick veneer appears to be in generally good condition, with the exception of some minor, thin cracks noted at the top corners of garage door openings.

*Cracking at Garage Header and Areas to Seal*

The brick siding appears to be in serviceable condition. Isolated areas of cracking or separation from wood siding should be repaired as necessary. Damaged bricks should be replaced and small cracks that open more can be caulked or repointed. It is important to maintain these to help prevent additional deterioration. We recommend that this brick siding be kept in service, since it is in generally good condition overall and is a low-maintenance siding.

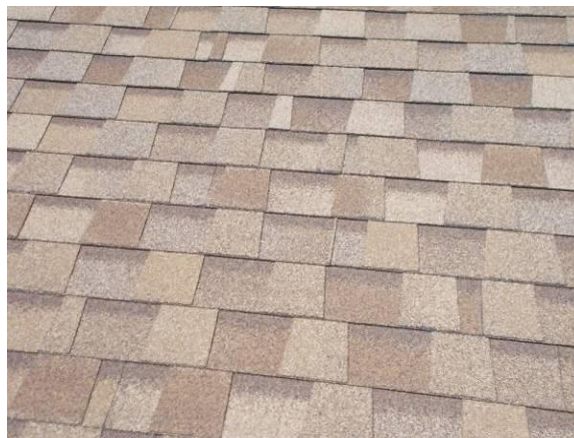
The roof surface appeared to be of average quality in comparison with other buildings. Some typical deterioration and granule loss was noted.

*Example of Roof Surface*
